ARBORICULTURAL IMPACT ASSESSMENT REPORT  
BS 5837:2012 'Trees in relation to design, demolition and construction. Recommendations'

Land east of Pines Hill, Stansted Mountfitchet, Essex

Luxus Homes Ltd

**DATE: August 2021**  
**OUR REF: SHA 1306**

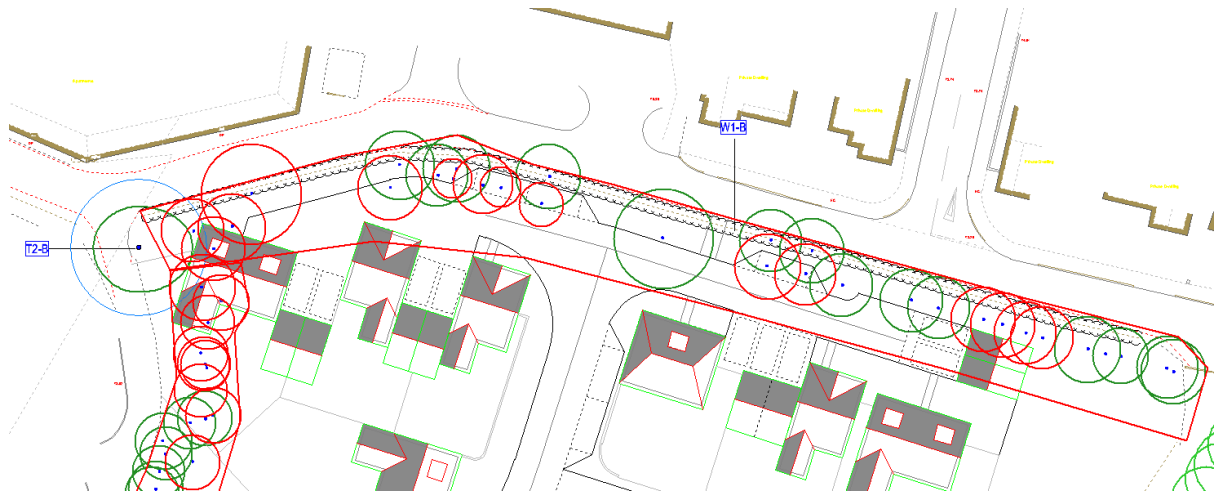
*Plan 1 – Extract from SHA 1306 TPP 1 – do not scale, north is vertical. Red trees to be removed and green to be retained*

Trees to be retained: 14 in W1, and T2. Trees to be removed: 16.

The trees to be removed, including any smaller or fallen trees not identified on the topographical survey will be marked up by the arboricultural consultant. Trees to be retained will have minor works for safety reasons and a further inspection will be carried out on their condition. The results of this will be reported to the Landscape Officer at Uttlesford District Council. A full tree surgery schedule is found at appendix 4.

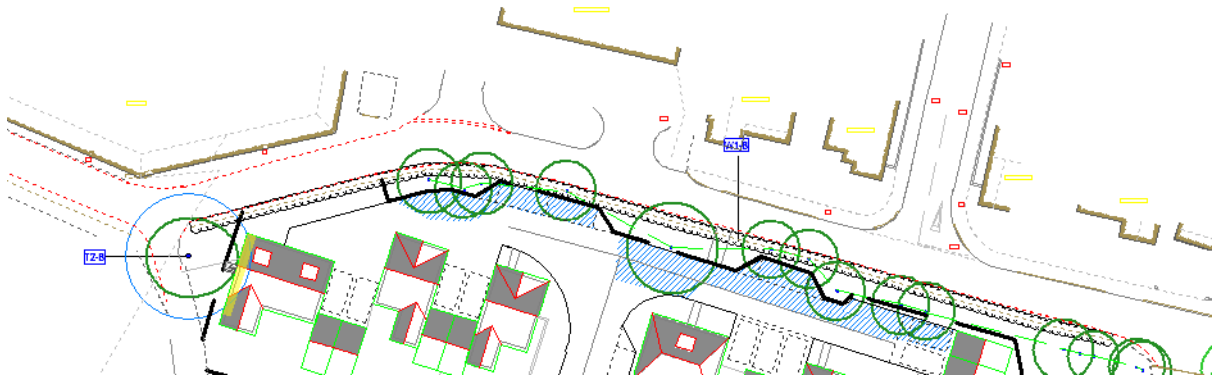
*Plan 2 – Extract from SHA 1306 TPP 2 – do not scale, north is vertical. Black dashed lines – tree protection fencing, blue dashed lines paving to be minimal dig and porous construction.*

The proposed property near the horse chestnut T2 is in the outer edge of the root protection area and is 6m from the trunk. As this area is currently occupied by the roots of trees to be removed, it is unlikely to be occupied by many roots from the horse chestnut. As a precaution, the foundation will be installed in accordance with the method statement at appendix 6.

*Yellow shaded area near T2 – area for arboricultural method statement for foundation installation*

The retained trees will be protected during construction by tree protection fencing in accordance with the specification at appendix 5 and at a location on the plan SHA 1306 TPP2 at appendix 3. The area to the south of the fencing will be protected with ground protection in accordance with the specification at appendix 5, or the sub base for the drive prior to any machinery being on site. The drive will be a minimal dig and porous construction in accordance with the draft method statement at appendix 6. The area to which this applies is shown by blue shading on the plan extract overleaf.

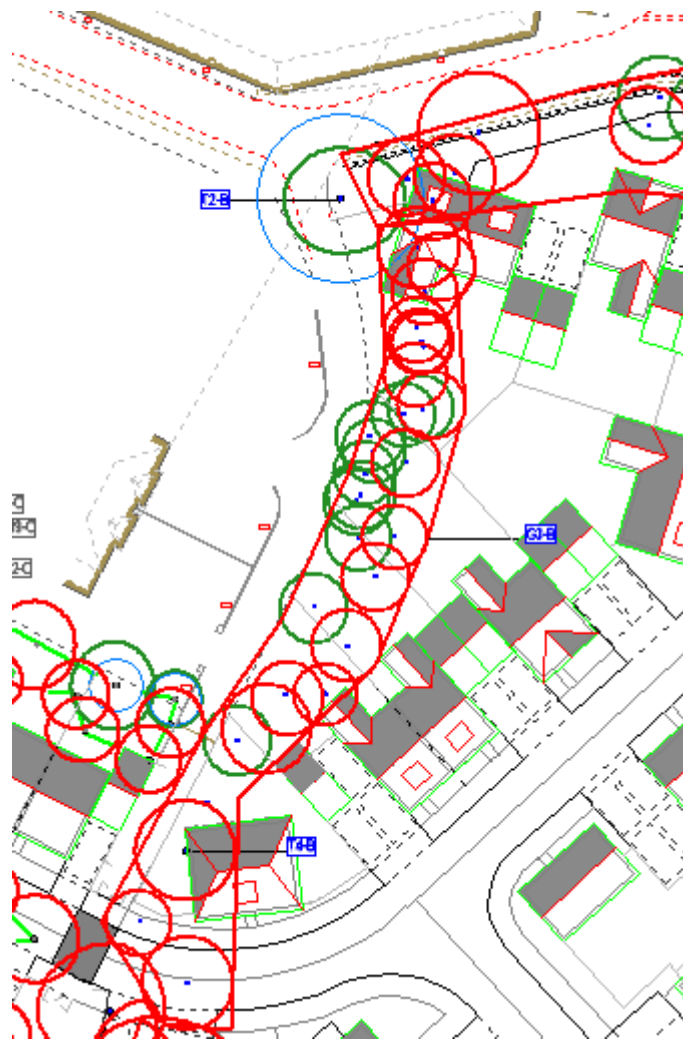
*Plan 3 – Extract from SHA 1306 TPP 1 – do not scale, north is vertical. Red trees to be removed and green to be retained*

The maximum number of trees have been retained without unreasonably dominating proposed rear gardens. The trees will be protected by tree protection fencing during works.

The trees are on the western aspect and will cast some shade in the evening, but the properties will be benefit from the screening and visual interest.

The trees to be removed, including any smaller or fallen trees not identified on the topographical survey will be marked up by the arboricultural consultant. Trees to be retained will have minor works for safety reasons and a further inspection will be carried out on their condition. The results of this will be reported to the Landscape Officer at Uttlesford District Council.

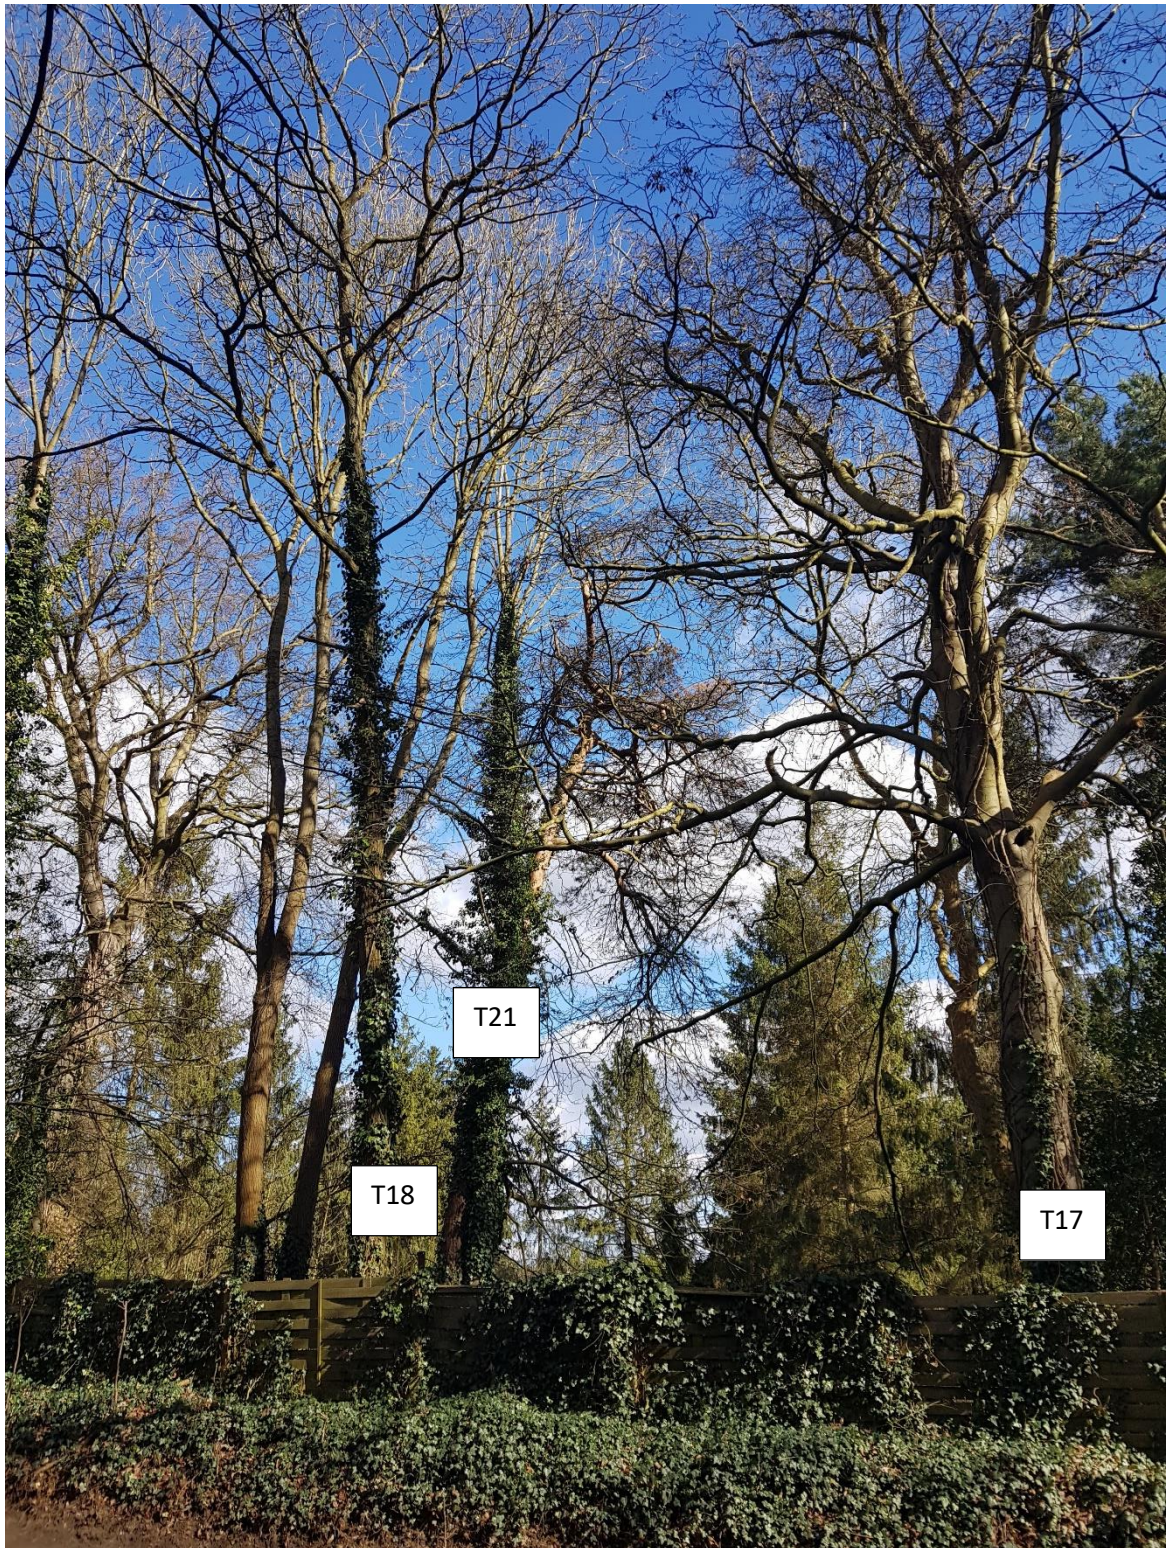
*Photo 8 of the view from Pines Hill*

This densely planted area includes two Norway spruce plantations and a mix of deciduous and coniferous trees, some of which are in a poor condition as detailed in the tree survey sheets at appendix 1. The best tree in terms of condition and visual amenity is T17 beech.

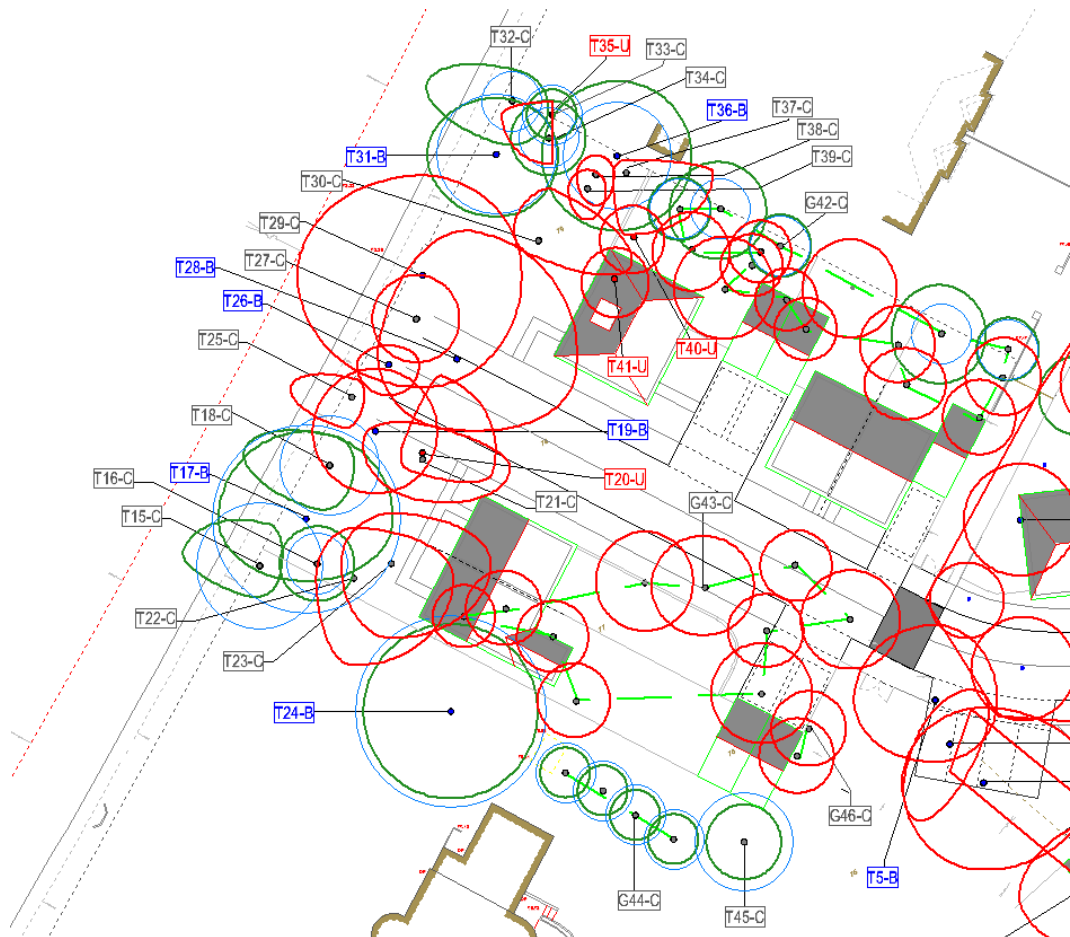
*Plan 4 – Extract from SHA 1306 TPP 1 – do not scale, north is vertical. Red trees to be removed and green to be retained*

One of the reasons for the high number of tree removals is the fact that the access from Pines Hill needs to be cut into the site, as the road is lower than the site. The drive will be edged with a retaining feature rather than battering back so that trees to the south of the access can be retained. The best tree, T17, is retained.

Trees to be retained will be protected during works by tree protection fencing. There is a slight incursion in the root protection for the proposed property near T24, however there are unlikely to be many roots present as there are two trees in G43 which will be removed in the footprint of the building. As a precaution the installation will take place under arboricultural supervision in accordance with the method statement at appendix 6. T24 will be lightly pruned back to the boundary line to enable scaffolding.
