**ACCIDENT**

<b>Aircraft Type and Registration:</b>	Pitts S-1S, G-BOXV	
<b>No &amp; Type of Engines:</b>	1 Superior XP-IO-360-A1HC3 piston engine	
<b>Year of Manufacture:</b>	1984 (Serial no: 7-0433)	
<b>Date &amp; Time (UTC):</b>	26 August 2022 at 0904 hrs	
<b>Location:</b>	Shobdon Airfield, Herefordshire	
<b>Type of Flight:</b>	Private	
<b>Persons on Board:</b>	Crew - 1	Passengers - None
<b>Injuries:</b>	Crew - 1 (Fatal)	Passengers - N/A
<b>Nature of Damage:</b>	Destroyed	
<b>Commander's Licence:</b>	Commercial Pilot's Licence	
<b>Commander's Age:</b>	59 years	
<b>Commander's Flying Experience:</b>	1,978 hours (of which 530 were on type) Last 90 days - 26 hours Last 28 days - 8 hours	
<b>Information Source:</b>	AAIB Field Investigation

**Synopsis**

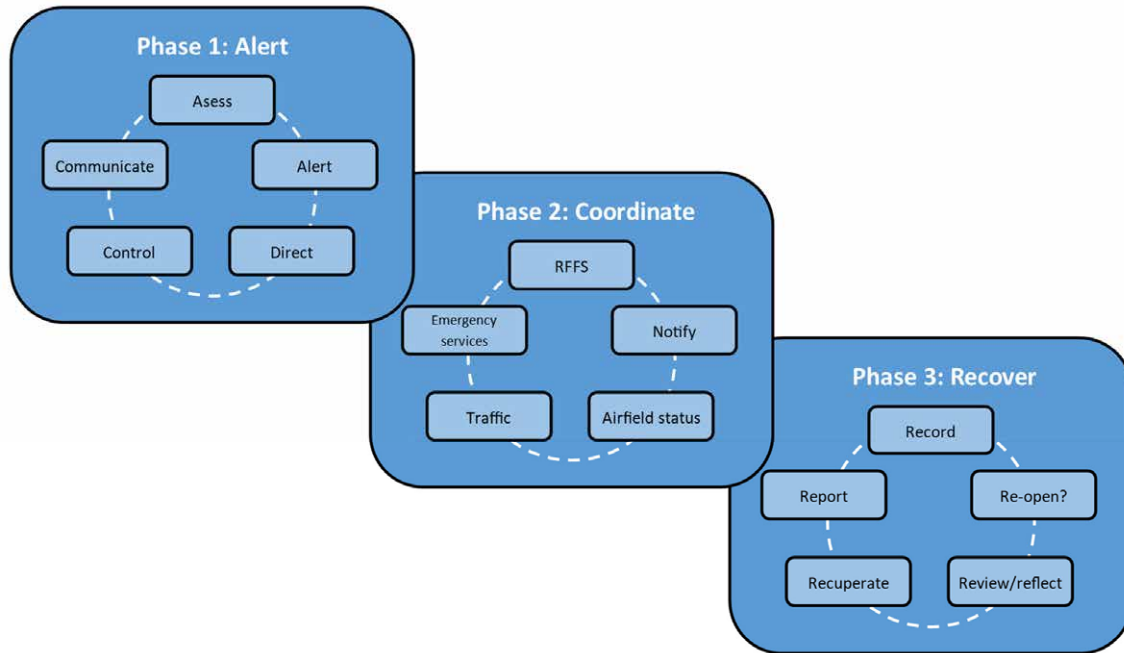
**Figure 7**

The combined operations team had recently updated the airfield incident response plan. Their previous experience was that, in stressful situations, standard sequential checklists were not always easy to follow, and their unidirectional flow pattern meant that, if steps in the process were missed, the slip was less likely to be caught and rectified. As a counter to this, they had developed a three-phase matrix response aide-memoire with key action priorities for each phase forming a circular flow chart (Figure 7).

Overview of airfield incident response matrix (used with permission)

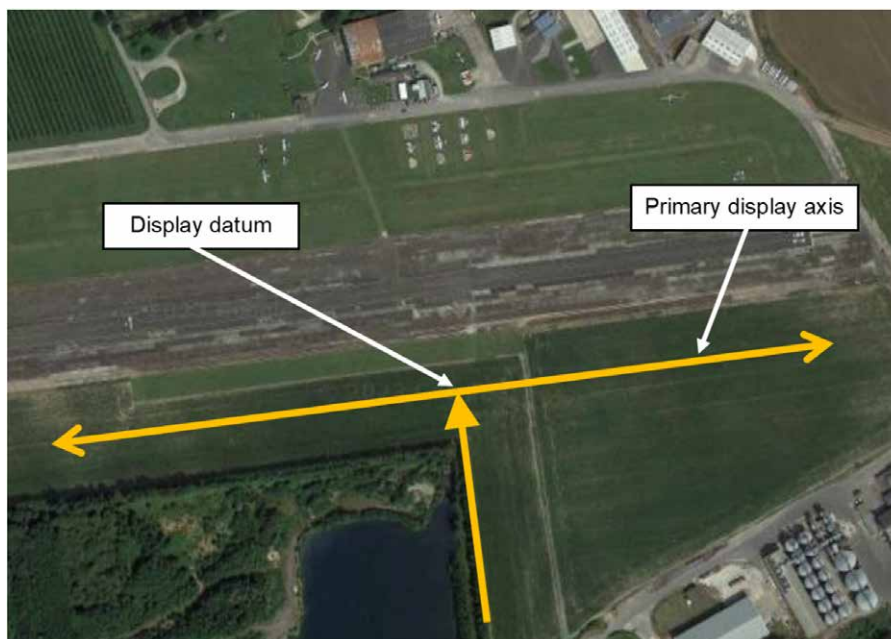
**Figure 8**

Documentation provided to the investigation indicated that, for his second planned flight, the pilot intended anchoring his display over a datum south of the runway (Figure 8). During the accident flight, the pilot began aerobatic manoeuvring south and west of this display area. The way the manoeuvres progressed suggested the pilot could have been using them to warm up while re-positioning the aircraft closer to his intended datum.

Primary display axis and datum for the pilot's second planned flight

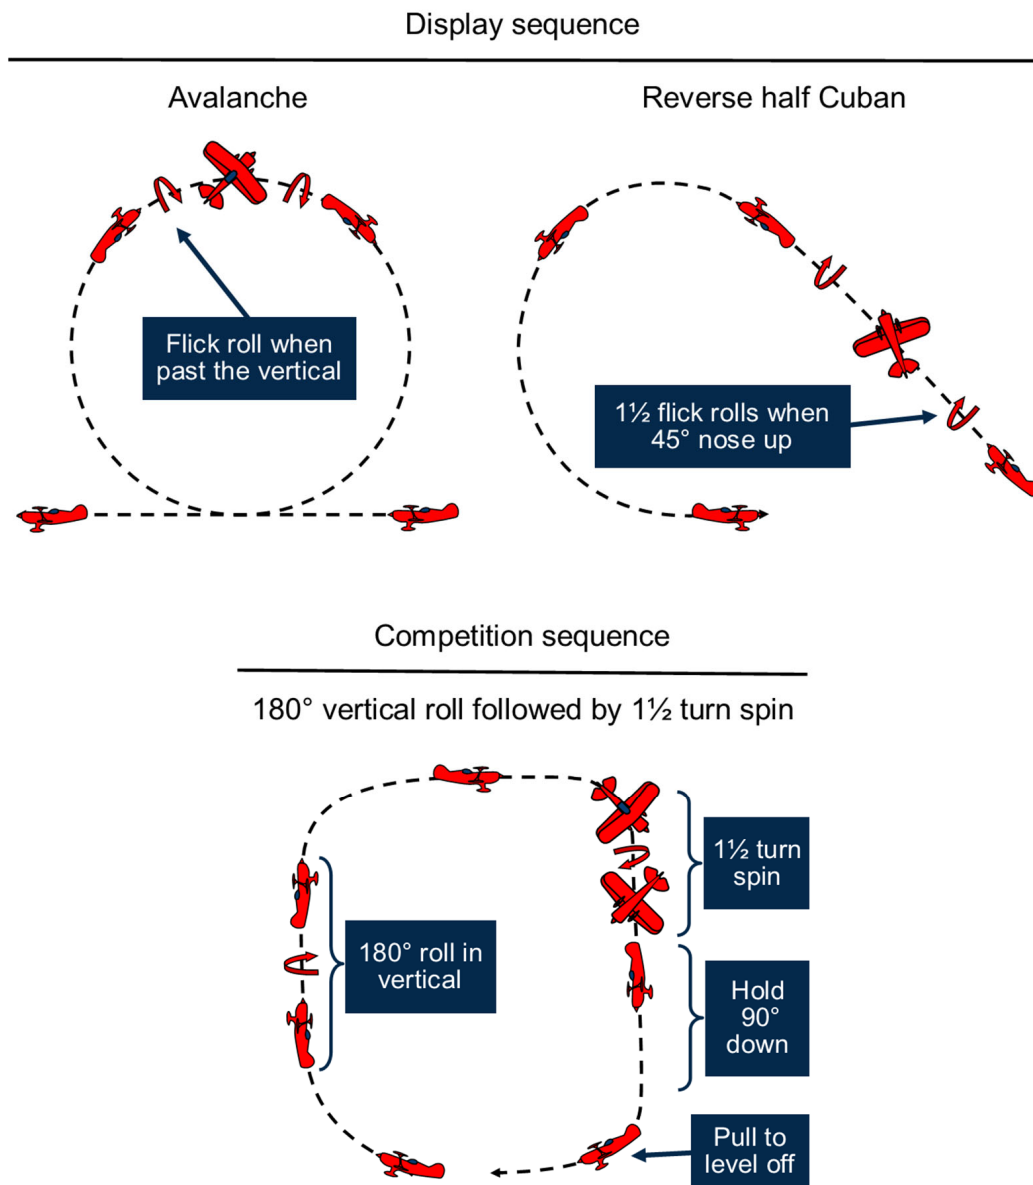
**Figure 9**

The closest comparable manoeuvres to that immediately preceding the accident were the 'Avalanche' and 'Reverse half Cuban' from his display sequence and a 180° vertical roll followed by a 1½ turn spin from his competition sequence (Figure 9). Annotations on a copy of the pilot's competition sequence indicated he used 2,500 ft agl as a target entry height for the spin and that, in contrast to the accident manoeuvre, it was preceded by decelerating level and erect flight to generate the required stall conditions for entry. While all three manoeuvres began with climbing rolls  $\pm 45^\circ$  from the vertical, none of them included a 450° upwards roll followed by a tight descending spiral.

Closest comparable manoeuvres from the pilot's known aerobatic sequences  
(not to scale)
