Annual Safety Review 2022

Air Accidents Investigation Branch
Farnborough House
Berkshire Copse Road
Aldershot
Hampshire
GU11 2HH.

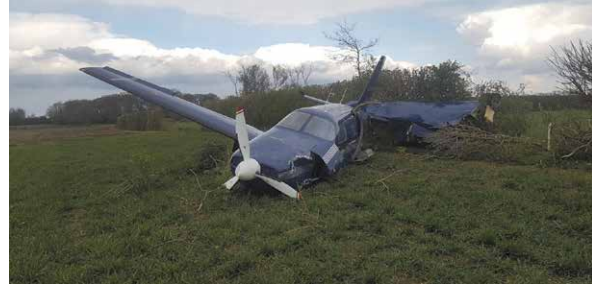
The electrically powered aircraft was undertaking experimental flight tests, under E Conditions, when power to the electrical motors was lost. A forced landing was carried out close to Cranfield airfield during which the aircraft was severely damaged.

G-HYZA accident site

The loss of power occurred during an interruption of the power supply when, as part of the test procedure, the battery was selected off with the intention of leaving the electrical motors solely powered by the hydrogen fuel cell. During this interruption the windmilling propeller generated a voltage high enough to operate the inverter protection system, which locked out the power to the motors. The pilot and observer were unable to reset the system and restore electrical power.

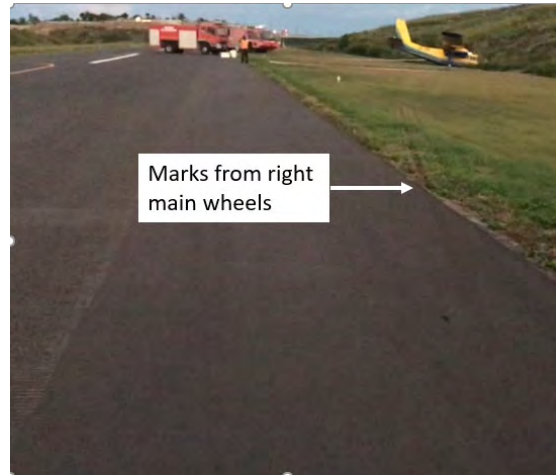
An inspection of the aircraft’s braking system revealed a slight brake fluid leak from one of the pistons in the left outboard brake calliper. This would have prevented full brake pressure being achieved on the left brakes, resulting in an asymmetric braking effect. Difficulty in maintaining directional control was compounded by the use of an incorrect braking technique on landing.

Still image captured from a video showing the aircraft’s departure point from Runway 10 and final resting place

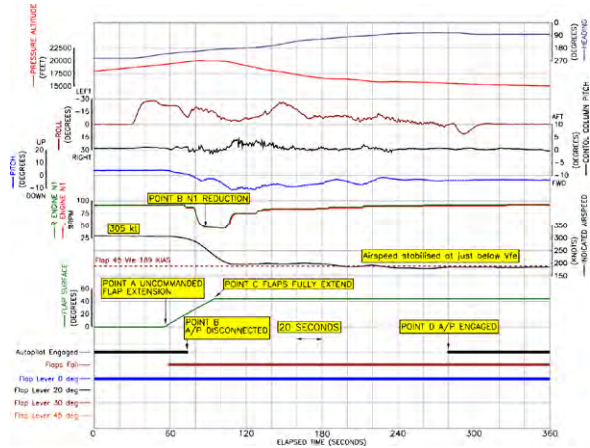
A Bombardier Challenger 604, registration D-AAAY, had an uncommanded flap extension, above the maximum flaps-extended speed while the aircraft was in the climb after departing Farnborough Airport. The aircraft returned to Farnborough where it landed without further incident.

FDR data of uncommanded flap extension

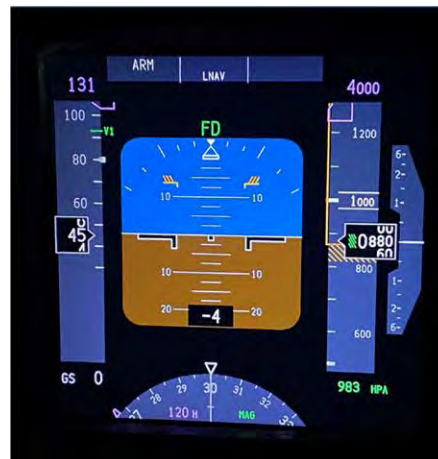
The thrust was not set correctly because the TOGA button was not pressed. It was not pressed because the co-pilot was startled by the aircraft starting to move when he set 70% power against the brakes. The aircraft started to move because the co-pilot applied insufficient brake pressure. The commander was distracted by a radio call and neither he, nor the co-pilot, checked the thrust was correctly set.

PFD prior to starting the takeoff
(image captured in a simulator)

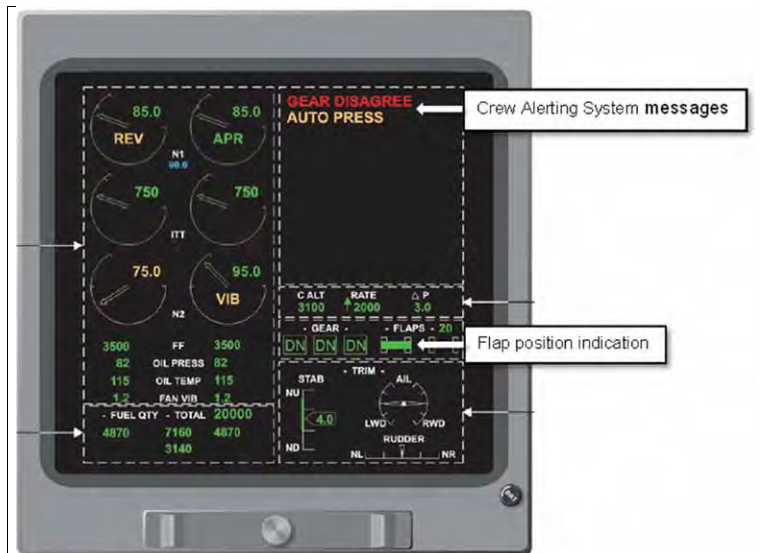
Illustration of EICAS primary page information

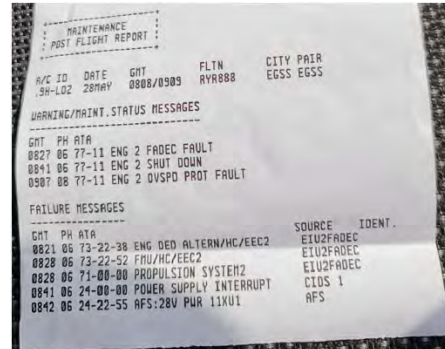
On a routine short flight, during final approach to land, the No 2 engine reduced to idle and would not respond to any control inputs. The flight crew performed a missed approach and, following the relevant checklist procedure, elected to shut down the engine. They then performed an uneventful single-engine approach and landed safely. The engineering investigation determined that the cause of the engine problem was most likely an inadvertent activation of the overspeed protection valve in the fuel control system. The problem has occurred previously on other V2500 engines and is being addressed through safety actions by the engine and aircraft manufacturers.

Post-flight report

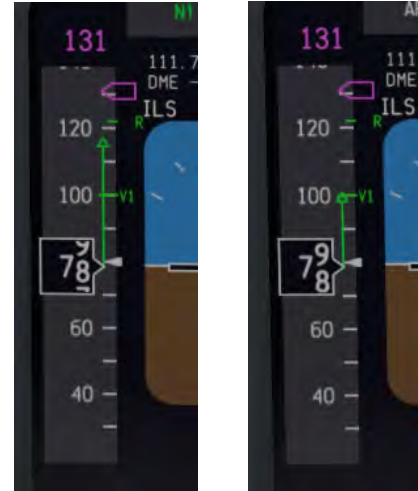
The thrust was not set correctly because the TOGA button was not pressed. It was not pressed because the co-pilot was startled by the aircraft starting to move when he set 70% power against the brakes. The aircraft started to move because the co-pilot applied insufficient brake pressure. The commander was distracted by a radio call and neither he, nor the co-pilot, checked the thrust was correctly set.

PFD Speed Tape trend arrow
(left image with 89% N₁,
right image with 70% N₁)
(Images captured on
a simulator)

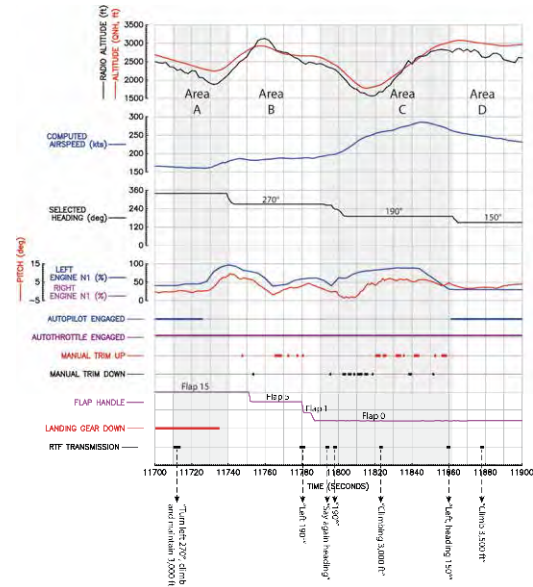
A serious incident occurred to a Boeing 737-800, registration G-FDZF, during a go-around at Aberdeen Airport on 11 September 2021. During the manually flown go-around, which was initiated at 2,250 ft amsl, the aircraft initially climbed, but just before it reached the cleared altitude of 3,000 ft amsl it began to descend. It descended to 1,780 ft amsl (1,565 ft agl) with a peak rate of descent of 3,100 fpm and accelerated to an airspeed of 286 kt (the selected airspeed was 200 kt) before the crew corrected the flightpath. The aircraft descended for a total of 57 seconds before the climb was re-established. It is likely that the crew allowed the aircraft to descend unnoticed having become overloaded by the high workload during the go-around.

Flight data for the approach and subsequent unintended descent

As a result of this serious incident, Aberdeen ATC changed its procedures for aircraft being broken off from the approach, and the aircraft manufacturer issued guidance to pilots about the behaviour of the Autopilot and Flight Director System (AFDS) and autothrottle during go-arounds. The aircraft operator informed all its pilots about the event; included extensive go-around training in its training cycle; and completed a full review on pilot recency, which introduced additional restrictions to manage pilots through periods of reduced flying.

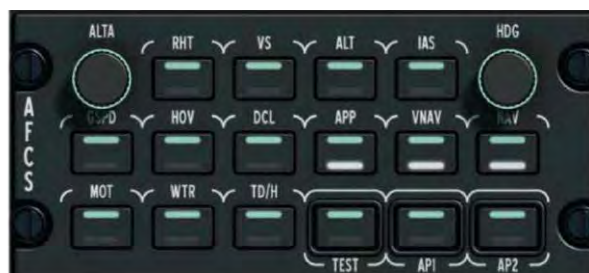
Autopilot Control Panel

The event was caused by a shortcoming in the design of the Phase 5 version of the AFCS software SAR upper modes which also resulted in incorrect AFCS mode indications to the flight crew. To address this issue pending the correction of the AFCS software in the Phase 9 release, the helicopter manufacturer issued a Technical Information Letter detailing actions to be taken in the event of a re-occurrence and updated the Flight Management System (FMS) Pilot's Guide for Phase 5, Phase 6 and Phase 8 software. The manufacturer has corrected the design shortcoming in the Phase 9 release of the AFCS software.

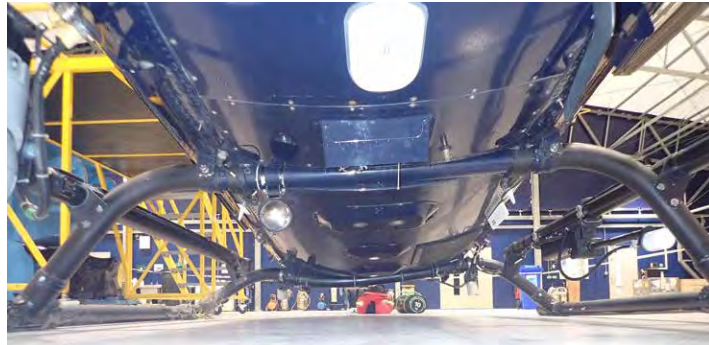
G-MPSB landing gear
(viewed from front looking rear)

While the aircraft's skid assembly was deformed as a result of the landing, the touchdown forces did not exceed the manufacturer's threshold for it to be classified as a 'hard landing.' The subsequent engineering investigation did not find any evidence of malfunction in the engine control systems. Engine No 1 probably did not respond because the rotor rpm droop compensation had been inadvertently trimmed in the wrong direction.

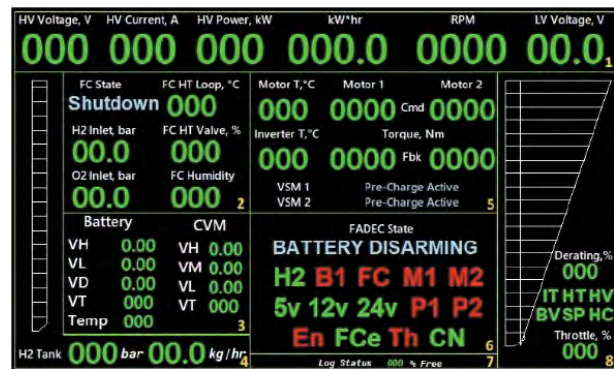
The loss of power occurred during an interruption of the power supply when, as part of the test procedure, the battery was selected OFF with the intention of leaving the electrical motors solely powered by the hydrogen fuel cell. During this interruption the windmilling propeller generated a voltage high enough to operate the inverter protection system, which locked out the power to the motors. The pilot and observer were unable to reset the system and restore electrical power.

Parameters displayed on pilot's powertrain electric cockpit display

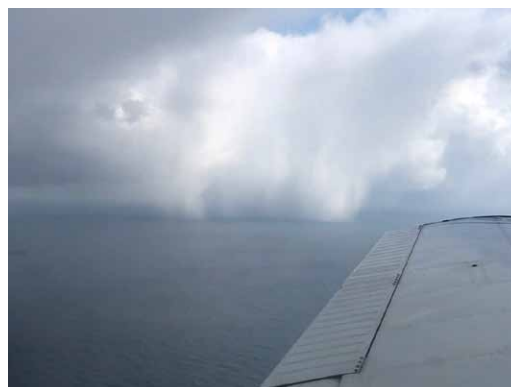
Photograph taken at 0924 hrs showing cloud to the surface

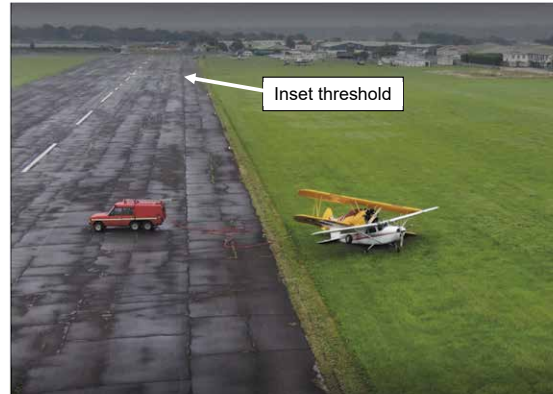
N68427 was completing a circuit at Dunkeswell Aerodrome when it landed on top of G-OMAG on the runway. G-OMAG had joined the circuit from the dead side and positioned ahead of N68427 on final for Runway 22. Neither pilot saw the other aircraft, nor were they alerted to the presence of the other by radio transmissions until late on the final approach.

Looking back to threshold of Runway 22
(image used with permission)

Following this accident, the CAA published a Supplementary Amendment to CAP 452 to improve the situational awareness of pilots operating at aerodromes providing an Air to Ground Communication Service.

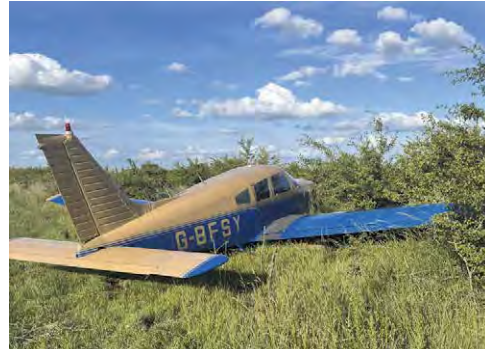
The aircraft landed on a disused section of runway at Chatteris Airfield, due to a combination of insufficient airfield detail available during flight planning, and disused runway markers obscured by long grass. Safety actions have been taken by the flight planning tool provider and local flying club to update the airfield information. The airfield has also taken action to maintain the grass length.

Accident site

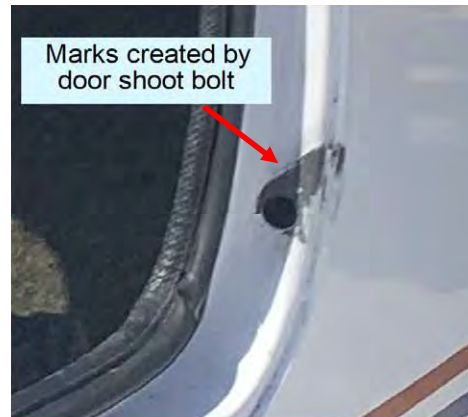
The pilot was on a local flight from Cotswold Airport with a passenger. The aircraft was flying at approximately 100 kt and 2,500 ft amsl when, without warning, the left cockpit door detached. After checking that the aircraft's control responses appeared normal, the pilot returned to Cotswold where the aircraft landed without further incident. Subsequent inspection of the left tailplane identified minor damage to the leading edge and upper surface consistent with it having been struck by the door.

Rear shoot bolt guide

This was the eighth event involving the inadvertent opening of cockpit doors fitted to Europa aircraft operated in the UK. The Light aircraft Association (LAA) have developed and issued a modification to the Europa to prevent the door latch lever reaching the closed position when the door is not properly latched.

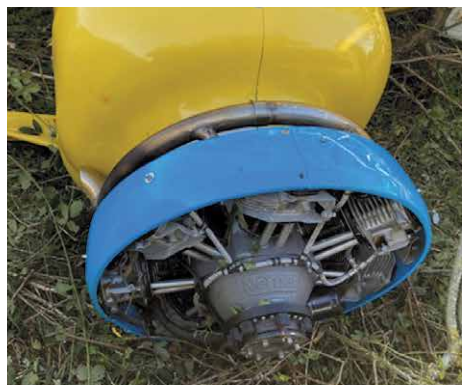
Shortly after takeoff the propeller departed the aircraft and then the engine over sped. All six propeller bolts failed in fatigue due to a lack of pre-load. It is possible that a misinterpretation of an engine manufacturer's requirement resulted in the incorrect bolt length being chosen. When the bolts were tightened to the correct torque they shanked, no pre-load was applied and failed due to normal propeller loads in fatigue. The aircraft was extensively damaged and the propeller was not recovered.

Close-up of propeller flange

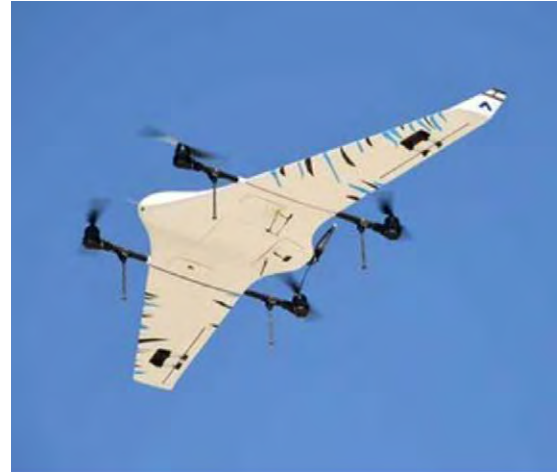
The Unmanned Aircraft (UA) was hovering at between 50 m to 65 m agl during a demonstration flight, when a rhythmic, lower than normal sound was heard emanating from the UA. It then dipped and spiralled downwards during which control could not be re-established. The UA hit the ground and was severely damaged. A fatigue failure of a blade attachment bolt caused one of the lift propeller blades to detach in flight.

- The manufacturer has introduced a 10-hour replacement schedule for the propellers and immediate propeller replacement if a Quadchute¹ event occurs.
- The manufacturer is carrying out a review of propeller designs for UAs under its development.

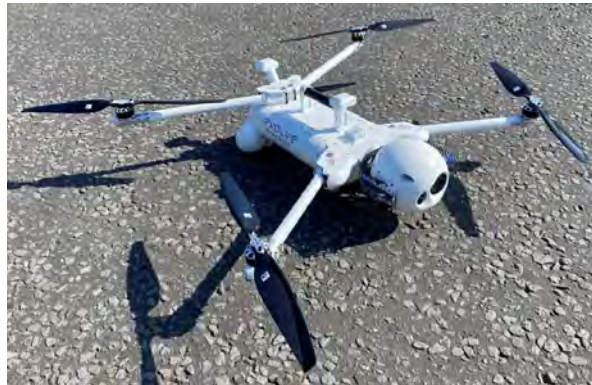
A screw which attached the propeller blade of an unmanned aircraft (UA) to the motor hub adaptor failed during a training flight. A second screw failure was experienced by the same operator after the UA had been repaired and had been fitted with a different design of hub adaptor and screws.

The first failure was caused by stress corrosion cracking possibly with the presence of hydrogen embrittlement. The second was a fatigue failure which may have been initiated and accelerated by hydrogen embrittlement. The hardness of both screws exceeded the specification which increased the susceptibility of the screws to hydrogen embrittlement.

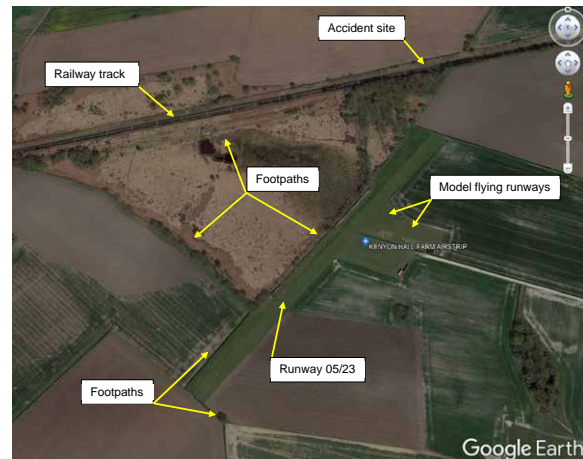
A turbine powered model aircraft suffered a loss of control during its maiden test flight. It continued to fly beyond visual line of sight before crashing on a railway track and was subsequently run over by a passing train. Safety actions taken as a result of this accident include publication of enhanced guidance for members by the British Model Flying Association (BMFA). The model flying club also amended its procedures relating to flying turbine powered models.

- In addition, the BMFA has updated its incident/accident reporting portal to specifically guide members to telephone Network Rail immediately in the event that an aircraft has come down on Network Rail property, in addition to the requirement to inform the AAIB.

- After the accident the club amended its procedures to require any turbine powered model to be approved by the club committee before it can be flown at the site, so that its suitability can be assessed. Following this investigation the club added a section to its procedures relating to retrieval of models that land outside the airfield boundary, which directly references the Network Rail 24-hour emergency telephone number.
