AAIB Bulletin

5/2023

Published 11 May 2023

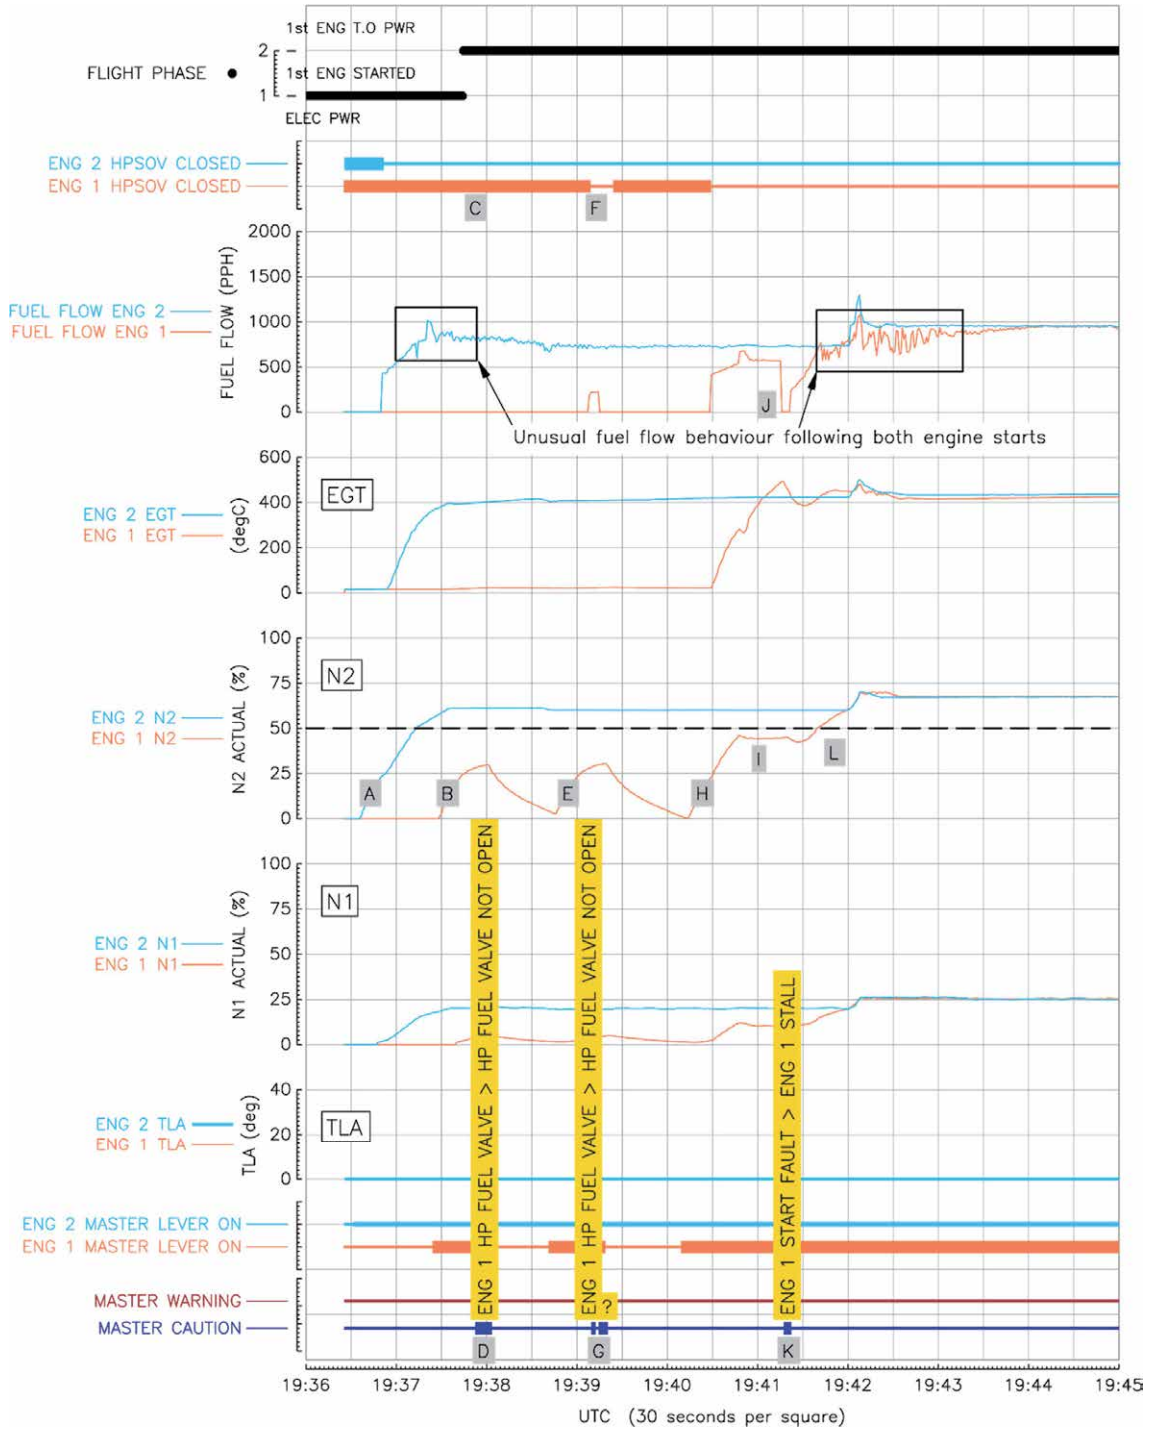
Figure 19

In February 2023, it was noted that Figures 19 and 21 in the report were incorrect in that they were identical to Figures 18 and 20 respectively. The correct versions of Figures 19 and 21 are shown below.

Correct version of Figure 19:

Krakow to Gatwick flight engine starts

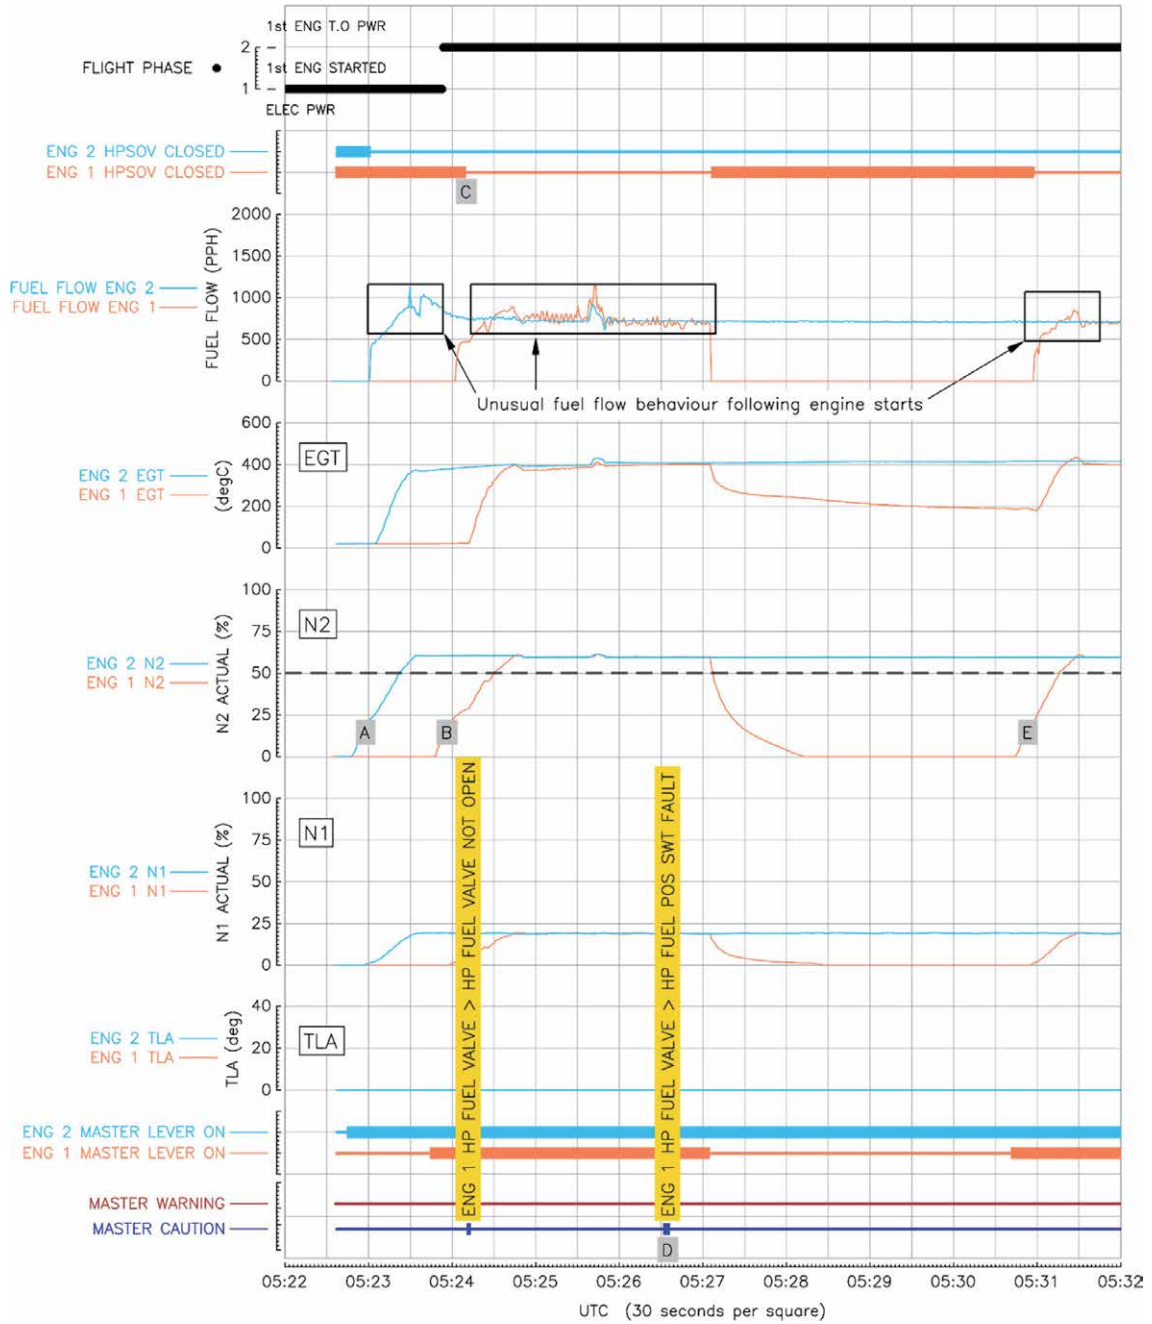
Figure 19
Krakow to Gatwick flight engine starts

Original version of Figure 19:

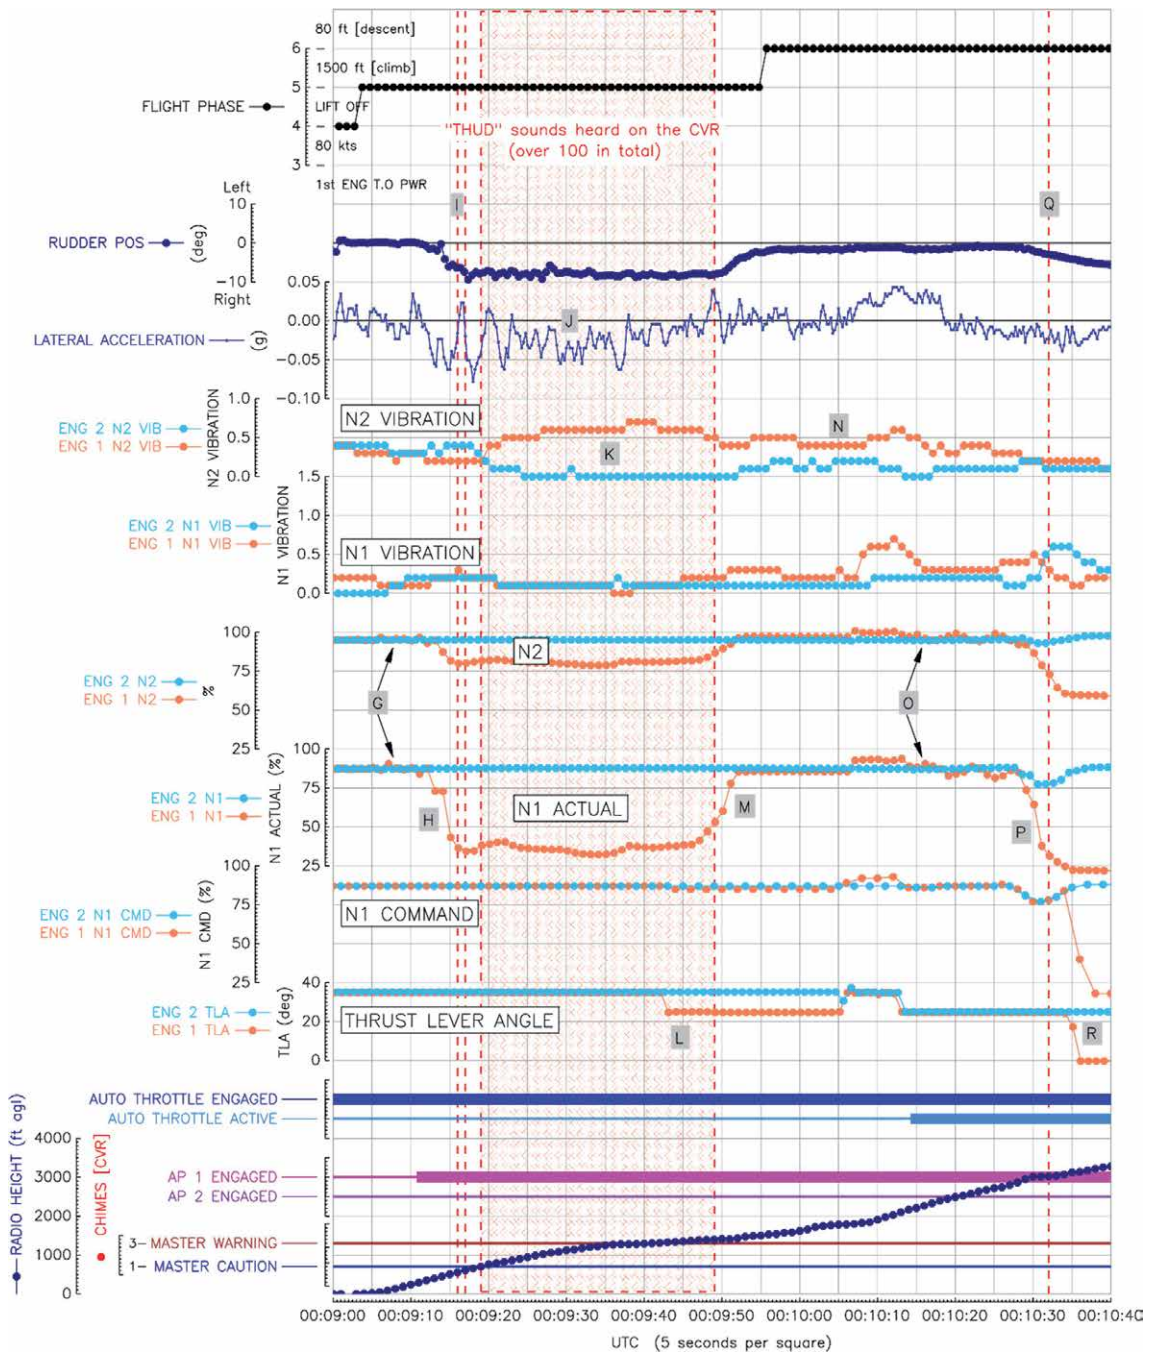
Figure 21

Correct version of Figure 21:

This also includes the new title for this figure.

Overview of flight data from the incident (plot 1 of 2)

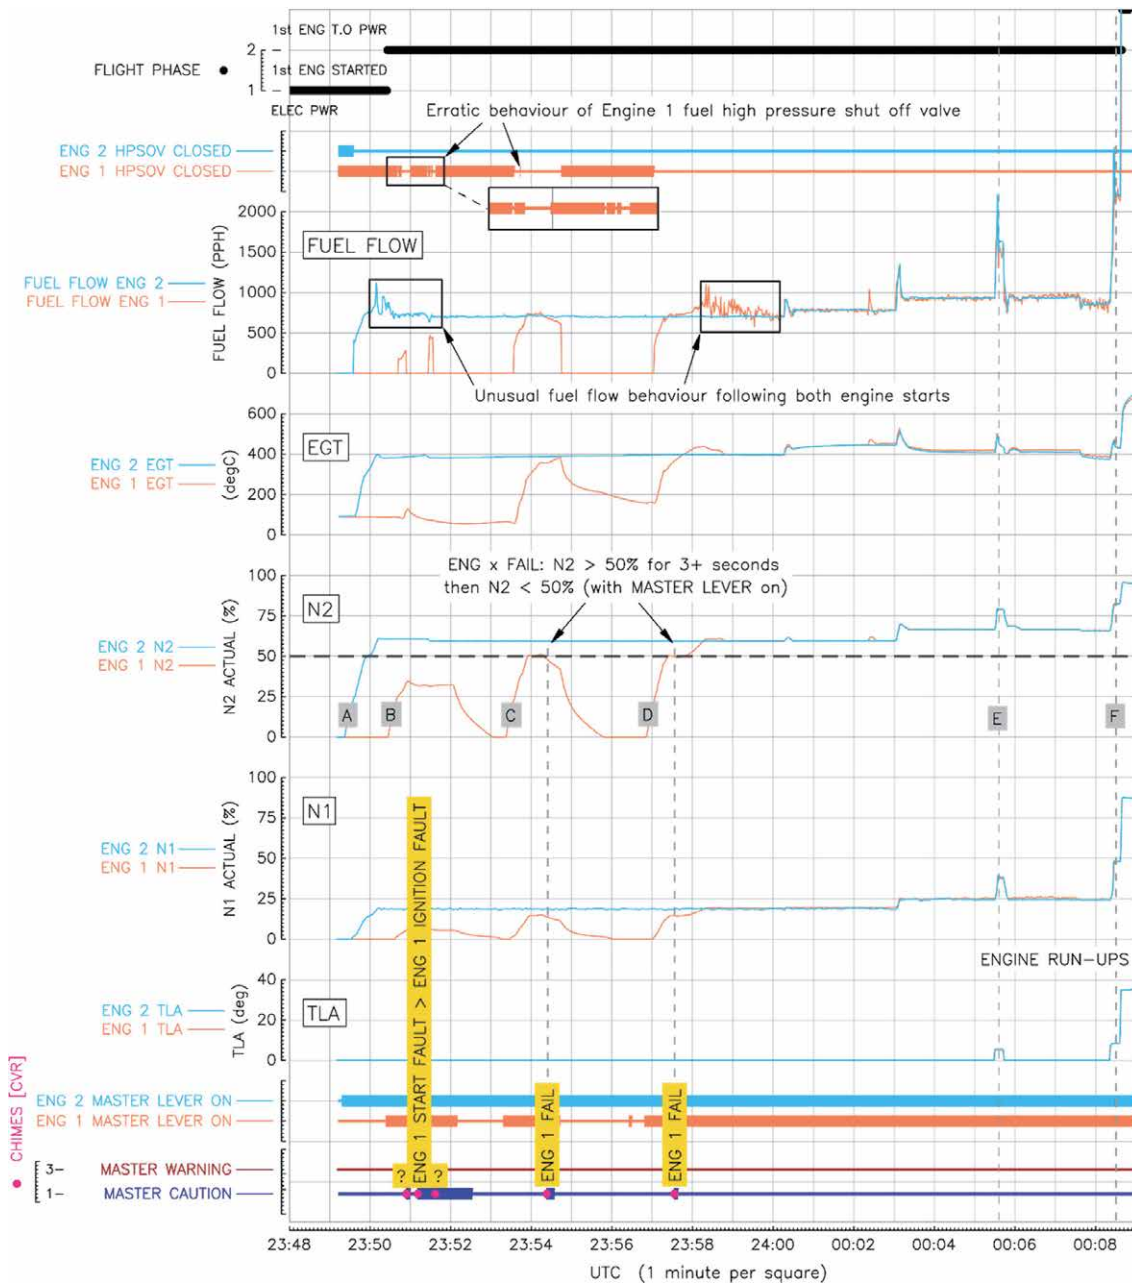
Figure 21

Original version of Figure 21:

Overview of incident flight data (plot 1 of 2)

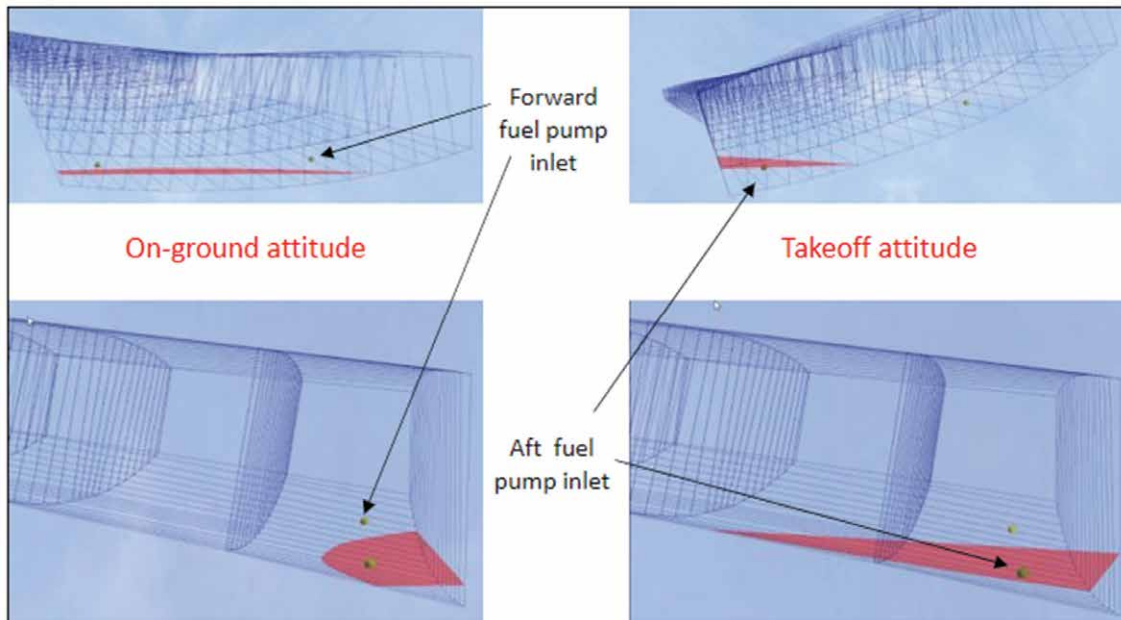
Figure 9

Original version of Figure 9:

View of the left wing fuel tank at the root with the fuel pump inlet positions in relation to approximately 30 kg of Kathon. Left – on-ground (0°). Right – takeoff (15°) (images courtesy Airbus)

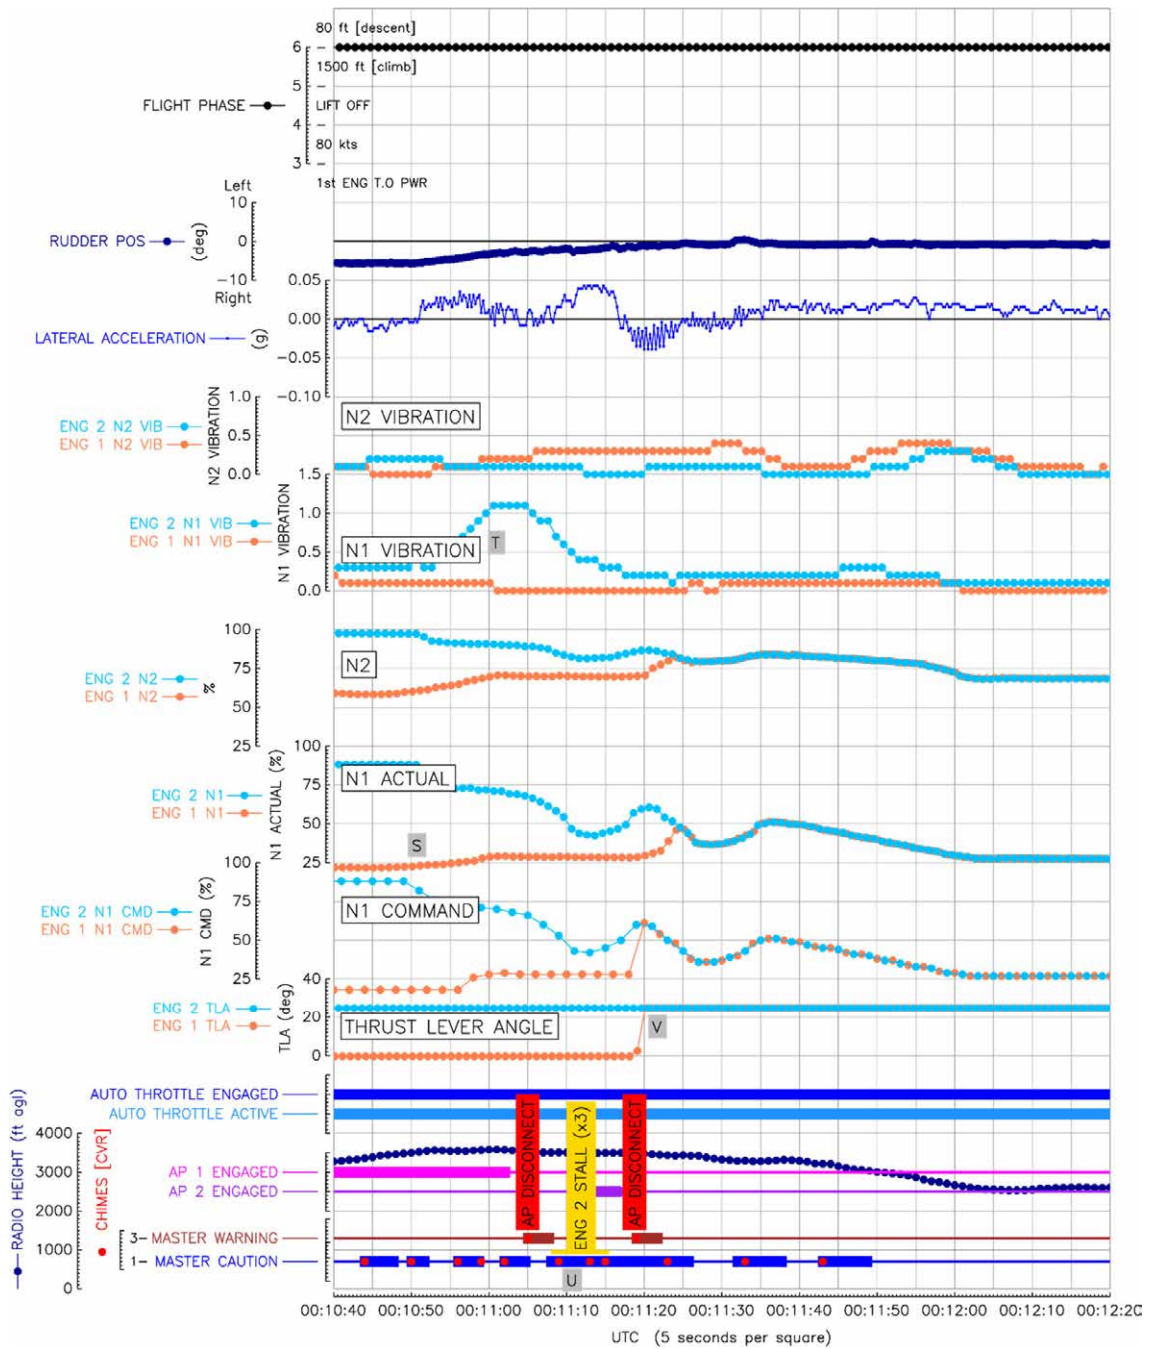
Figure 22 remains the same, however the title has been amended.

Figure 22
Overview of flight data from the incident (plot 2 of 2)
