ACCIDENT

Aircraft Type and Registration:	1) Boeing 777-300(ER), HL-7782 2) Boeing 757-256, TF-FIK
No & Type of Engines:	1) 2 GE Aviation GE90 turbofan engines 2) 2 Rolls Royce RB211 turbofan engines
Year of Manufacture:	1) 2009 (Serial no: 37643) 2) 1999 (Serial no: 26254)
Date & Time (UTC):	28 September 2022 at 1850 hrs
Location:	London Heathrow Airport
Type of Flight:	1) Commercial Air Transport (Passenger) 2) Commercial Air Transport (Passenger)
Persons on Board:	1) Crew - 18 Passengers - 199 2) Crew - 6 Passengers - Unknown
Injuries:	1) Crew - None Passengers - None 2) Crew - None Passengers - None
Nature of Damage:	1) Left wingtip damage 2) Damage to the rudder
Commander's Licence:	1) Airline Transport Pilot's Licence 2) Airline Transport Pilot's Licence
Commander's Age:	1) 52 years 2) 55 years
Commander's Flying Experience:	1) 10,561 hours (of which 3,384 were on type) Last 90 days – 249 hours Last 28 days – 73 hours 2) 15,500 hours (of which 12,500 were on type) Last 90 days – 160 hours Last 28 days – 50 hours

Synopsis

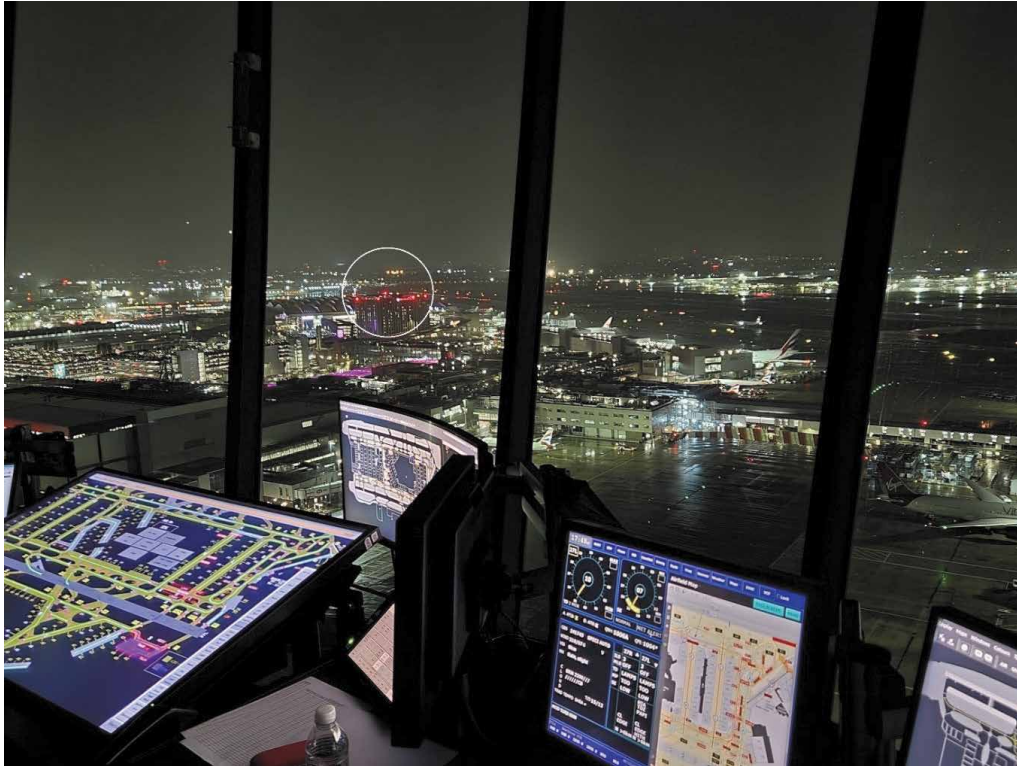
Figure 8

Stand 241 cannot be seen from the ATC visual control tower as it is obscured by a hotel and the terminal buildings. The view from the ground controller's position in use at the time is shown in Figure 8. Figure 9 shows an image from the ATC ground movement radar as the B777 taxied past Stand 241. A small primary radar return can be seen at the back of the stand and is likely to be the B757 protruding from the stand. Primary radar returns are masked once the aircraft is on stand. An aircraft normally shows a secondary radar return until its transponder is switched off. Whilst taxiing, a label giving the aircraft's callsign (and parking stand for inbound aircraft) is displayed alongside the secondary return. These labels are suppressed when the aircraft is on stand. With the B757 not fully parked it would normally show as a hollow diamond until the transponder is switched off. However, as shown in Figure 9, no diamond was displayed for this aircraft. It was not determined why the diamond was not displayed. ATC reported that the controller would not normally

View from the ATC ground controller position (location of Stand 241 circled)

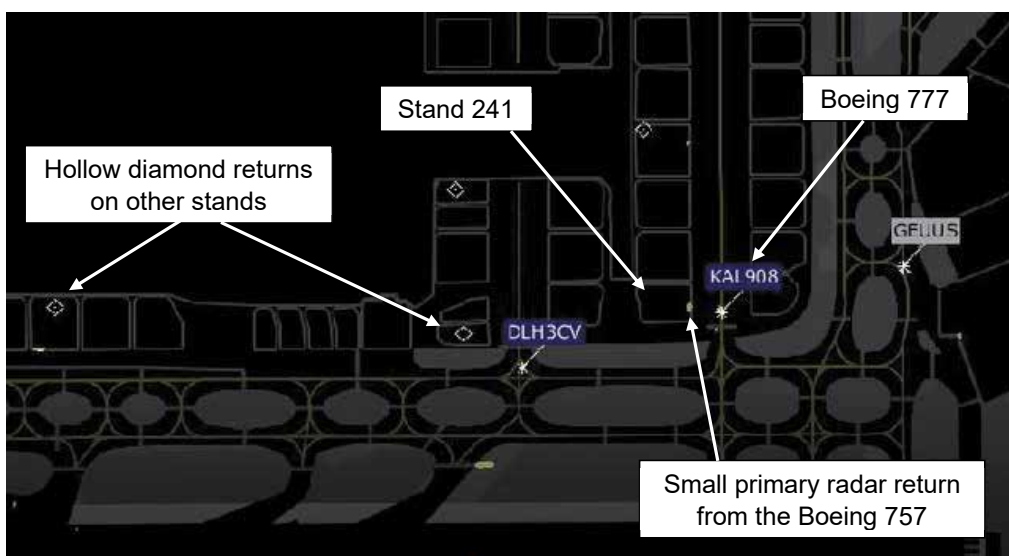
Figure 9

respond to the small primary returns as they are common across the airport. Similarly, even if the hollow diamond had been displayed, it is unlikely to have suggested anything abnormal to the controllers as these are often displayed on stands (as can be seen on several other stands in Figure 9).

Extract for the ground movement radar as the B777 passed Stand 241
