## ACCIDENT

<b>Aircraft Type and Registration:</b>	Cessna Citation 560XL, EC-KPB
<b>No &amp; Type of Engines:</b>	2 Pratt and Whitney PW545C turbofan engines
<b>Year of Manufacture:</b>	2008
<b>Date &amp; Time (UTC):</b>	1 June 2022 at 1420 hrs
<b>Location:</b>	RAF Northolt, South Ruislip, Middlesex
<b>Type of Flight:</b>	Commercial Air Transport
<b>Persons on Board:</b>	Crew - 2                      Passengers - 3
<b>Injuries:</b>	Crew - None                      Passengers - None
<b>Nature of Damage:</b>	Detached nosewheel and fractured nose gear forks
<b>Commander's Licence:</b>	Airline Transport Pilot's Licence
<b>Commander's Age:</b>	48 years
<b>Commander's Flying Experience:</b>	3,800 hours (of which 850 were on type) Last 90 days - 243 hours Last 28 days - 78 hours
<b>Information Source:</b>	Aircraft Accident Report Form submitted by the pilot and additional enquiries with the operator

## Synopsis

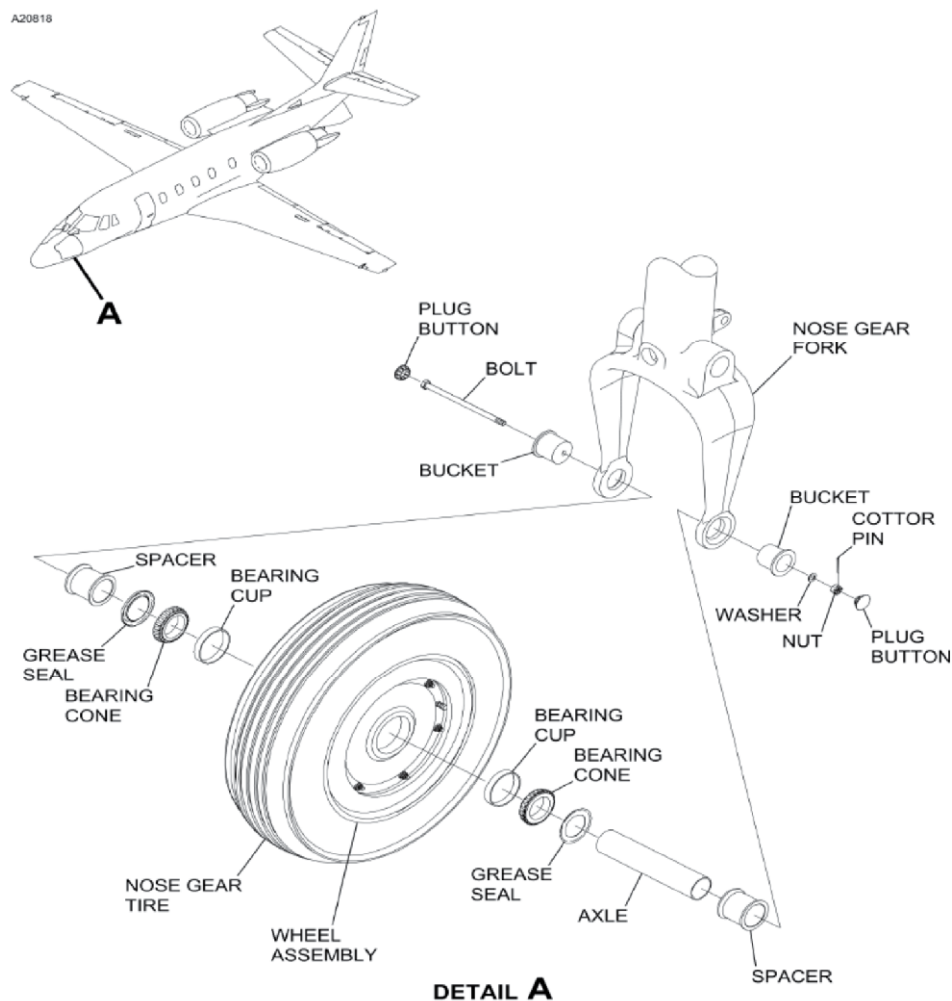
Figure 2

The Cessna Citation 560XL has a traditional tricycle landing gear. The NLG has a single strut arrangement with a single wheel attached to the fork (Figure 2). The NLG is steerable via the pilot's rudder pedals and is not braked.

Cessna Citation 560XL NLG arrangement  
(reproduced with permission)
