ACCIDENT

Aircraft Type and Registration:	DJI Mavic 2 Enterprise	
No & Type of Engines:	Four electric motors	
Year of Manufacture:	Unknown	
Date & Time (UTC):	7 August 2022 at 1648 hrs	
Location:	Bangor Train Station Car Park, Gwynedd	
Type of Flight:	Emergency Services Operations	
Persons on Board:	Crew - None	Passengers - None
Injuries:	Crew - N/A	Passengers - N/A
Nature of Damage:	Damaged beyond economic repair	
Commander's Licence:	Other	
Commander's Age:	37 years	
Commander's Flying Experience:	7 hours (of which 4 were on type) Last 90 days - 1 hour Last 28 days - 1 hour	
Information Source:	Aircraft Accident Report Form submitted by the pilot and further enquiries by the AAIB

Synopsis

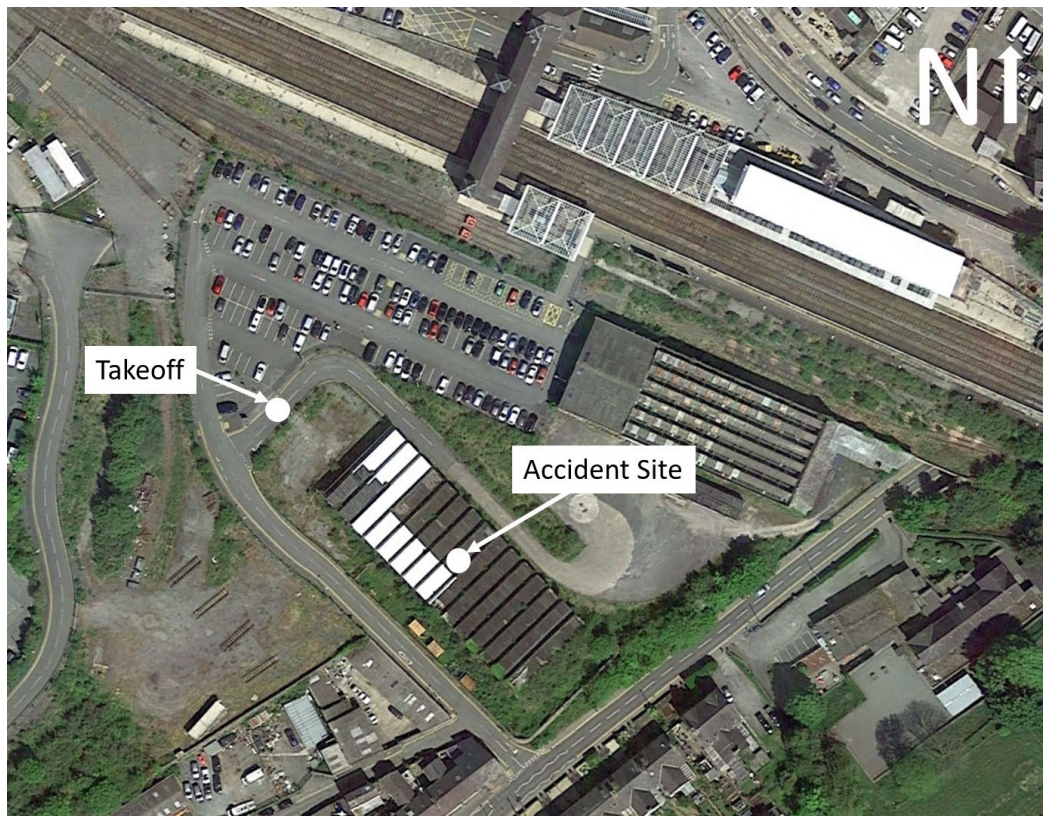
Takeoff and accident site location

About 4 minutes after takeoff another officer joined him who he asked to act as his observer. The aircraft was hovering over the centre of the building in Figure 1 when, about 6 minutes after takeoff, the pilot lost signal and video feed on his controller screen. The observer told him that they had seen the aircraft drop and the noise had stopped. The pilot looked up and could not see the aircraft.

It was located shortly afterwards on the roof of the building. The battery had separated from the airframe and they were about 1.3 metre apart from each other.
