ACCIDENT

Aircraft Type and Registration:	Guimbal Cabri G2, G-CJEK
No & Type of Engines:	1 Lycoming O-360-J2A piston engine
Year of Manufacture:	2016 (Serial no: 1151)
Date & Time (UTC):	20 June 2022 at 1059 hrs
Location:	Near Burton in Lonsdale, North Yorkshire
Type of Flight:	Private
Persons on Board:	Crew - 1 Passengers - 1
Injuries:	Crew - 1 (Fatal) Passengers - 1 (Fatal)
Nature of Damage:	Helicopter destroyed
Commander's Licence:	Private Pilot's Licence (Helicopter)
Commander's Age:	66 years
Commander's Flying Experience:	Approximately 538 hours (of which approximately 258 were on type) Last 90 days – Not available Last 28 days – Not available
Information Source:	AAIB Field Investigation

Synopsis

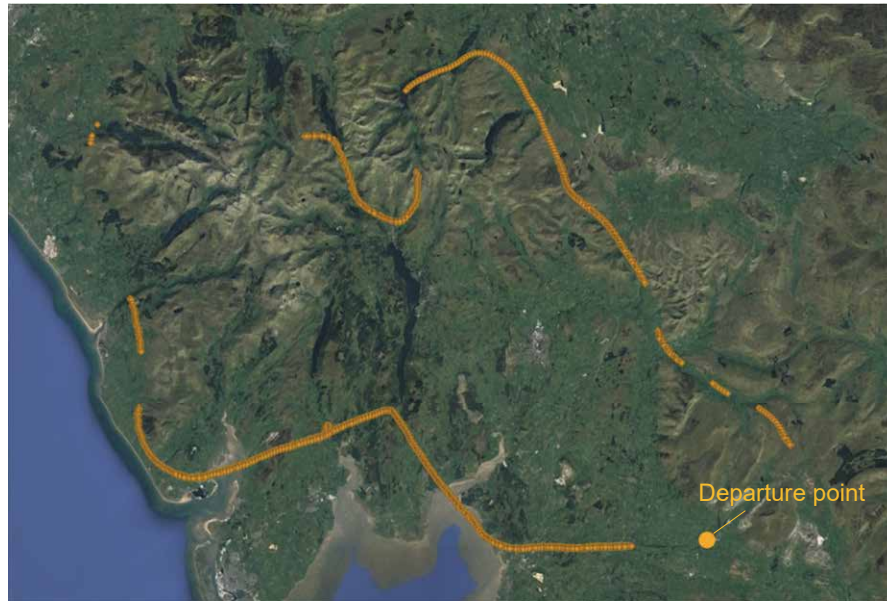
Figure 1

Radar track of route flown

Radar coverage was lost, due to terrain masking, nine miles to the north-east of the accident site, but was used to confirm the approximate duration of G-CJEK's flight and is shown in Figure 1. RTF recordings were made available to the AAIB, and all communications were routine.
