Report on the investigation of  
the man overboard from the stern trawler  
***Copious (LK 985)***  
resulting in one fatality  
approximately 30 nautical miles south-east of the  
Shetland Isles  
on 18 February 2021

VERY SERIOUS MARINE CASUALTY

REPORT NO 3/2023

JUNE 2023

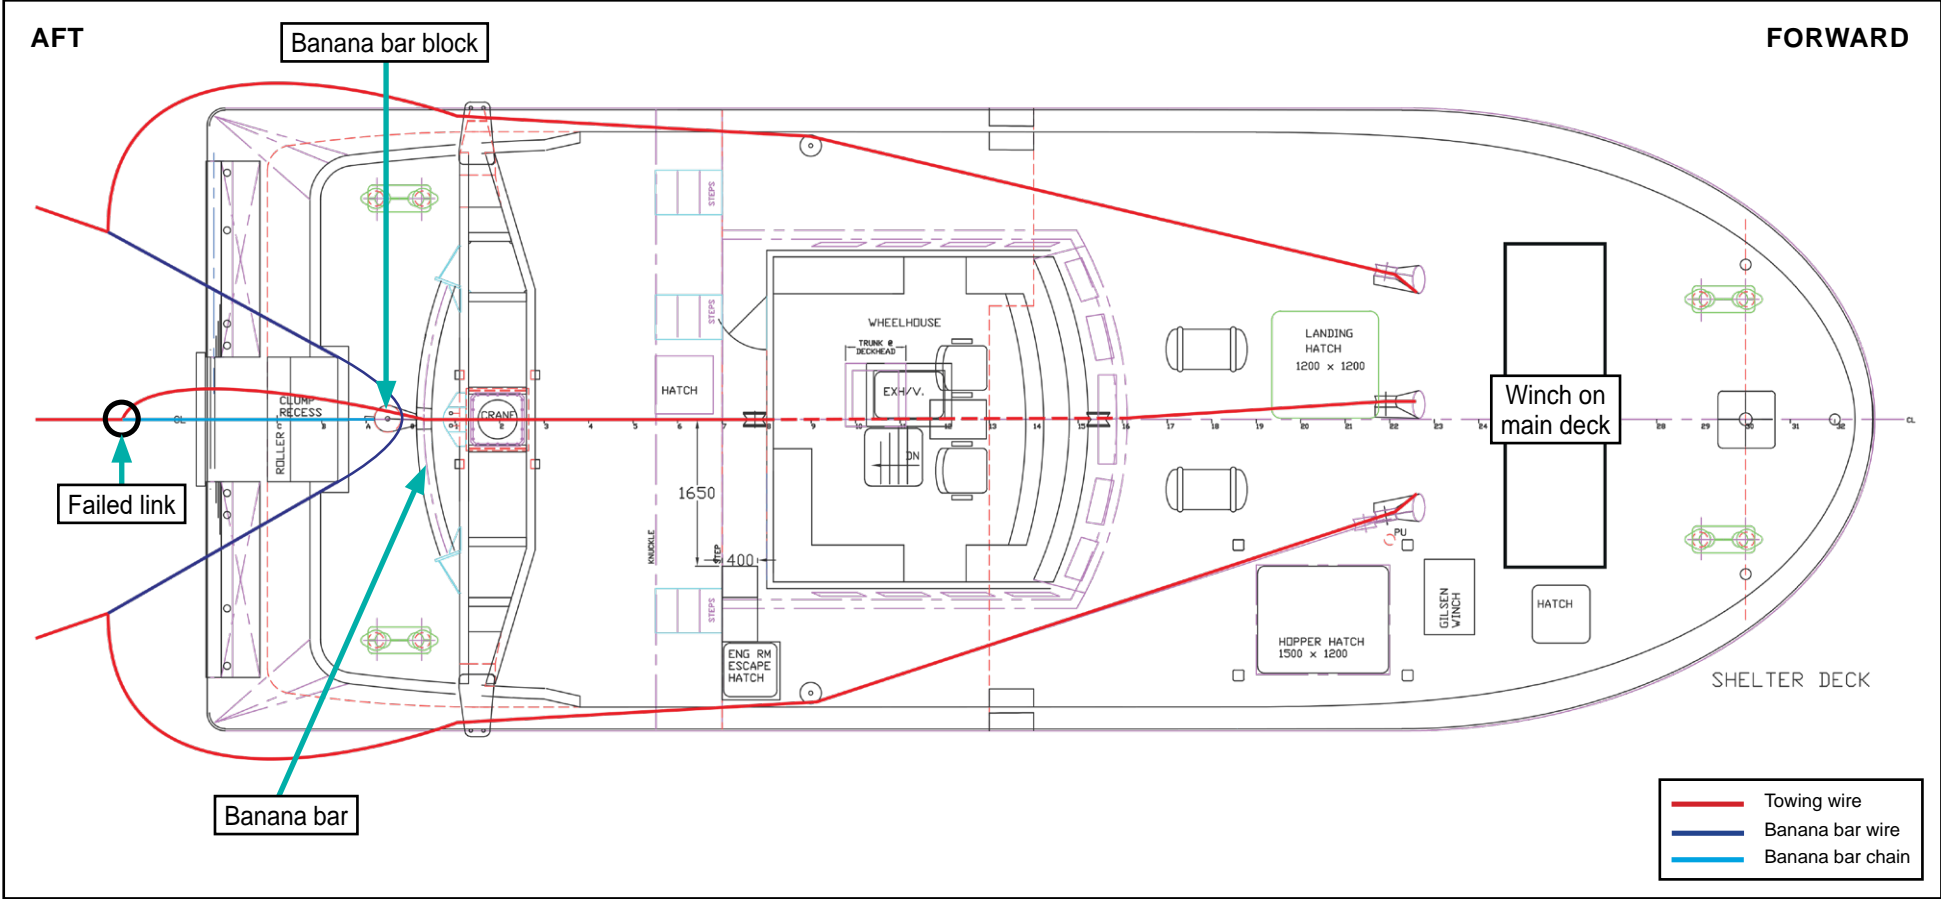
Figure 2: Plan diagram of towing wires on *Copious*'s upper deck

The towing wires came off the winch that was in the forward part of the main deck. They passed up through the deckhead on to the upper deck and ran aft to the gantry and then outboard. The middle towing wire ran under the wheelhouse (**Figure 2**). The weight of the trawl was transferred to a banana bar (**Figure 3**) when trawling. This consisted of a curved lubricated bar across the central section of the stern, on which ran a block (**Figure 2 and 3**). After the nets and towing wires had been fully payed out, the banana bar wire running through this block connected to the outer towing wires, depending on the required depth of trawl. The middle towing wire consisted of two sections of wire (hereafter referred to as the vessel-side and net-side sections), joined by a link. As the middle towing wire was payed out, the banana bar chain was connected to this link, which included the use of a hammerlock<sup>1</sup> (**Figure 4**). The towing wires were payed out further once the banana bar wire and chain were connected, which caused the towing wires to slacken on the vessel-side of the connections and the weight of the fishing gear to be taken on the banana bar.

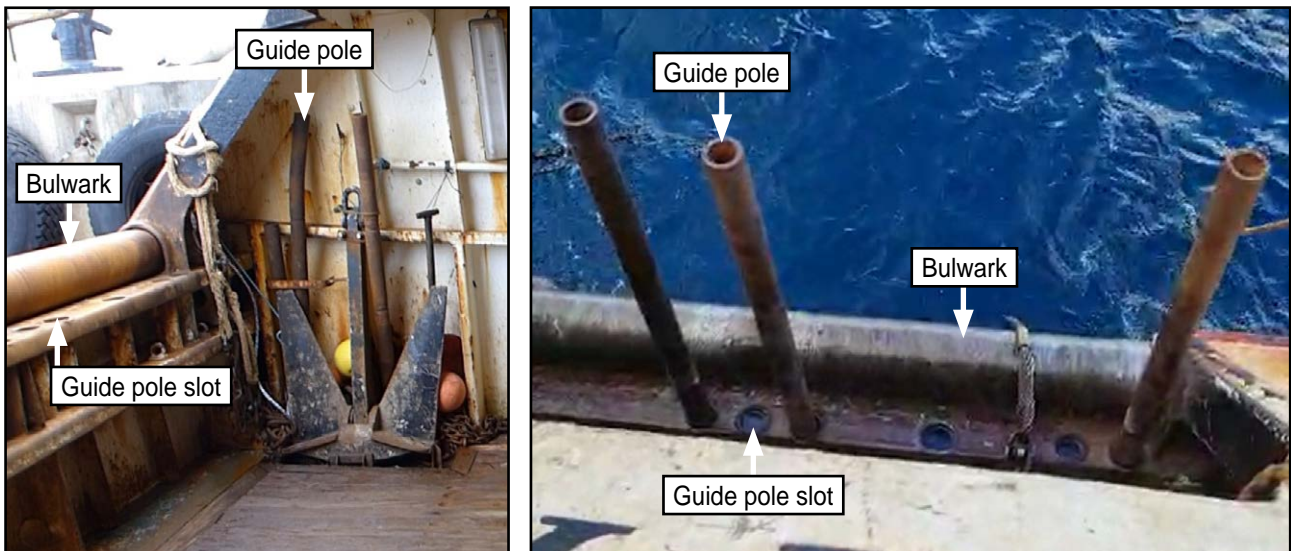
**Figure 7:** The guide poles and guide pole slots

The crew member on the main deck, whose role it was to place the guide poles<sup>2</sup> into the stern bulwark (**Figure 7**), had seen the deckhand arrive on the main deck and turned around to restow the guide pole he was holding so he could offer his assistance. The deckhand stepped up onto the stern bulwark with the shackle in his hand and asked the crew member to hold the back of his lifejacket. However, as the crew member and skipper both turned back around from their respective tasks, they saw the deckhand lose balance and fall overboard.

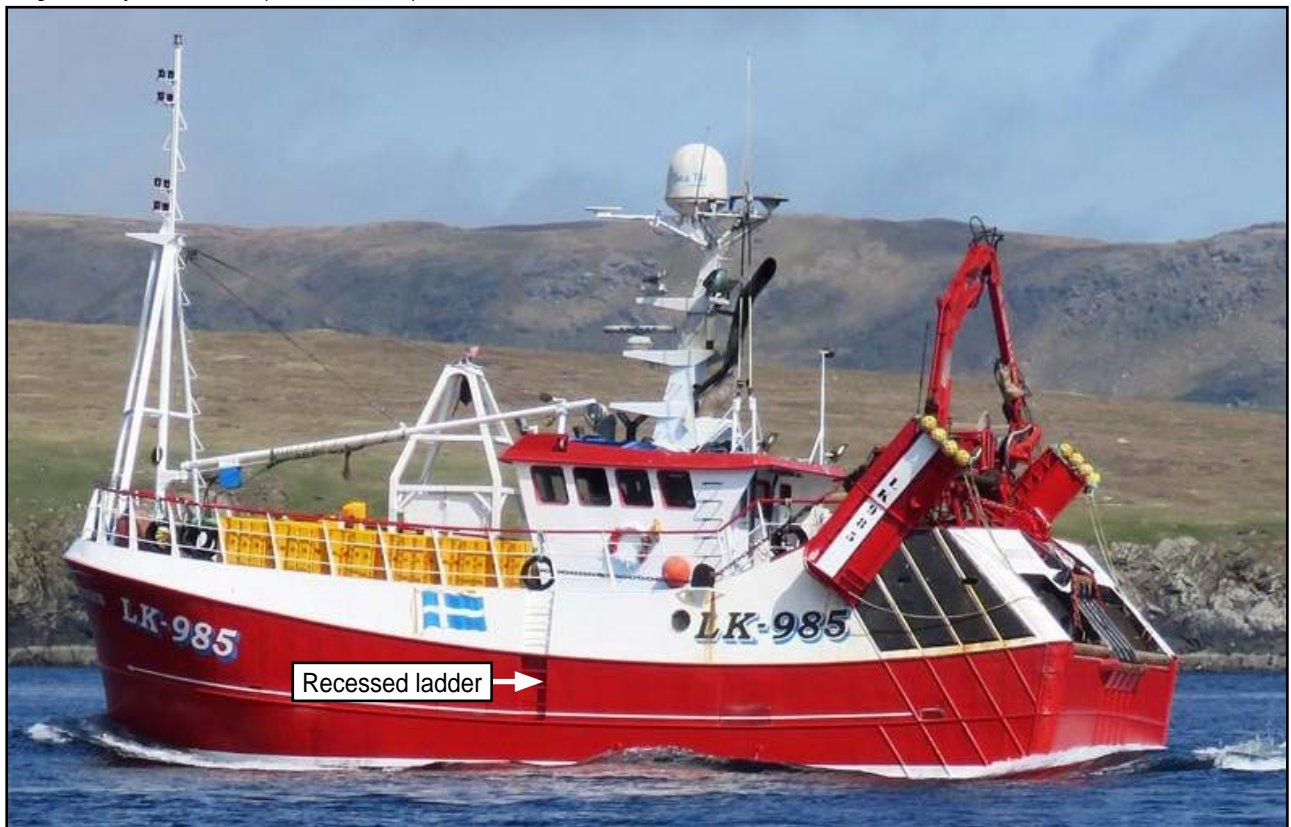
**Figure 8:** The recessed ladder

The remaining crew had by now made their way onto the upper deck and, together with the skipper, managed to pull the deckhand round to the recessed ladder (**Figure 8**) on the port side of the vessel by using the other end of the mooring rope. The skipper then climbed down the ladder to try and calm the panicking deckhand and help him climb the ladder. The deckhand managed to grab a rung of the ladder with both hands, but the large swell took him away. The crew manoeuvred the

deckhand back to the ladder for a second time using the mooring rope, but he was becoming increasingly incapacitated, and the swell once again took him away from the side of the vessel. The crew observed the deckhand's lifejacket ride up around his head as his body became limp.
