AAIB Bulletin

7/2023

Published 13 July 2023

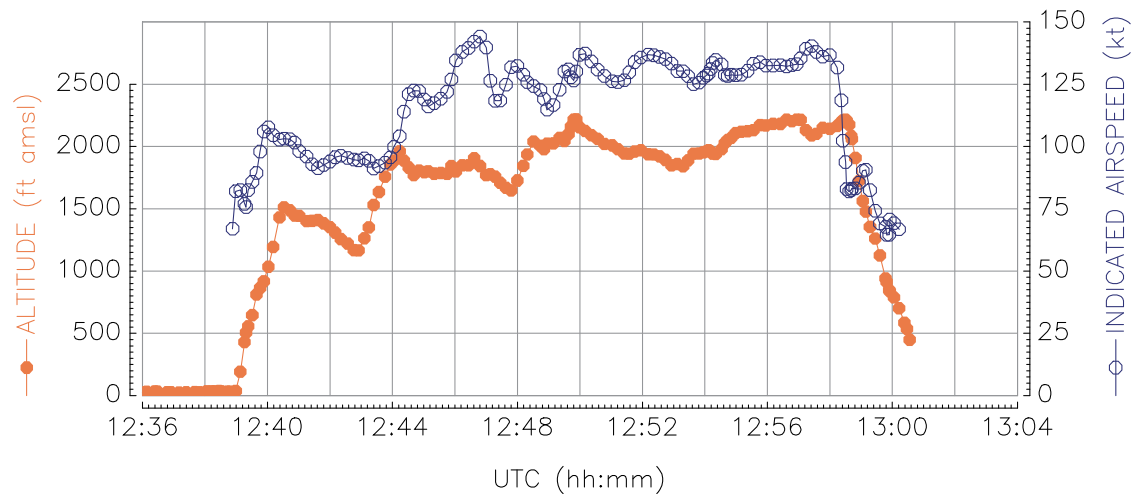
For the accident flight, the aircraft was airborne for 21 minutes, and the GPS was powered up 13 minutes before takeoff. Figure 2 shows that the aircraft’s cruise height varied around 2,000 ft amsl and an average calculated airspeed of 130 KIAS.

Accident flight GPS altitude and calculated IAS

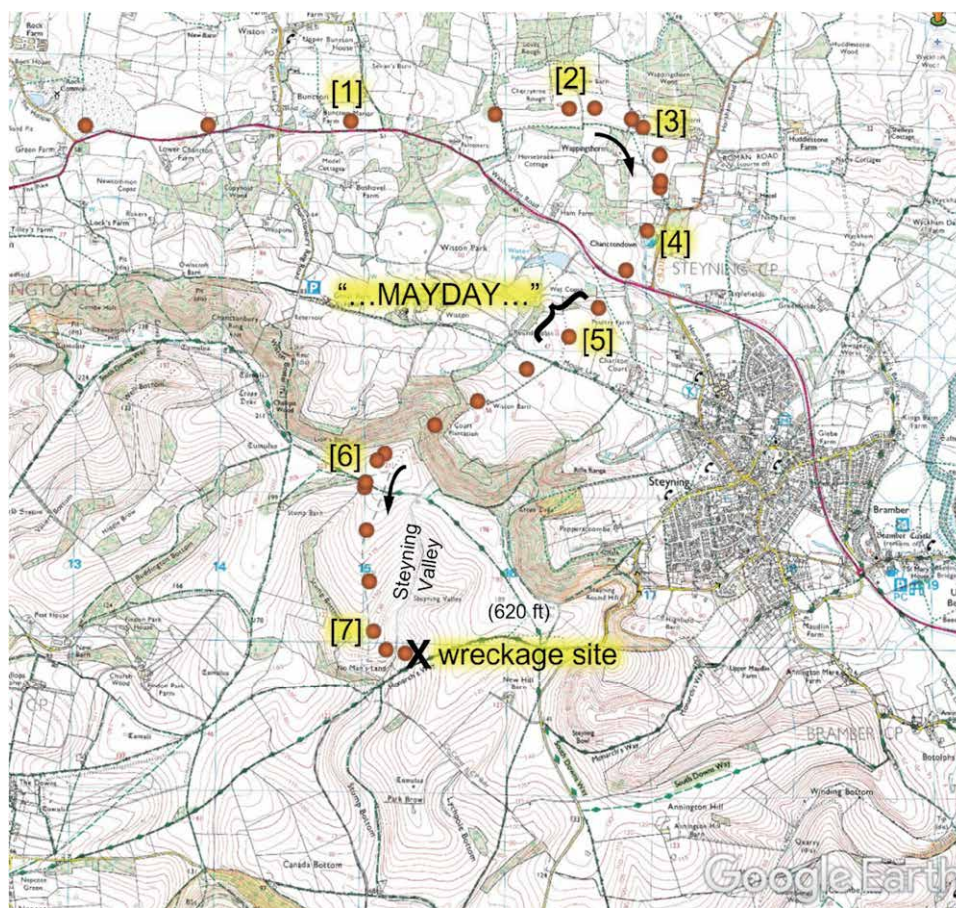
Figure 3 details the GPS altitude and GPS derived data, and Figure 4 the ground track, for the last three minutes of the flight. The figures start at 1257:30 hrs just before the Mode A squawk⁴ changed from 7011 (Southampton listening squawk) to 7000, with the aircraft tracking parallel to the northern border of the South Downs National Park, at approximately 2,100 ft amsl and about 136 KIAS. Points highlighted in the figures are:

Ground track for last 3 minutes of the accident flight

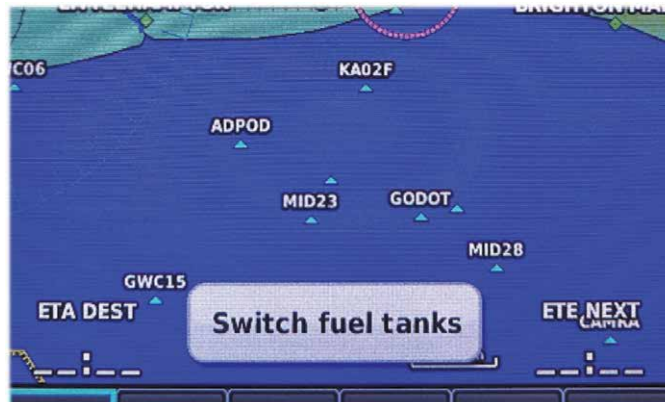
Figure 5

A switch fuel tanks alarm (fuel alarm) feature of the GPS unit was active and setup to display a 'Switch fuel tanks' message on the unit's screen every 15 minutes (Figure 5). The message could be cancelled by touching it and would be displayed again 15 minutes after it was last displayed (ie if a message was left on for 10 minutes before being cancelled it would display again after another 5 minutes). The GPS unit also allowed an audio alert – a single beep – which would sound at the same time the message was displayed; however, this option had been selected off.

GPS unit's 'Switch fuel tanks' alarm message

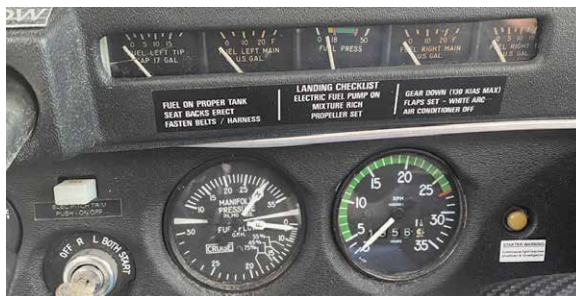
Figure 11

Fuel quantity gauges for each of the four tanks were fitted to the cockpit engine instrument cluster on the lower left side of the instrument panel together with a fuel pressure gauge and a fuel flow indicator (Figure 11).

G-KNOW analogue fuel information²⁴

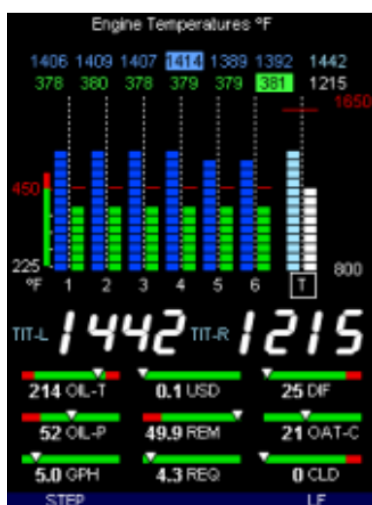
Figure 12

Typical display configuration of the EMU²⁵

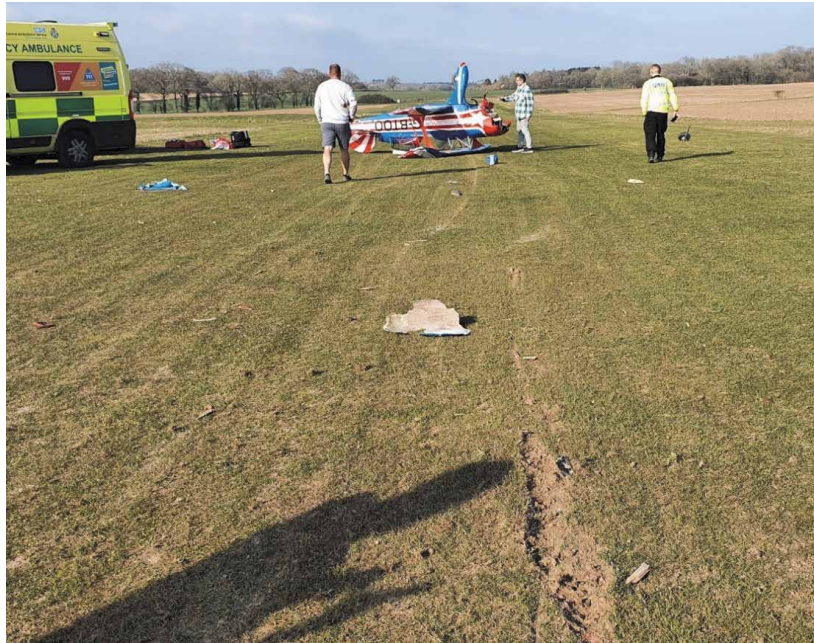
Figure 1

View along Runway 03 at Popham
Image used with permission

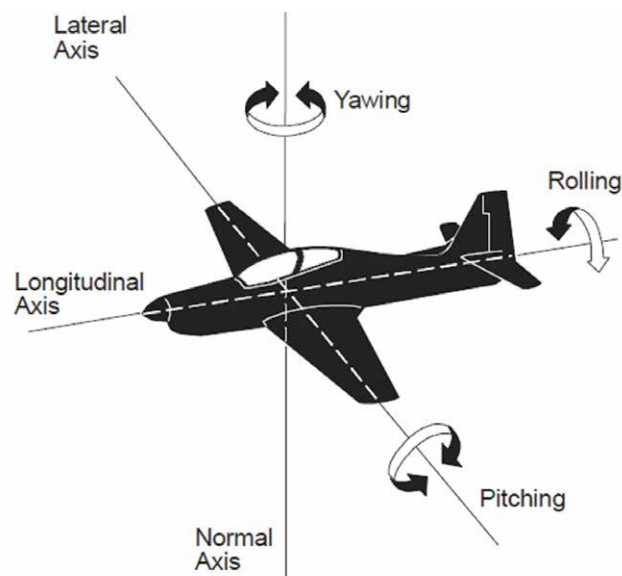
Figure 5

The secondary effects of power are on the pitch, yaw and roll trim of the aircraft about the axes (Figure 5). Any change in power alters the thrust which, in turn, affects the longitudinal trim of the aircraft about the lateral axis, primarily through the effect of the slipstream on the tailplane – more power – nose up, less power – nose down. Thrust also affects the strength of the slipstream over the fin and rudder changing the yaw trim of the aircraft about the normal axis. Further, as power changes, the torque reaction on the propeller will tend to roll the aircraft in the opposite direction to the rotation of the propeller.

Axes and trim of the aircraft

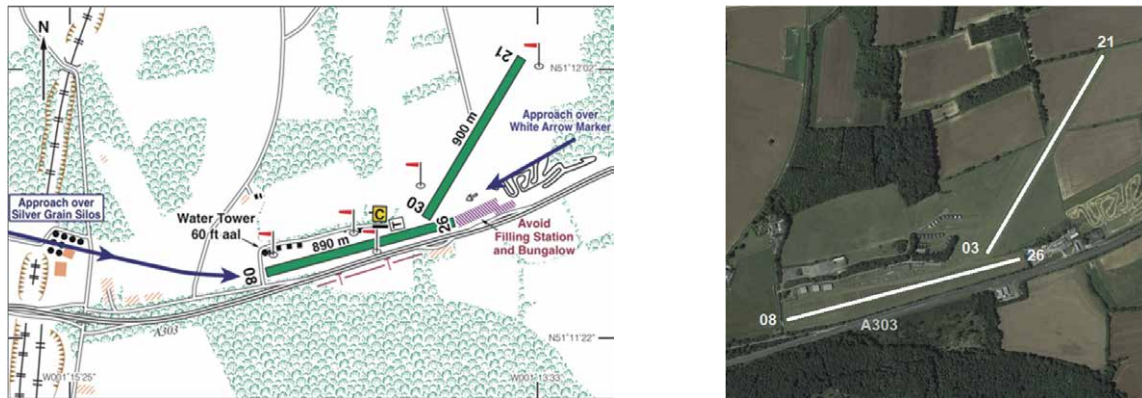
Figure 6

Popham Airfield has two grass strips, Runway 03/21 and Runway 08/26 (Figure 6). There are trees to south of the A303 on the undershoot of the approach to Runway 03; this runway has a marked downslope of 1.3%.

Popham Airfield (Source: Pooleys and Google Earth)

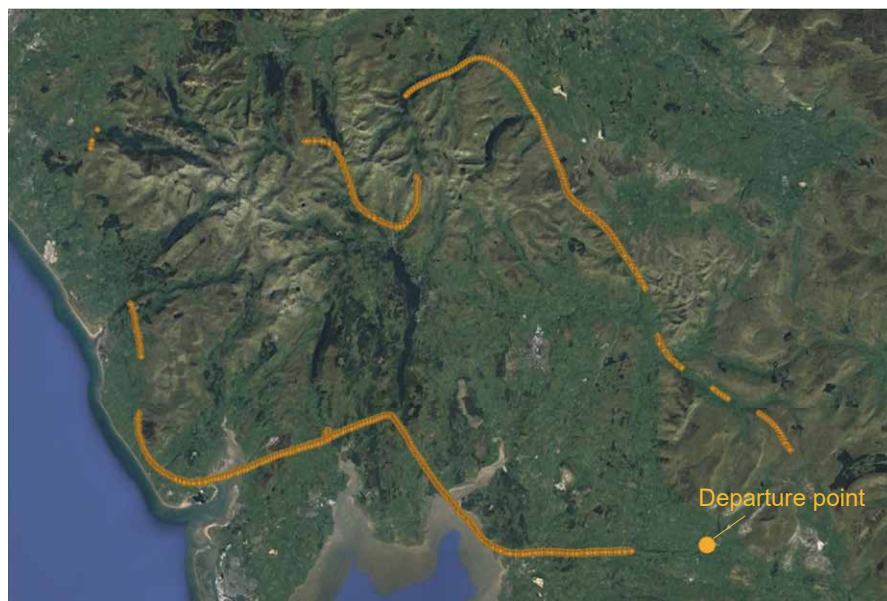
Figure 1

The helicopter departed initially on a westerly track then routed around the Lake District (Figure 1), before returning to the landing site approximately 1 hour and 20 minutes later. The pilot did not report any problems during his routine interactions with ATC throughout the flight.

Radar track of route flown

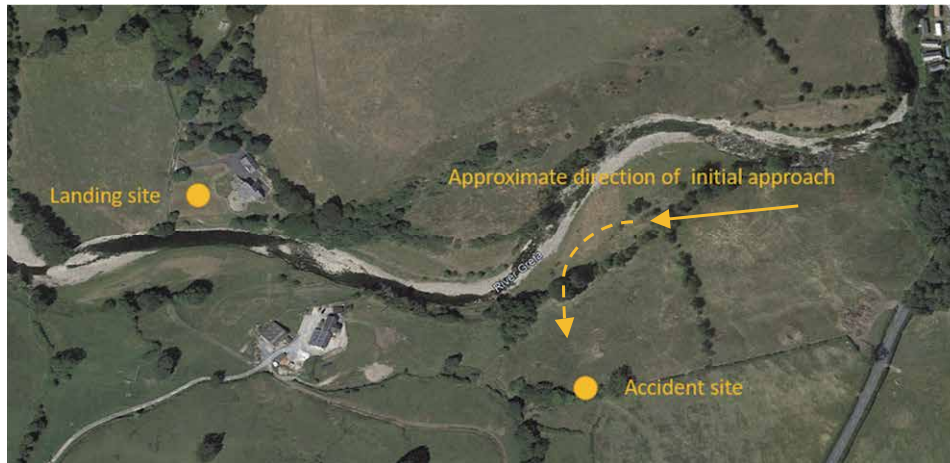
**Figure 2**

There was limited closed-circuit television (CCTV) recorded from a nearby farmhouse which captured short periods of the helicopter’s flight path prior to the accident. It showed the helicopter initially flying in a westerly direction (Figure 2) before it began what appeared to be a controlled left turn. The helicopter then continued heading approximately south, with decreasing groundspeed and climbed from an approximate height of 70 ft before the turn to about 130 ft when it went out of view of the CCTV.

Approximate direction of initial approach

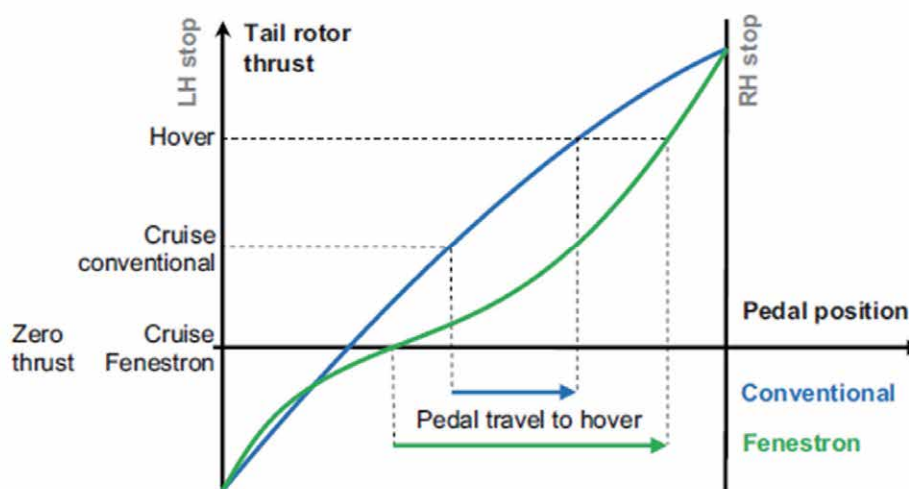
Figure 3

SL 12-001 states the Cabri G2 is immune to stall and to what is commonly referred to as 'loss of tail rotor effectiveness' (LTE). It highlights the need for pilots to use a much greater pedal input for a given tail rotor thrust than that which would be required in helicopters with a conventional tail rotor (Figure 3) and the need for pilots to react to uncommanded yaw without delay.

Comparison of thrust curves for identical performance tail rotors Conventional/Fenestron

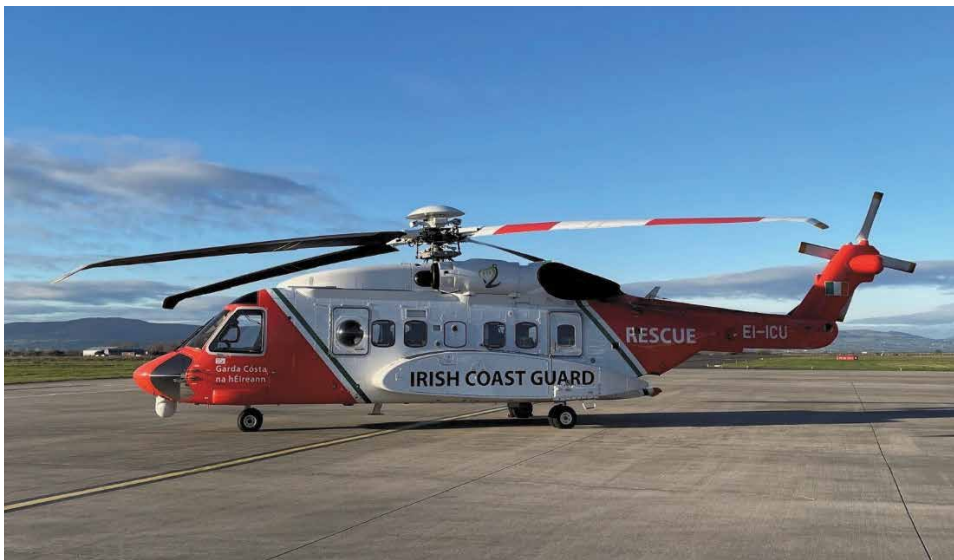
Figure 2

EI-ICU at the City of Derry Airport. Image used with permission

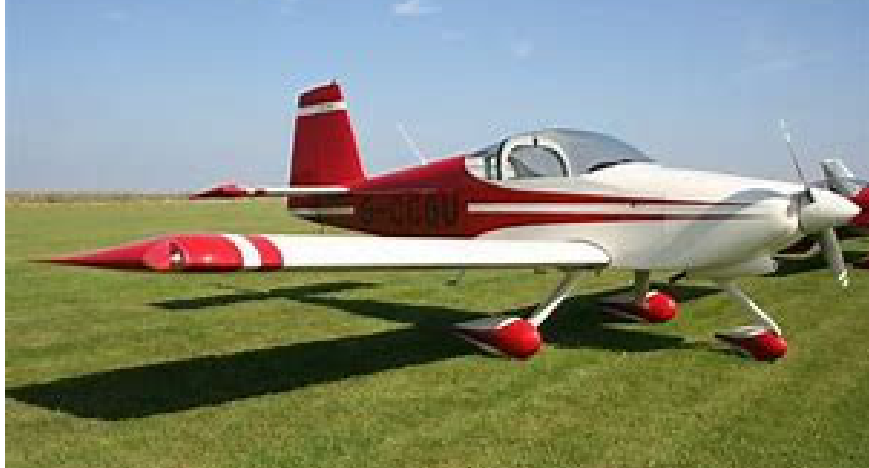
Figure 1
Vans RV-9A

Just before touchdown the pilot saw a heavy goods vehicle (HGV) very close to the right of the aircraft, and the right wingtip struck the rear of the HGV trailer. The vehicle was crossing the undershoot from left to right. The pilot recalled nothing else until he became aware that the aircraft was inverted on the ground with the canopy broken (Figure 2). A roll bar behind the aircraft seats kept the cockpit off the ground protecting the occupants, and the aircraft harnesses successfully restrained both occupants in their seats. A car that had been following the HGV stopped and the occupants assisted the pilot and passenger to escape by breaking away sections of canopy perspex to clear an exit path. Ambulance personnel from the Air Ambulance base at Henstridge were quickly on scene and gave medical assistance, and they were subsequently supported by the local emergency services. There was no fire on the aircraft. Both those on board were taken to hospital by ambulance, and the pilot was released later that evening having sustained only minor injuries. The passenger remained in hospital for three days as he had sustained a broken wrist, which required surgical intervention to correct.
