Rail Accident Investigation Branch

Rail Accident Report

Buffer stop collision at Enfield Town station 12 October 2021

Report 13/2022
November 2022

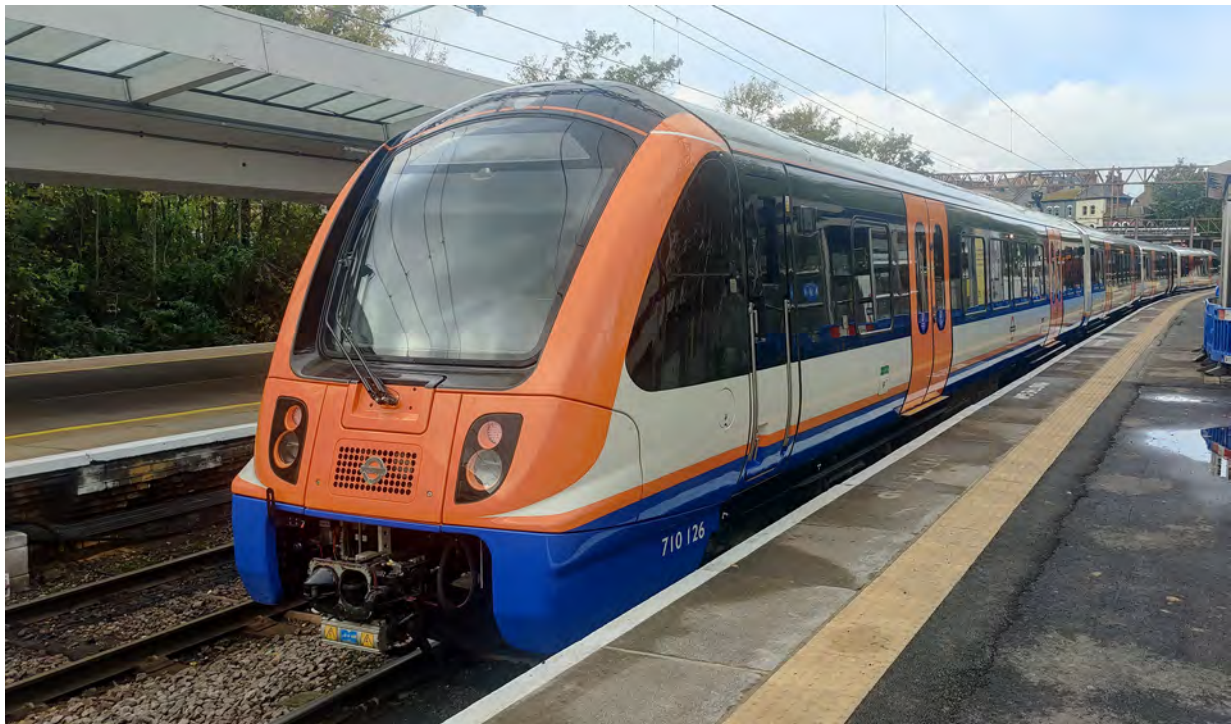
Figure 6: Class 710 electric multiple unit

- 13 The train involved in the collision consisted of two four-car, class 710 electric multiple units (figure 6). Class 710 units were introduced onto Enfield Town services during 2020.

- 14 Post-accident testing of the train found no faults in the train's braking. The maintainer's records for the units involved showed that all the scheduled maintenance was up to date. RAIB found no evidence to suggest that the condition of the train contributed to the accident.
