Maritime &  
Coastguard  
Agency

# SS Richard Montgomery: Survey Report 2022

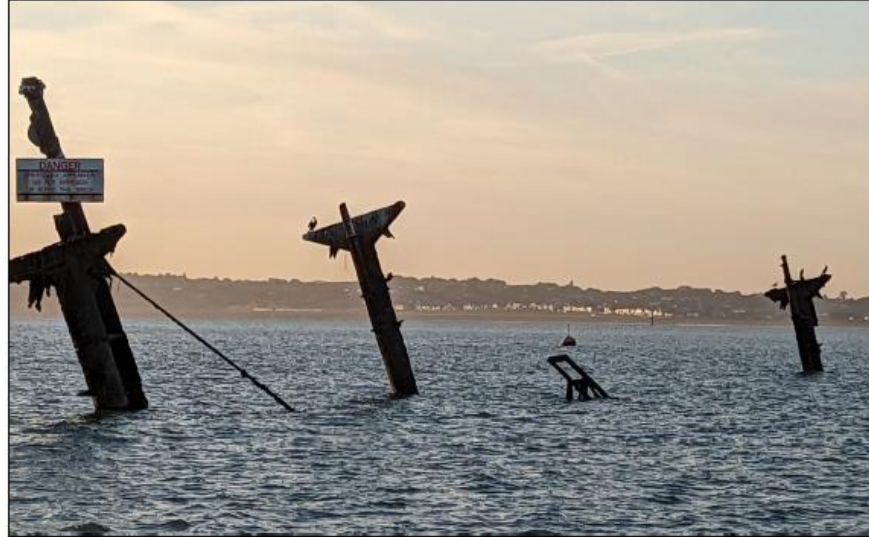
- 2.1.4** The vessel remains on Sheerness Middle Sand, lying in two sections in its own scour pit and sitting on exposed bedrock which is believed to be London Clay. The SSRM lies across the tide and all three masts are visible above the water at all states of the tide (see Figure 1 below).

*Figure 1: Photograph of the SSRM's three masts above the water.*

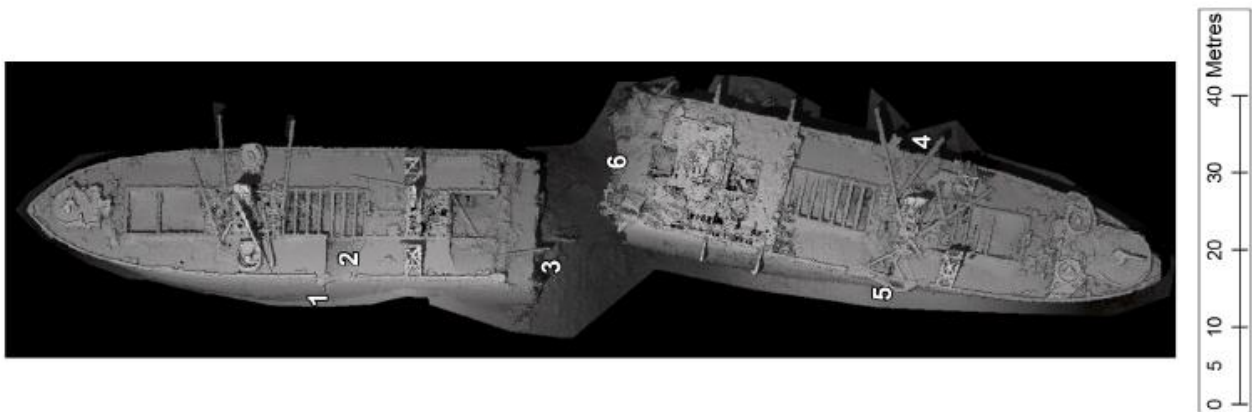
- 2.3.2** The data analysis covers the entirety of the wreck and identifies 96 features on the wreck which have been used in successive surveys as markers for measuring levels of change. Of these, there are six areas which have repeatedly demonstrated levels of accelerated deterioration and are therefore a specific focus of each survey.

Figure 2: SSRM top-down image showing the 6 Key Areas.

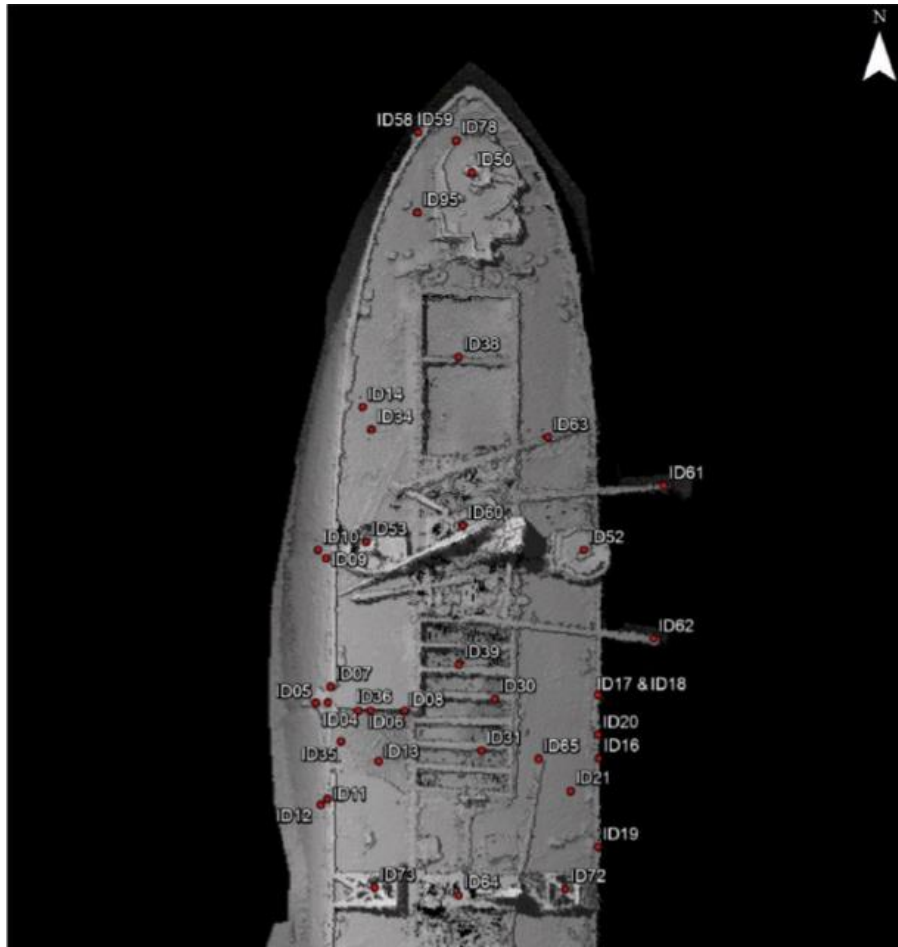
- 4.2.1** Over the whole of the wreck, 96 specific features have been used in successive surveys as comparison points for quantifying change and deterioration. The location of these features is given in Figures 9 & 10.
- 4.2.2** In addition to the 96 features the six Key Areas that have been highlighted in previous surveys as areas of significant structural change are monitored in each survey.

Figure 9: ID features on the Forward section.

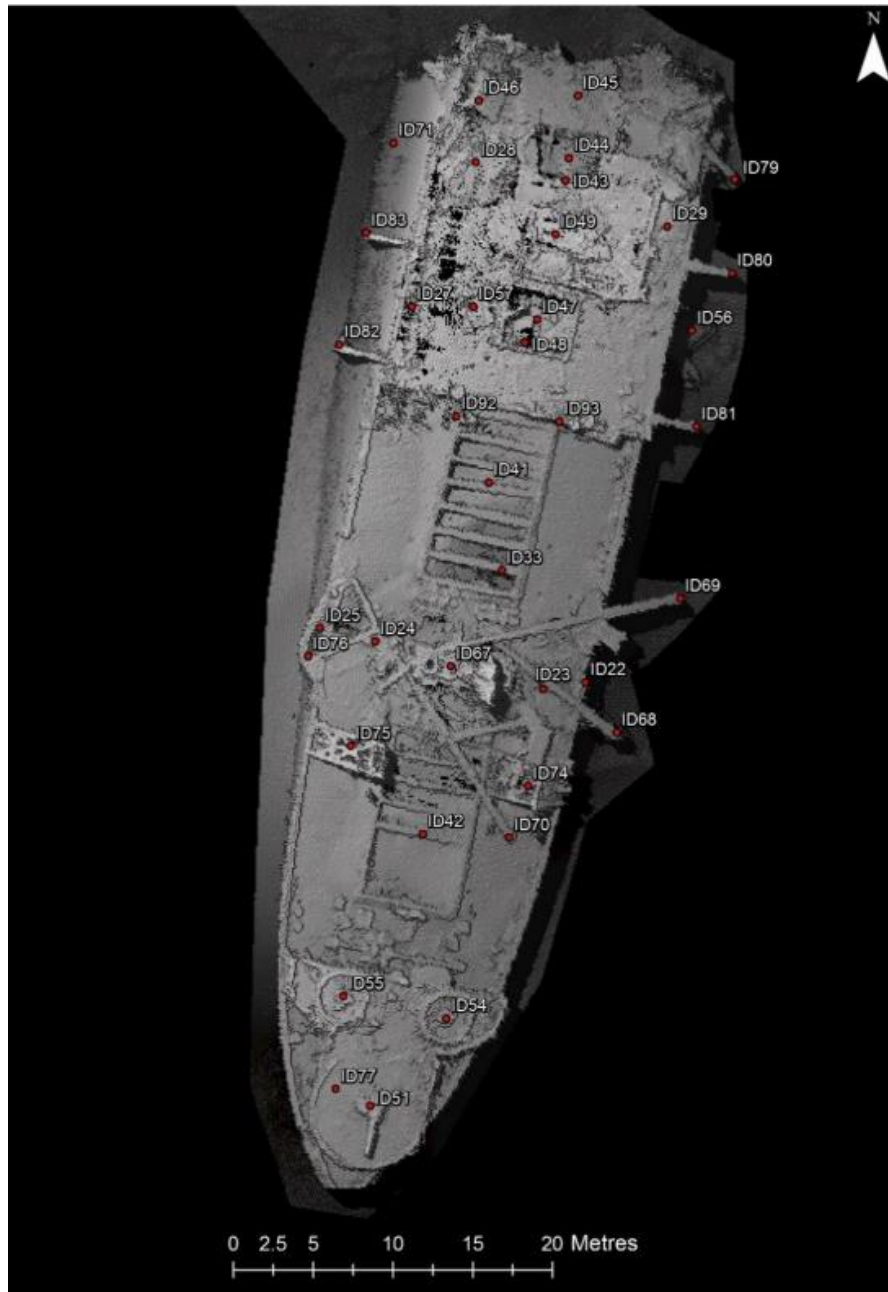
Figure 10: ID features on the Astern section.

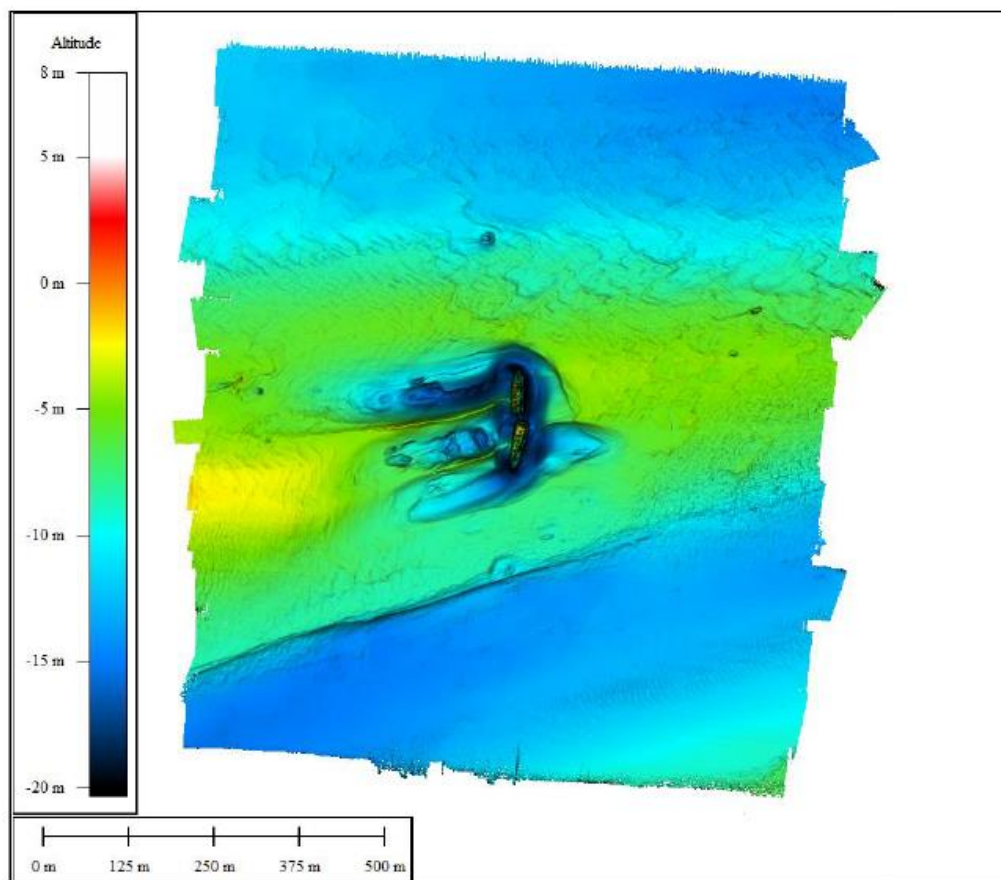
**5.1.1** An overview of the seabed surrounding the wreck of the SSRM is illustrated in Figure 32.

*Figure 32: Shaded relief plan of seabed survey area.*
