Maritime &
Coastguard
Agency

SS Richard Montgomery: Survey Report 2020

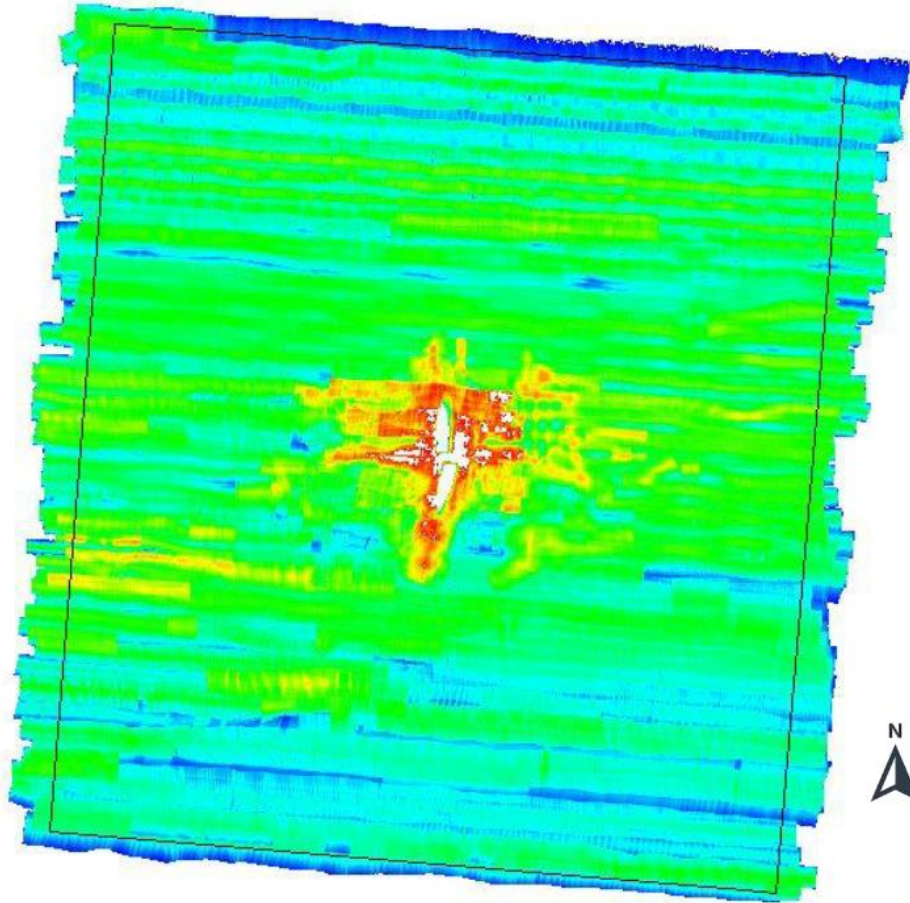
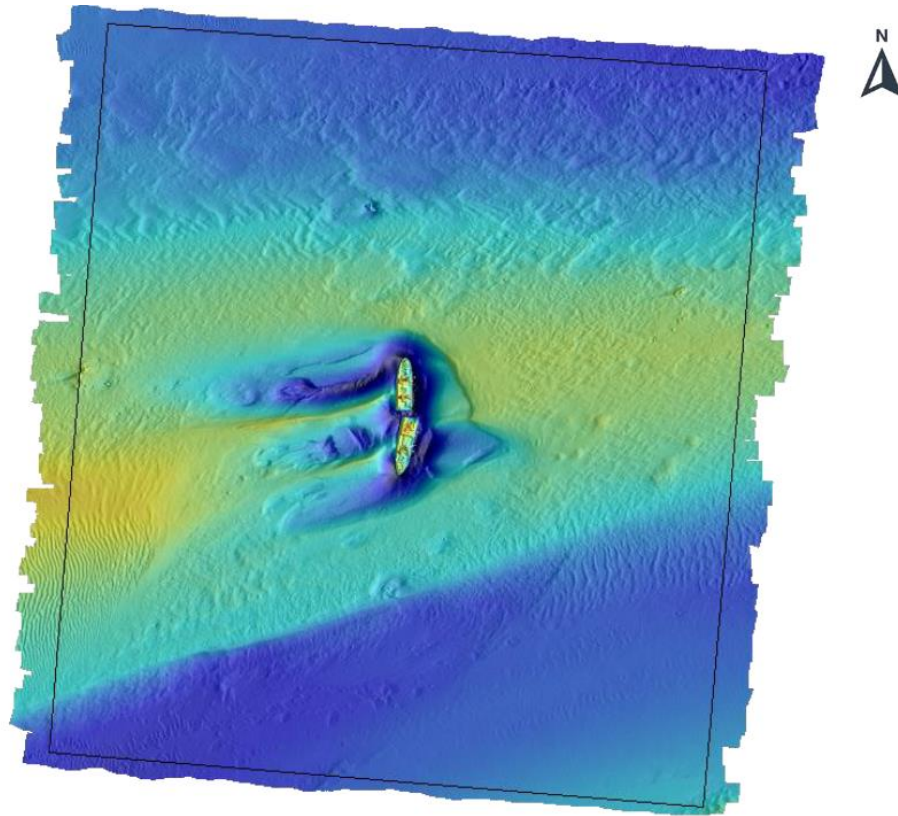
- 3.4.9 An overview of the seabed surrounding the wreck of the SSRM is illustrated below. Changes to the seafloor are fairly limited with the majority remaining stable ($\pm 0.1\text{m}$) between the 2019 and 2020 surveys. The sand bank to the east of SSRM has migrated slightly west (towards the wreck).

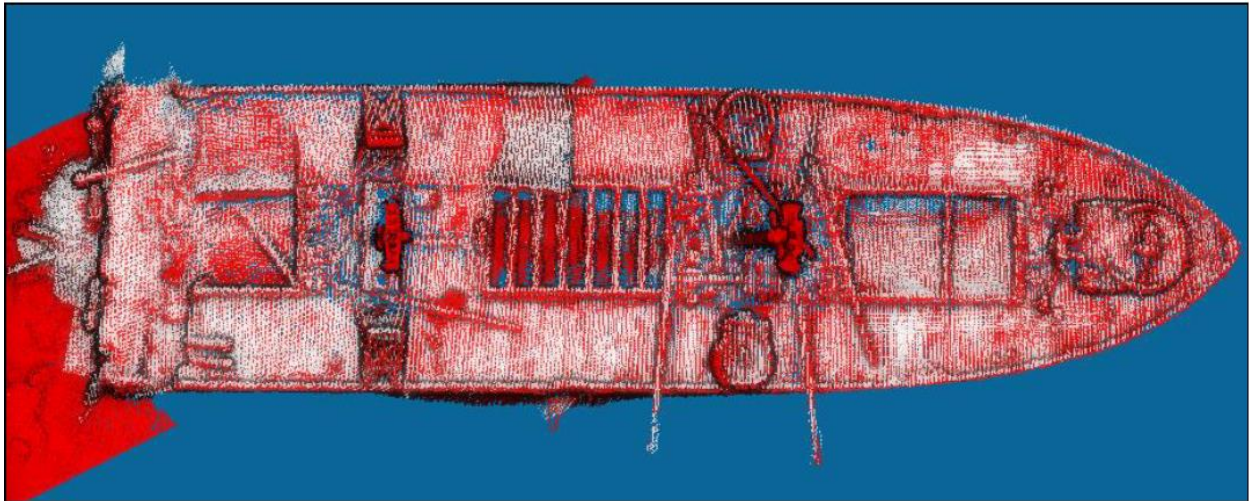
Figure 11 2020 data (red) and 2010 data (white) of the forward part of the wreck.

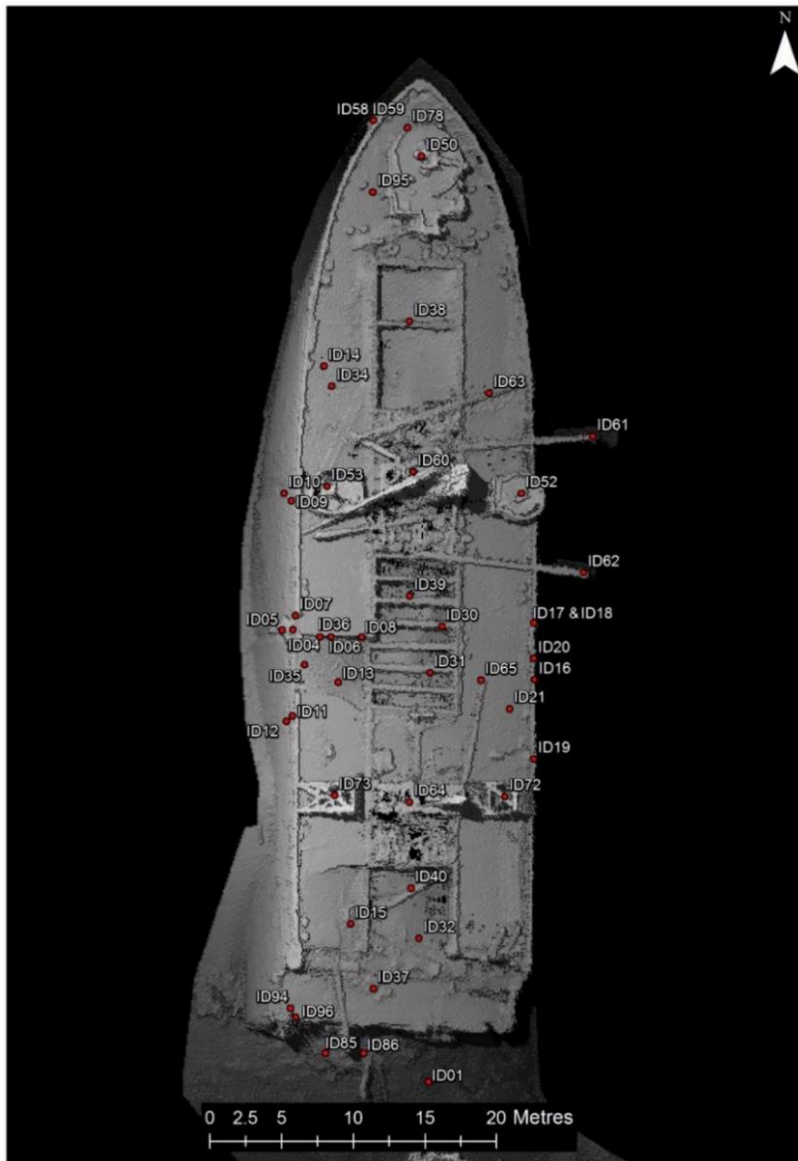
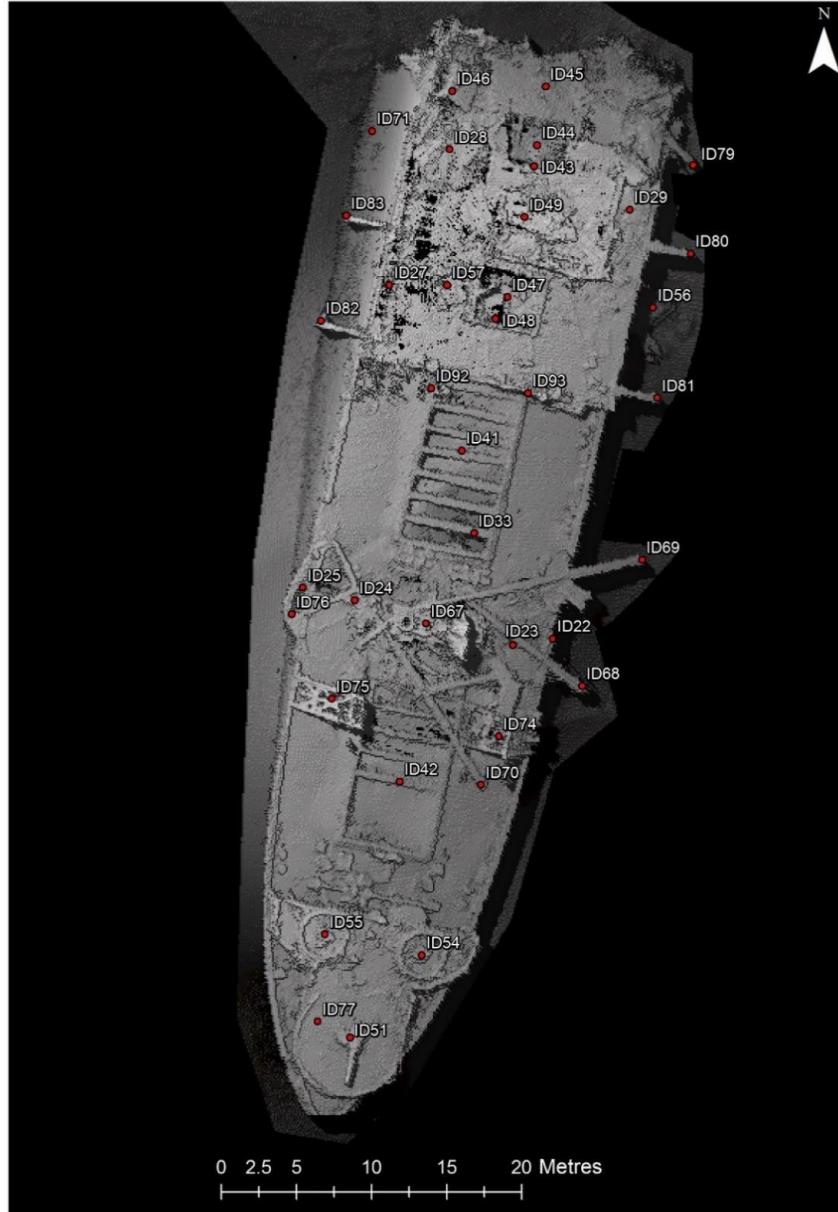
- 4.4.1 Over the whole of the wreck, 96 specific features have been used in successive surveys as comparison points for quantifying change and deterioration (*Table 2 List of features*). The location of these features is given in Figure 15 and Figure 16.
- 4.4.2 All feature IDs detailed in this report are consistent with those from previous survey. Three features showing change have been identified at ID15, ID51 and ID 86 between the August 2019 survey and the September 2020 survey. These are described in detail below.

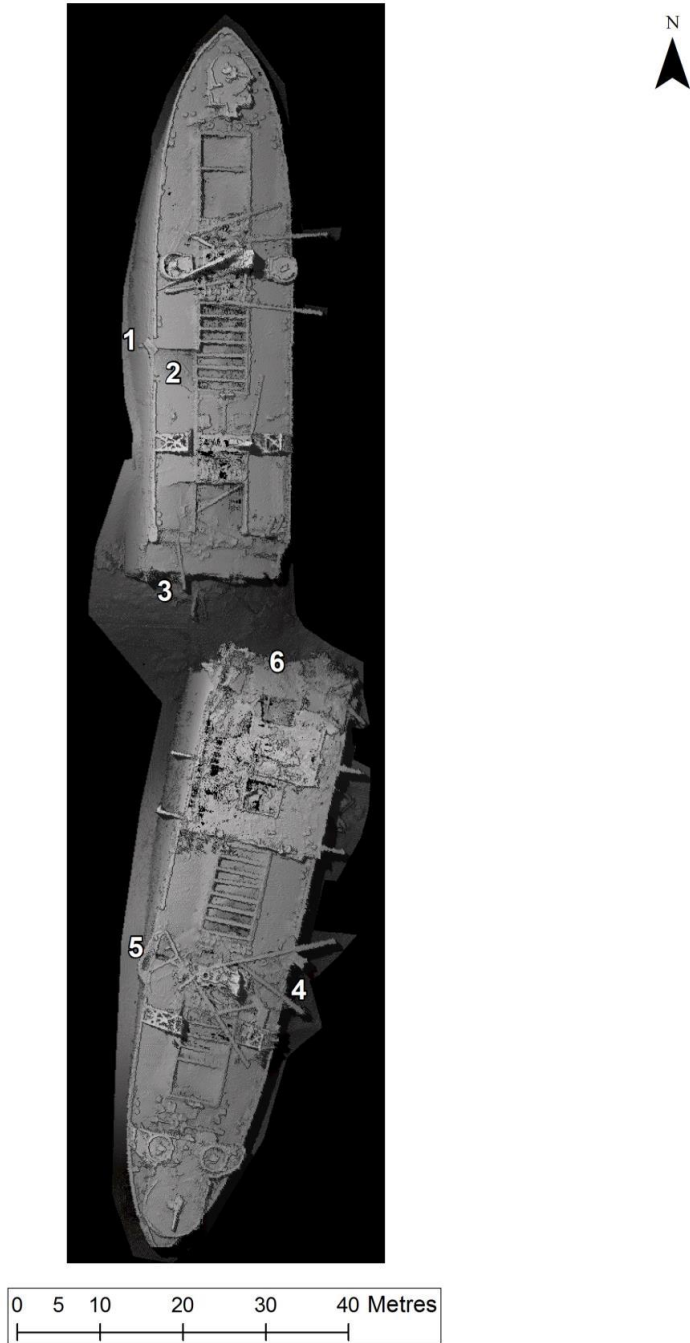
- 4.5.1 In addition to the 96 features, six Key Areas that have been highlighted in previous surveys as areas of significant structural change are monitored in each survey (Figure 20).
- 4.5.2 No changes were identified in any of the Key Areas, however these areas are further described below.

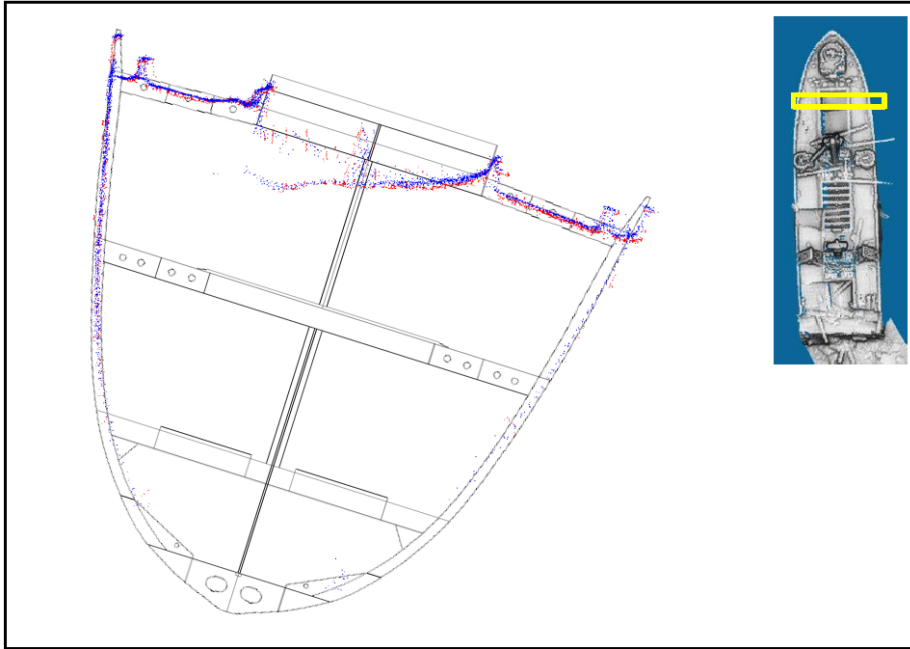
4.7.8 No appreciable difference is evident between the data sets for the 2017 and September 2020 surveys. The sediment level to the front of Hold 1 is remarkably similar. At the rear end there has been a small amount of erosion to the sediment in the 'tween deck space although the general profile of the sediment remains the same.

Figure 30 Cross section through the hull at frames 17-18 at the forward end of No. 1 hatch. Blue 2017, red 2020.

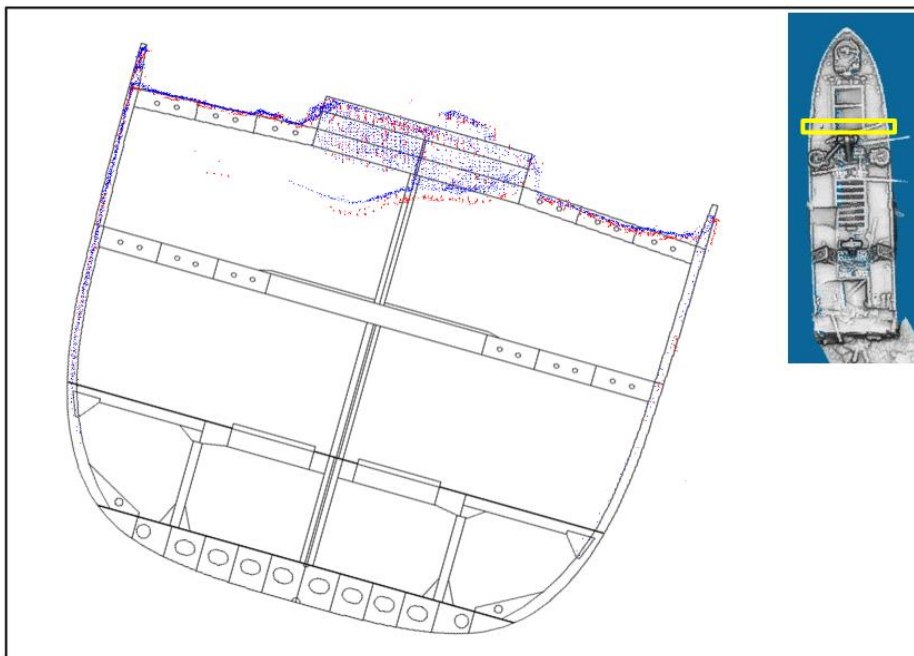
Figure 31 Cross section through the hull at frame 32, the aft end of No.1 hatch. Blue 2017, red 2020.

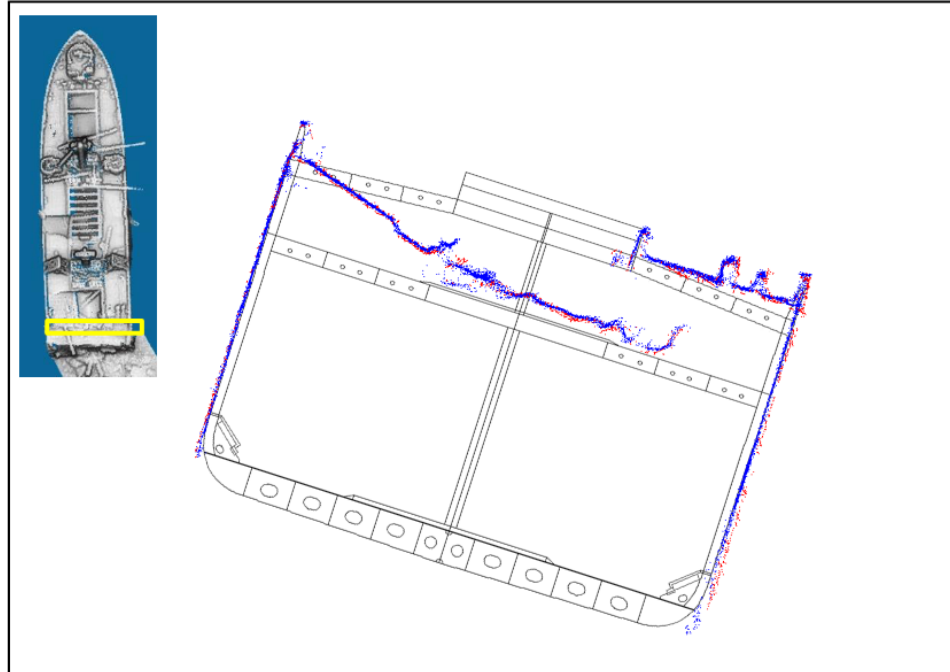
Figure 36 Cross section through the hull at frame 82, the aft end of No. 3 Hatch. Blue 2017, red 2020.

- 4.7.16 The sediment in the forward part of No. 4 Hatch shows distinct similarities with that in Nos 1 and 2 Hatches with the starboard side of the 'tween deck space being filled and the port side remaining clear above the horizontal to the top of the hatch coaming (Figure 36). However, the rear of the hatch area shows a different story with the first (and only) indication that the Second Deck or the lower hatch covers have failed. Here the sediment layer descends below the level of the Second Deck (Figure 37) confirming some form of collapse, probably a partial collapse of the lower hatch cover. This has happened at some time between 2010 (where the survey showed the sediment above the Second Deck) and the 2017 survey where the sediment is just below the second deck. The sediment deepened slightly between the 2017 survey and the August 2019 survey but has remained largely static between August 2019 and September 2020.

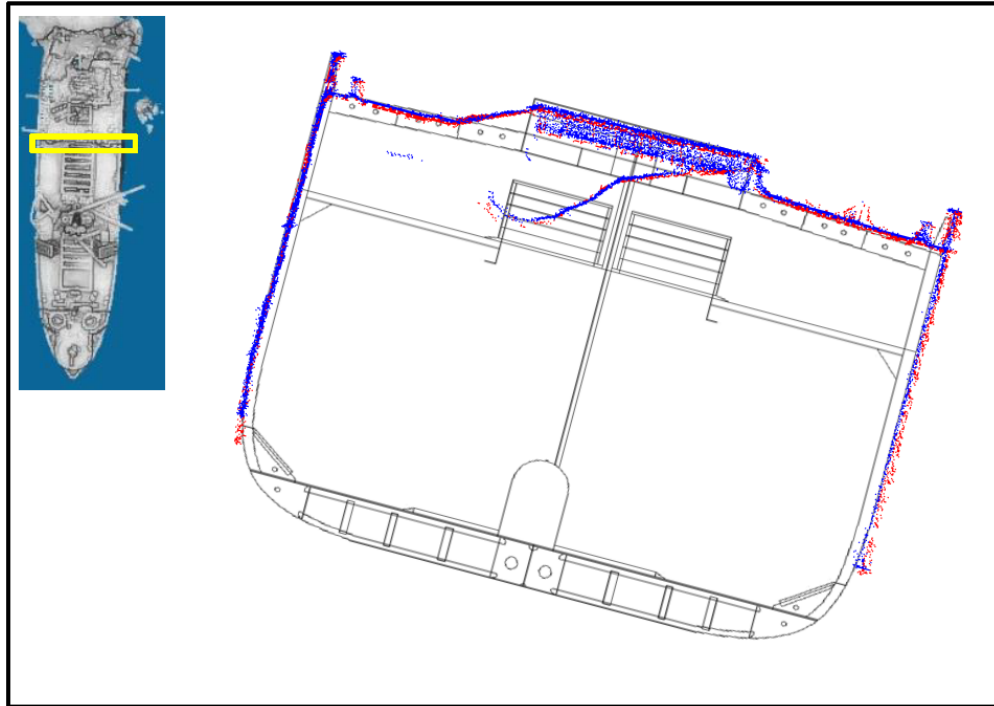
Figure 37 Cross section through the hull at frame 114, the forward end of No. 4 Hatch. Blue 2017, red 2020.

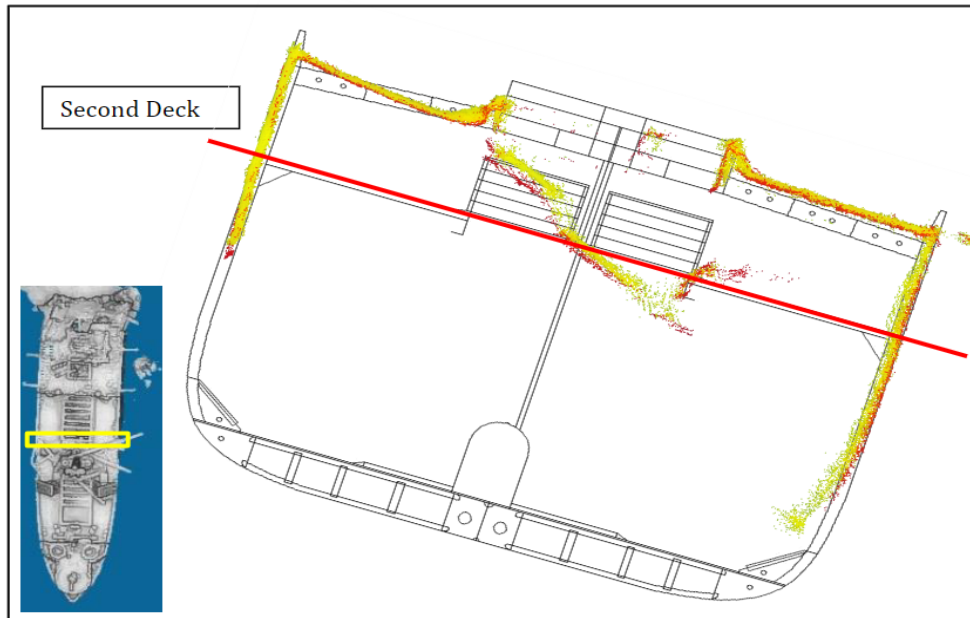
Figure 38 Cross section through the hull at frame 114, the rear of No. 4 Hatch. Yellow 2019, red 2020.

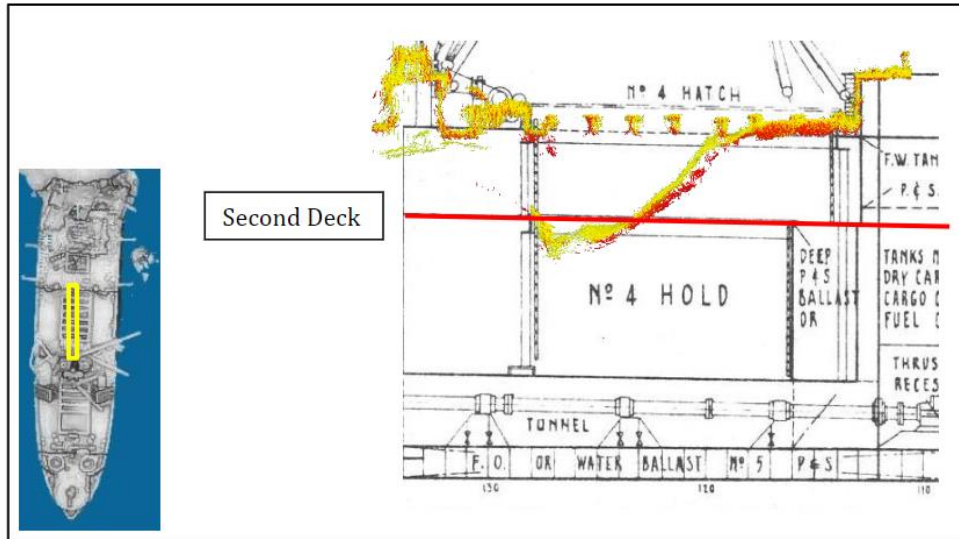
Figure 39 Longitudinal cross section through No. 4 Hold. Yellow 2019, red 2020.

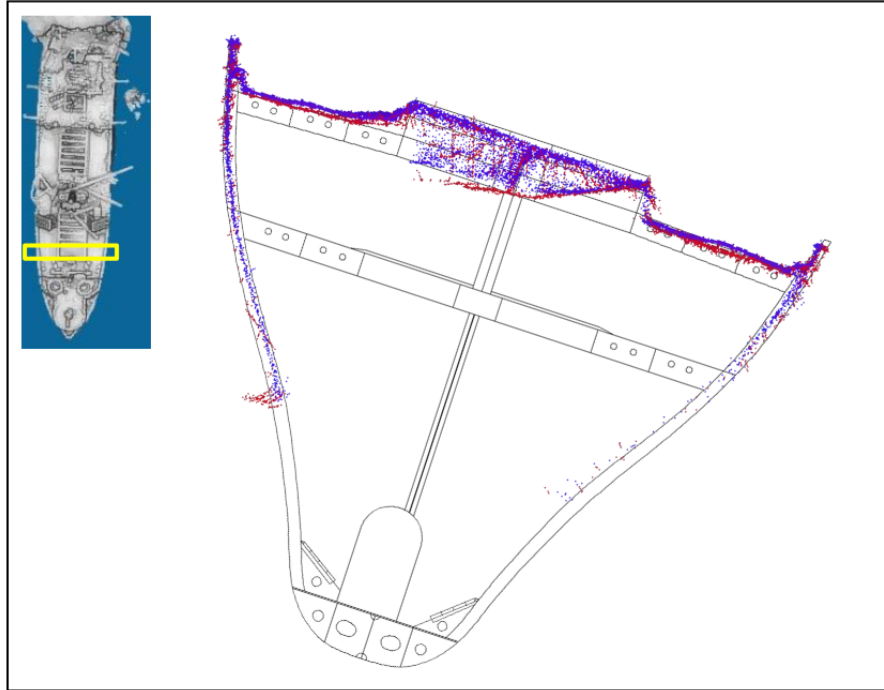
- 4.7.17 The rear most hold. The forward four of the six hatch cover supports remain in place. Sediment levels in the 'tween deck space again follow the pattern of the other mainly intact holds, in that the starboard side is filled while the port side remains clear above the level of the horizontal from the top of the hatch coaming. As with the other holds, except Hold 4, there is no indication that the Second Deck or the lower hatch cover have collapsed.
- 4.7.18 The sediment levels appear to have been stable for several years and the 2017 to 2020 surveys are shown below.

Figure 40 Cross section through the hull at frame 154, the aft of No. 5 Hatch. Blue 2017, red 2020.

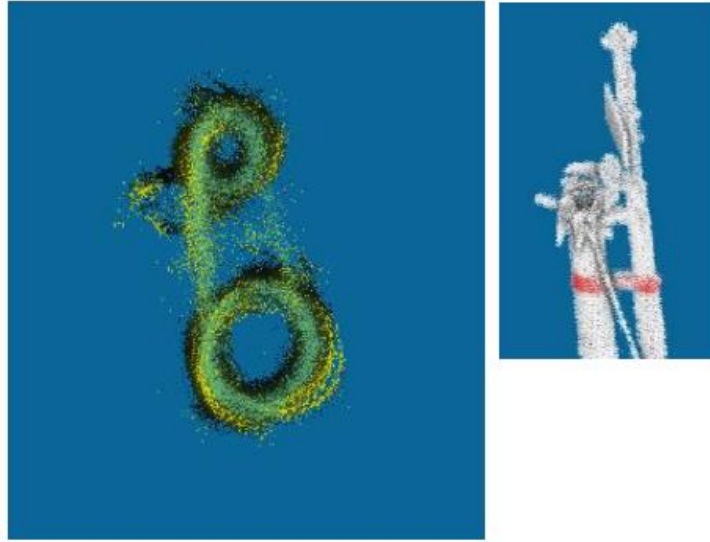
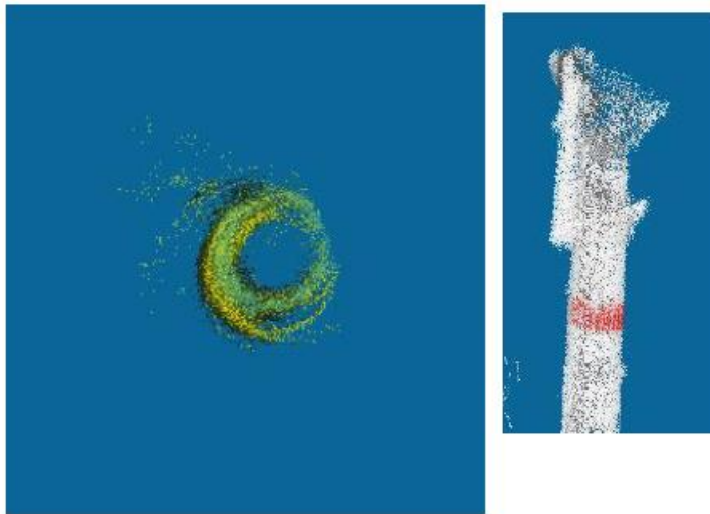
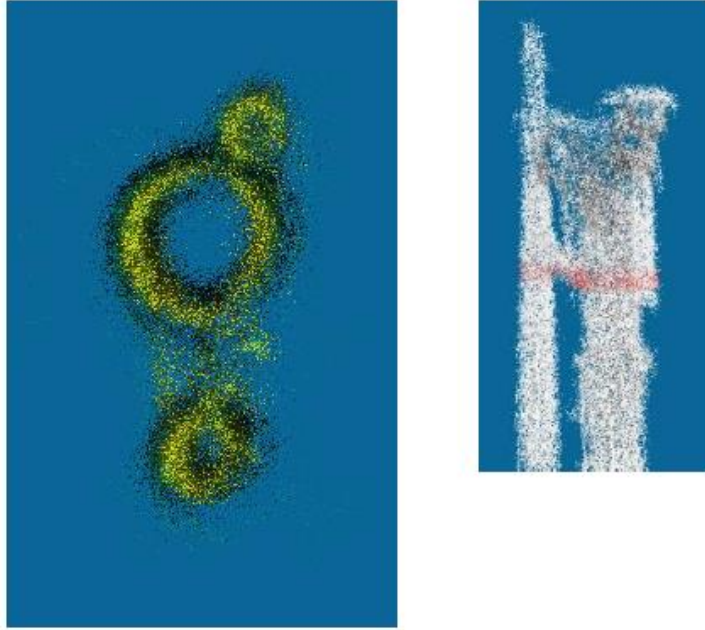
- 4.8.2 The laser data from the August 2019 survey was combined with the 2020 laser data to create a set of cross sections (one per mast). These show excellent agreement between the data from the two surveys (see Figures 41 to 43).

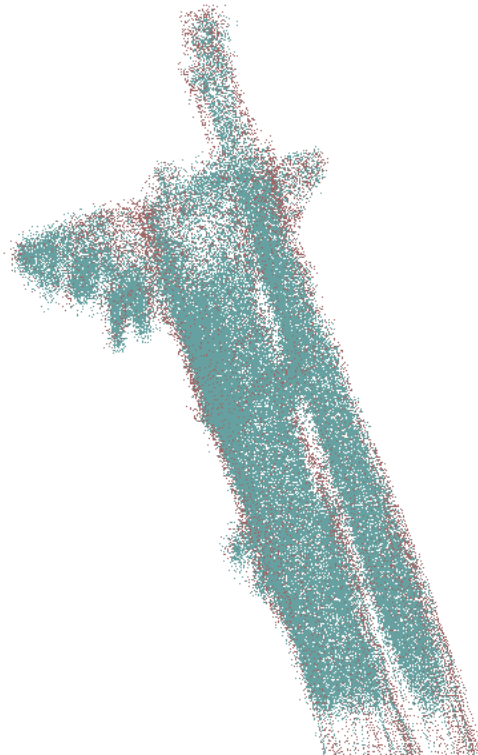
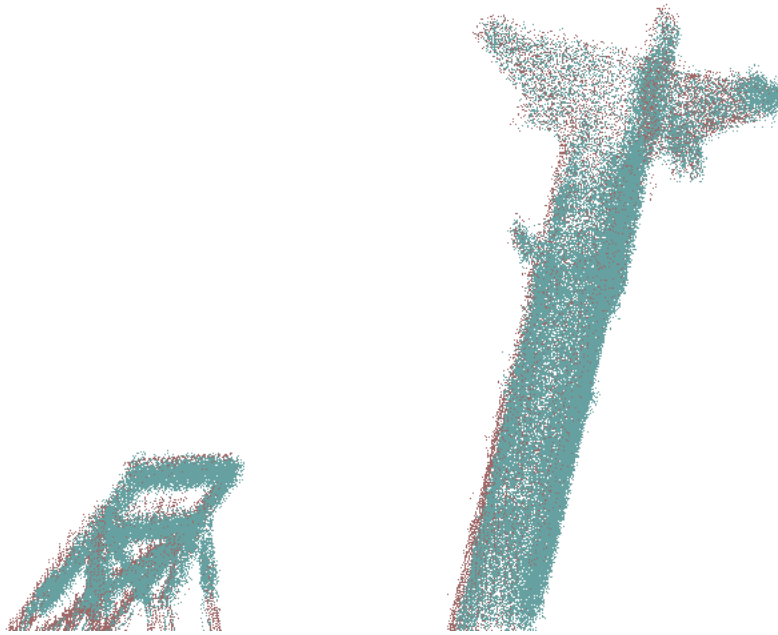
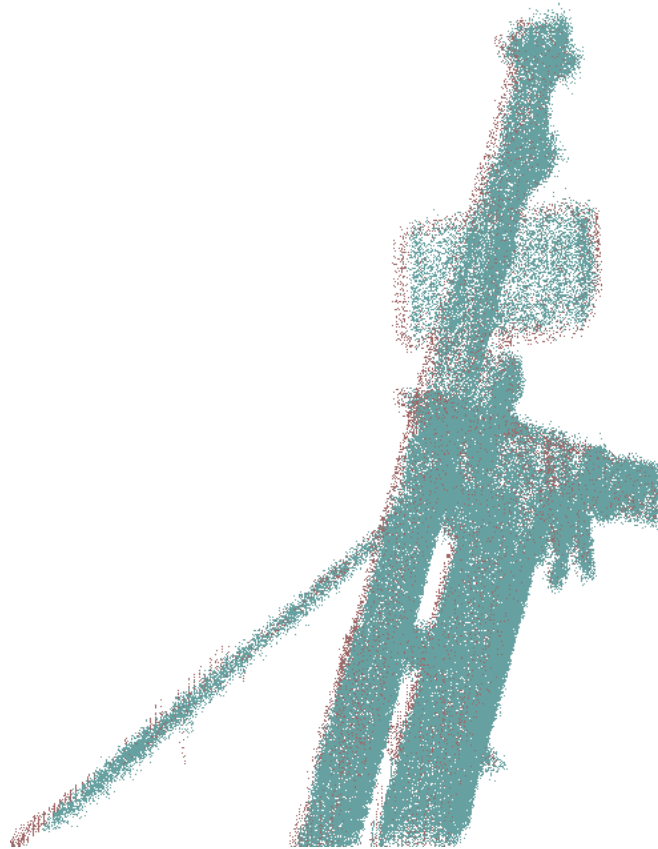
- 4.8.3 As an additional check, the 2017 data was combined with the 2020 data. Again, the two data sets show very close alignment indicating that there has been no movement since 2017 (see Figure 44 to Figure 47). By extension, the lack of movement in the masts implies that the wreck has not settled or moved as the masts, which are firmly fixed to the wreck, would also have done so.

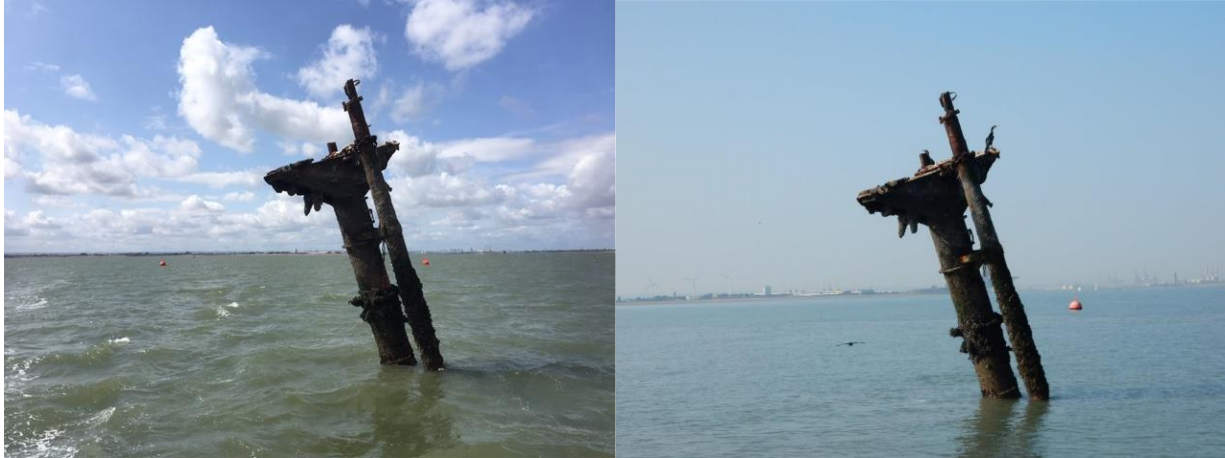
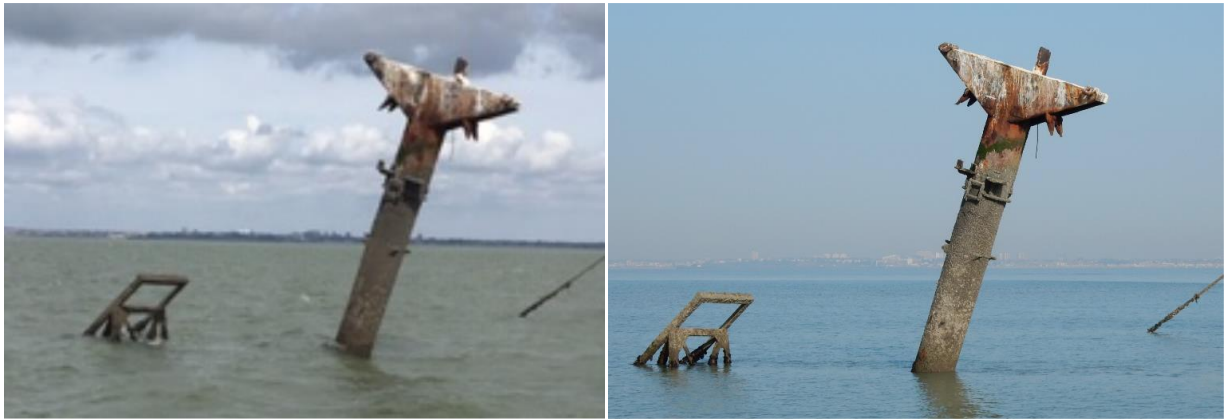
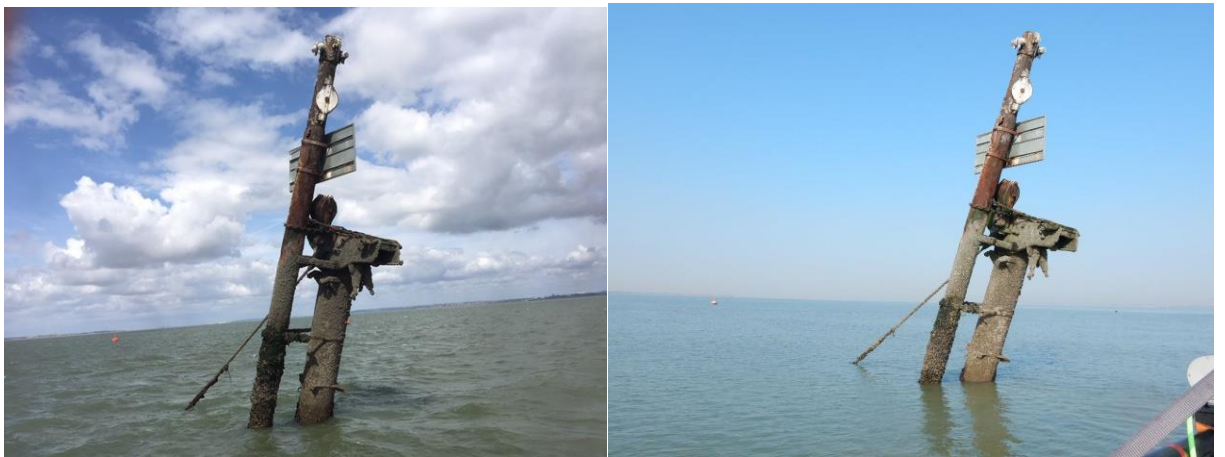
- 4.8.4 Photographs of the masts from the August 2019 and September 2020 surveys are also included in Figure 47 to Figure 49. These also indicate that there have been no changes since August 2019.

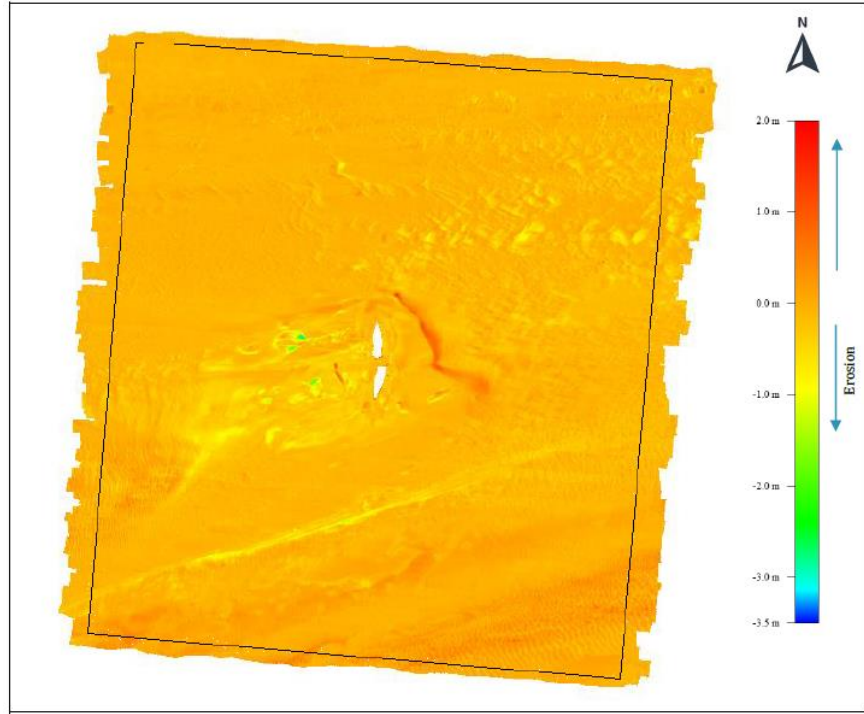
- 5.1.2 A difference plot was made between the August 2019 and September 2020 surveys. The results of this are shown in Figure 50 below. In general, there are only minor changes in the depths. However, a sand bank to the west of SSRM wreck has extended slightly to the west making the general depth in this area about 2m shallower. Similarly, the sandbank to the east of the wreck has also extended to the west again making the general depth some 2m shallower. This continues a trend reported on in previous survey reports or a general westerly migration of the sand bank.

Figure 50 Surface difference results September 2020 – August 2019.

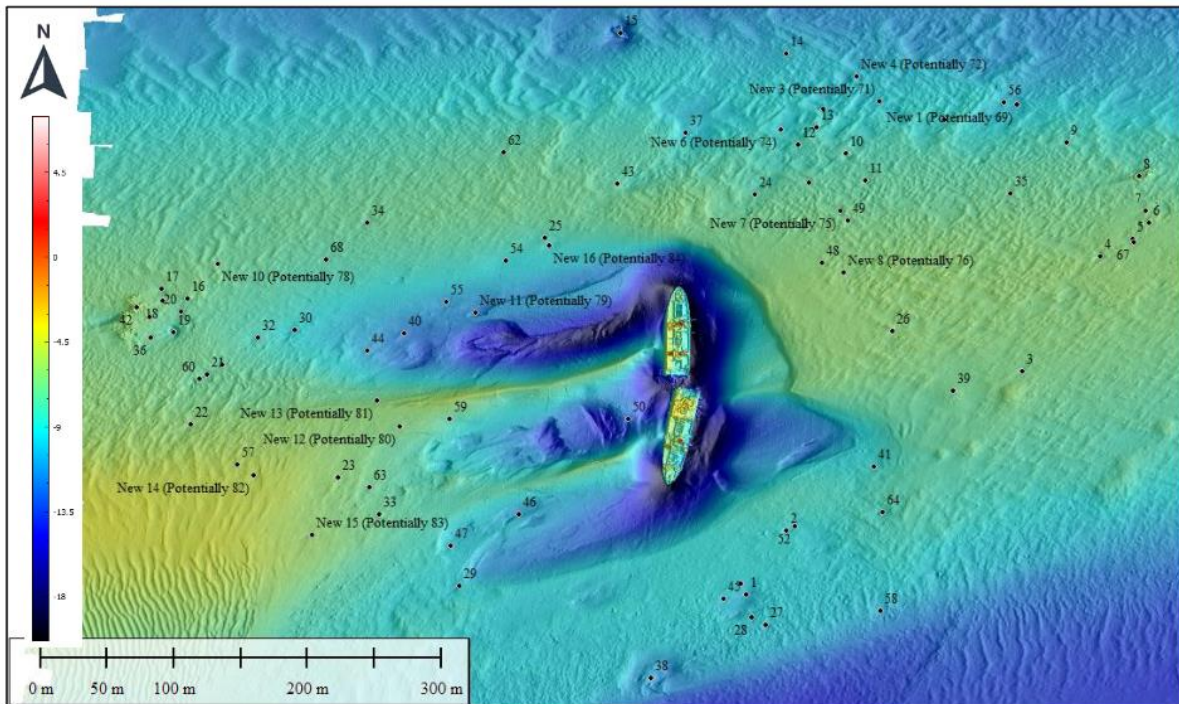
- 5.2.1 The seabed contact list from 2019, with a total of 68 contacts, was compared against this year's bathymetry. Analysis of the 2020 dataset has added a further 16 targets to the contact list, while 12 items from the 2017 contact list are not apparent on the 2019 data.
- 5.2.2 Seabed contacts are shown in Figure 52. Although the image does not cover the full extent of the survey, no identified contacts exist outside the area shown.
