Maritime &
Coastguard
Agency

SS Richard Montgomery: Survey Report 2018

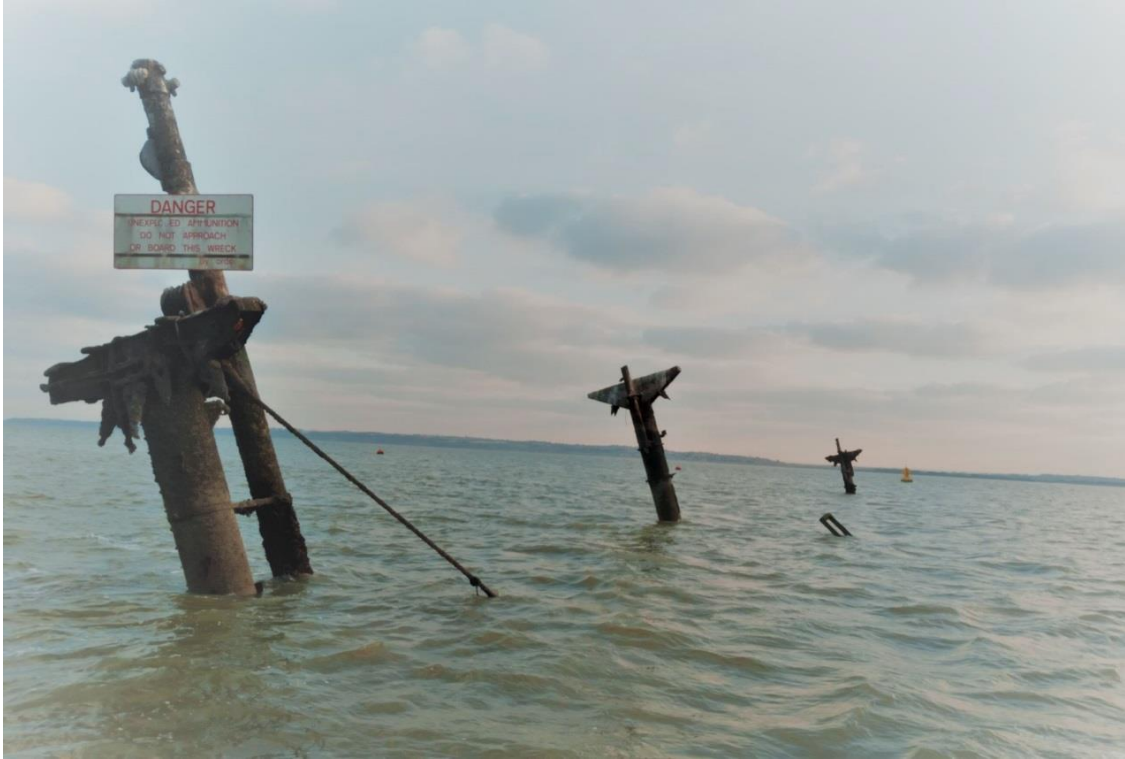
- 2.1.4 The vessel remains on Sheerness Middle Sand, lying in two sections in its own scour pit and sitting on exposed bedrock which is believed to be London Clay. The SSRM lies across the tide and all three masts are visible above the water at all states of the tide (see Figure 2 below, taken from North approach).

Figure 2 Photograph of the SSRM's three masts above the water – left to right: fore mast, main mast and mizzen mast.

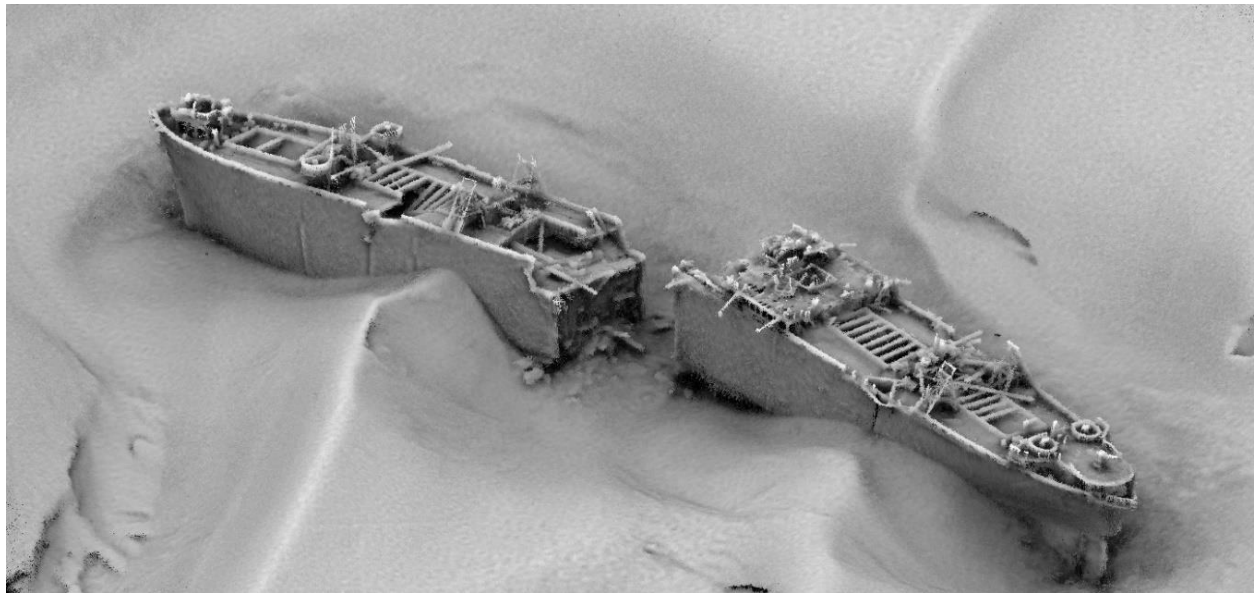
Figure 3 Overview of Port side of SSRM

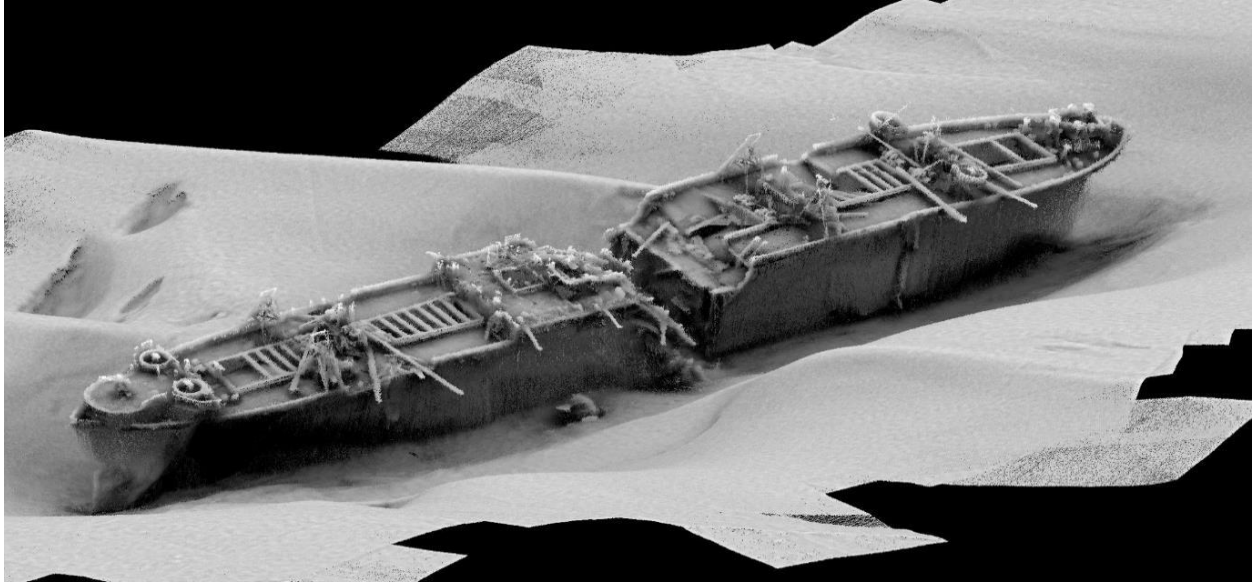
Figure 4 Overview of Starboard side of SSRM.

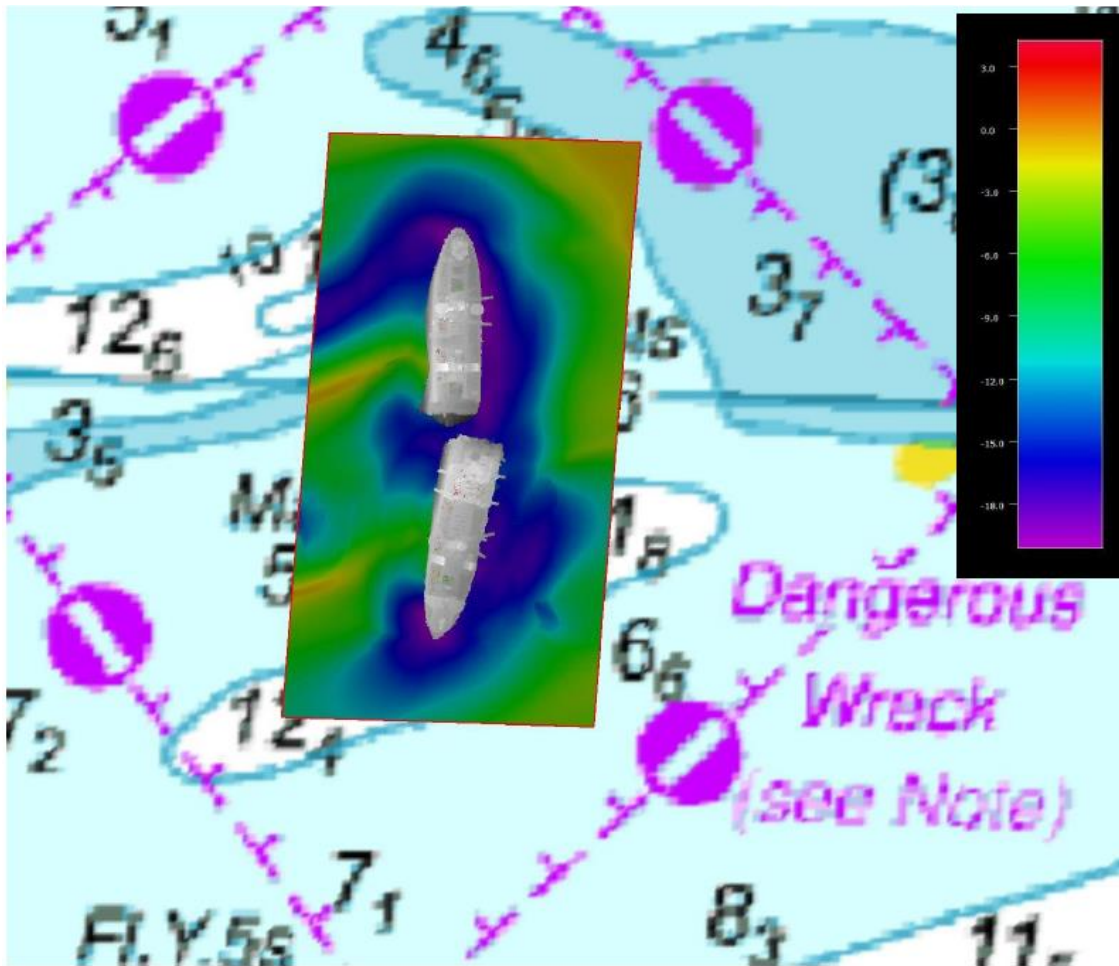
Figure 5 Surrounding seabed MBES survey.

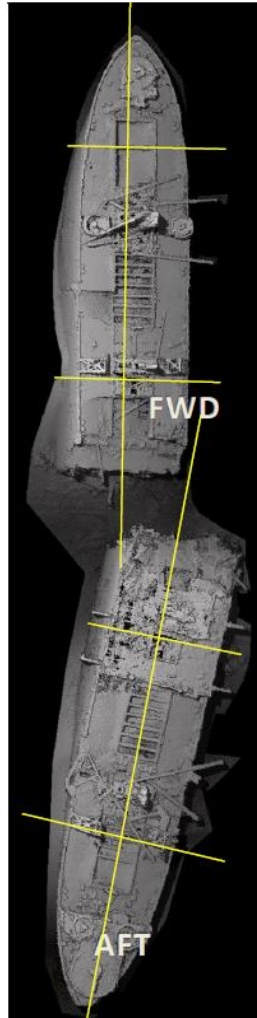
- 4.2.2 Profiles of the hull were reviewed to monitor for any wreck movements or listing which may have occurred since the previous surveys. The locations of these profiles are shown in yellow in Figure 7.

Figure 7 Location of profiles examined.

4.2.3 The data shows good correlation between previous datasets with no change observed in the various profiles of the wreck. This suggests that the SSRM has remained stable in all planes of attitude and position, and any minor changes are attributed to small scale feature changes only.

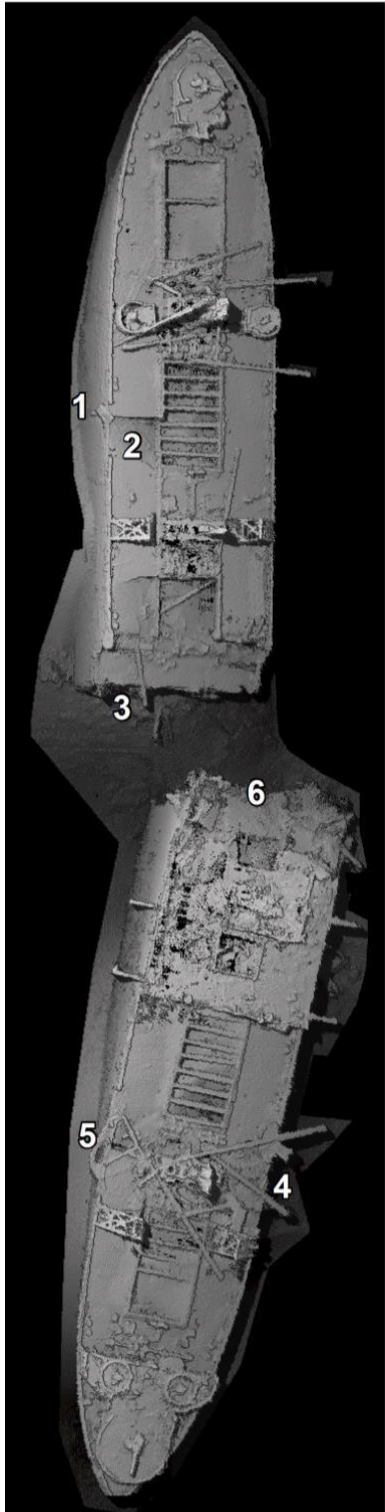
- 4.3.1 Over the whole of the wreck, 96 specific features have been used in successive surveys as comparison points for quantifying change and deterioration. The location of these features is given in Figures 8 and 9.
- 4.3.2 In addition to the 96 features there are six Key Areas that have been highlighted in previous surveys as areas of significant structural change which are monitored each survey. The location of these is shown in Figure 14.

Figure 14 Six Key Areas of SSRM significant for structural change.

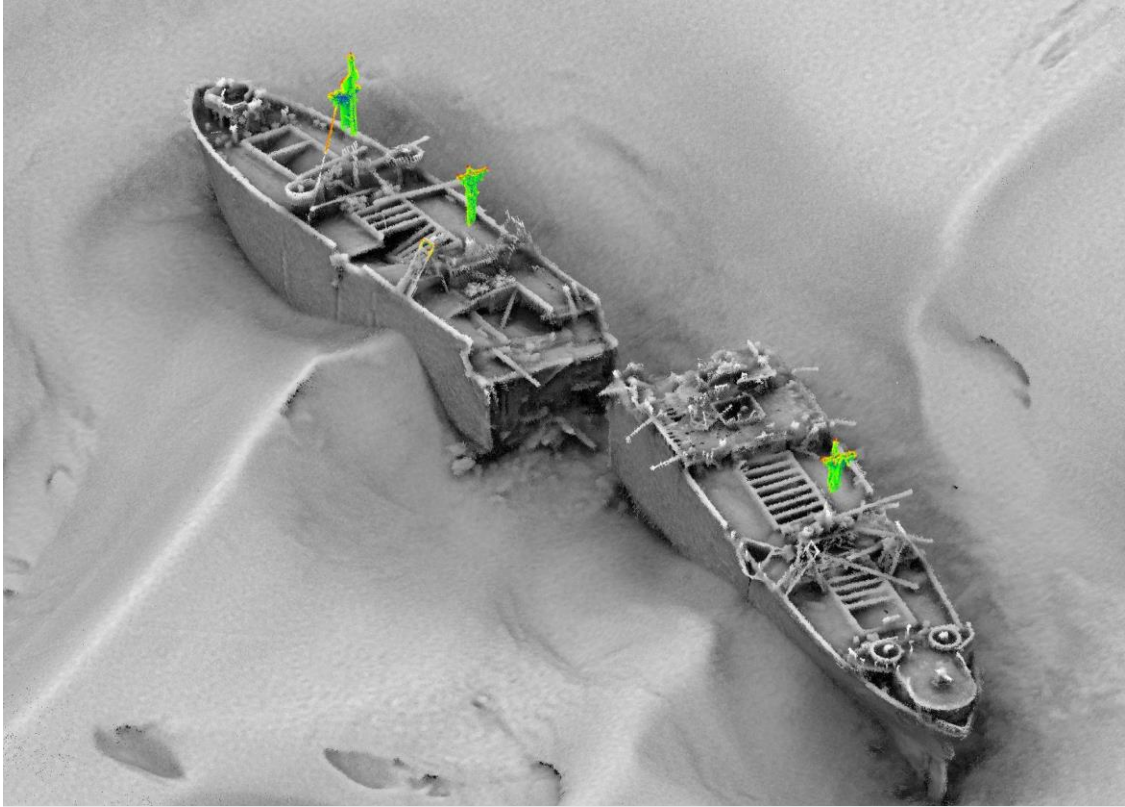
- 4.6.1 The laser scan results are illustrated in Figures 43-45. The three masts are well defined within the laser data and show good correlation with the bathymetry derived points on the foremast stay and on the life raft davit. Unfortunately, due to the angle of the MBES heads and the height of tide when the MBES data was acquired a vertical data gap of approximately 1m exists between the Laser and MBES on the main mast structures.

Figure 43 2018 survey Laser scan data points (green to red) integrated with the MBES data.

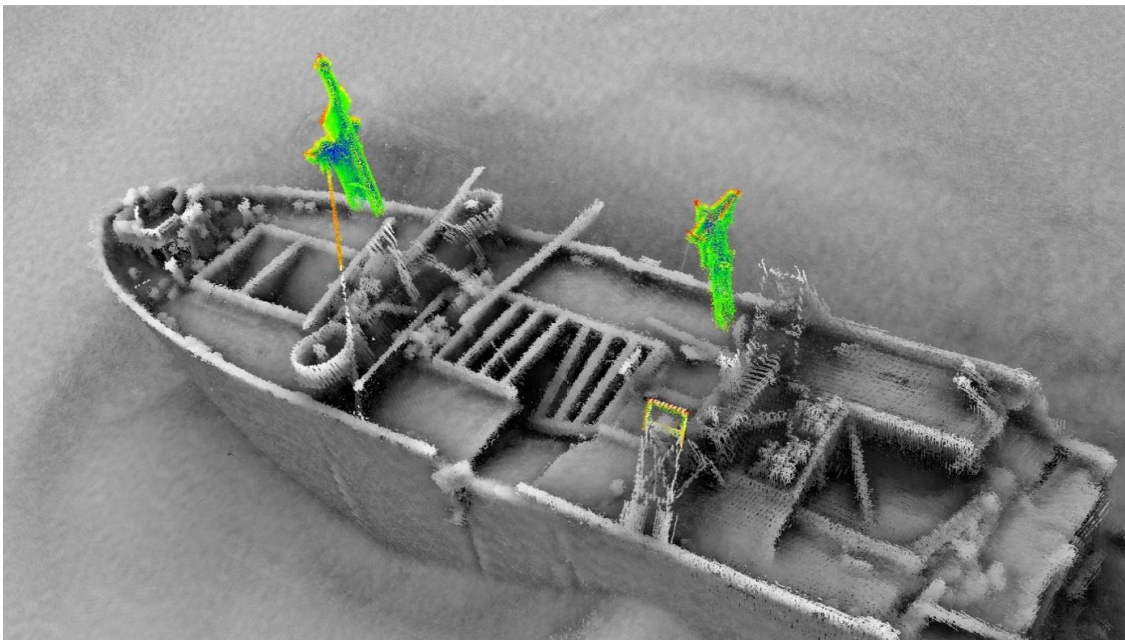
Figure 44 Fore and main mast area from 2018 survey data (laser data in green to red).

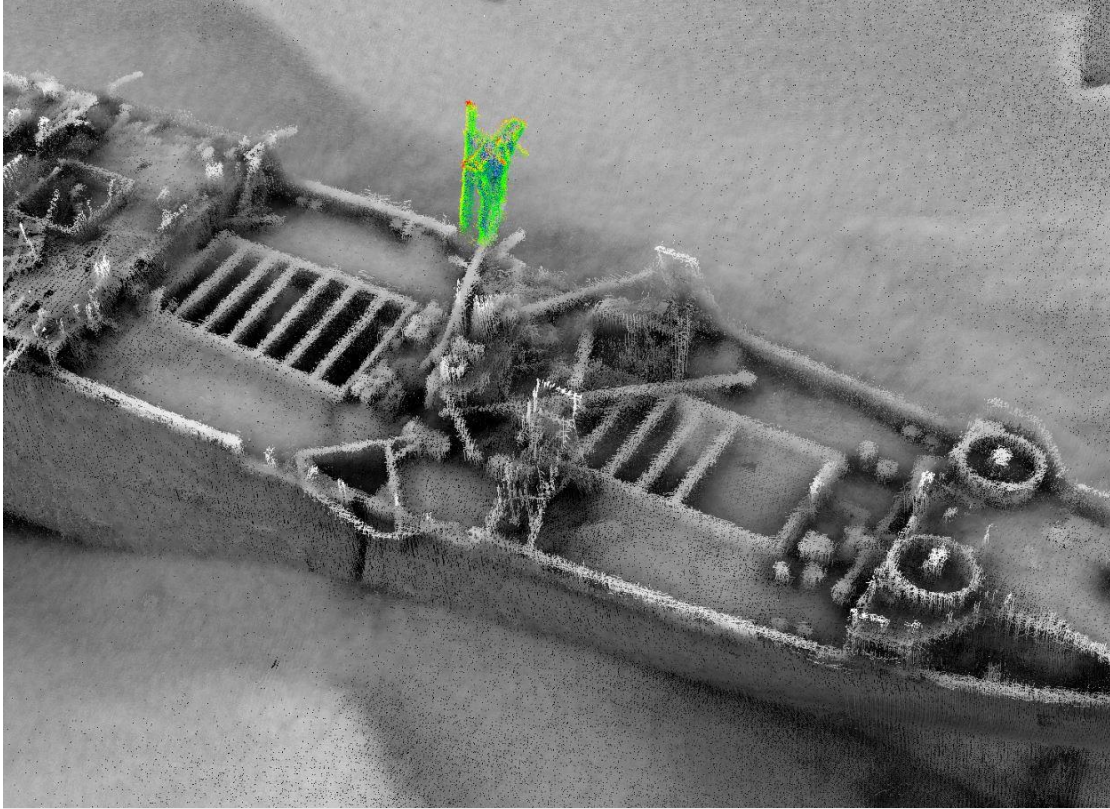
Figure 45 Mizzen mast from 2018 survey data (laser data green to red).

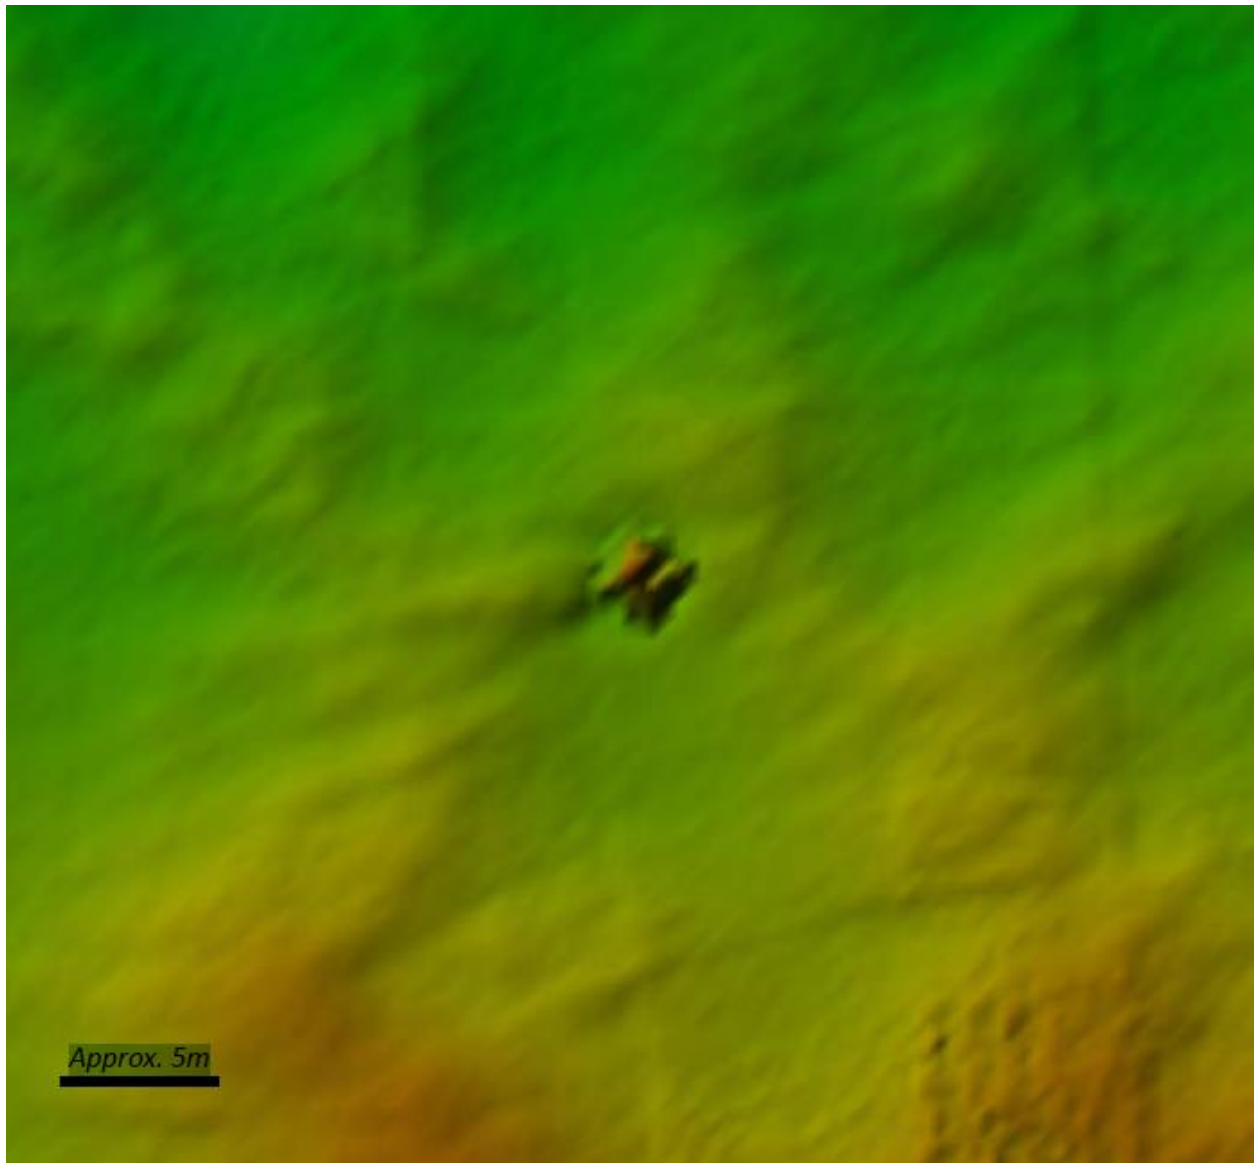
- 5.3.1 A further brief survey was undertaken to confirm the position of some Cefas instrumentation that had been deployed just outside the SSRM Exclusion Zone.
- 5.3.2 The Cefas seabed MiniLander, equipped with oceanographic recording equipment, was successfully located and no scouring was evident on the seabed around the lander in the data collected. Figure 50 and Figure 51 show the Cefas equipment on the seabed.

Figure 50 Shaded relief bathymetry of CEFAS MiniLander on seabed.

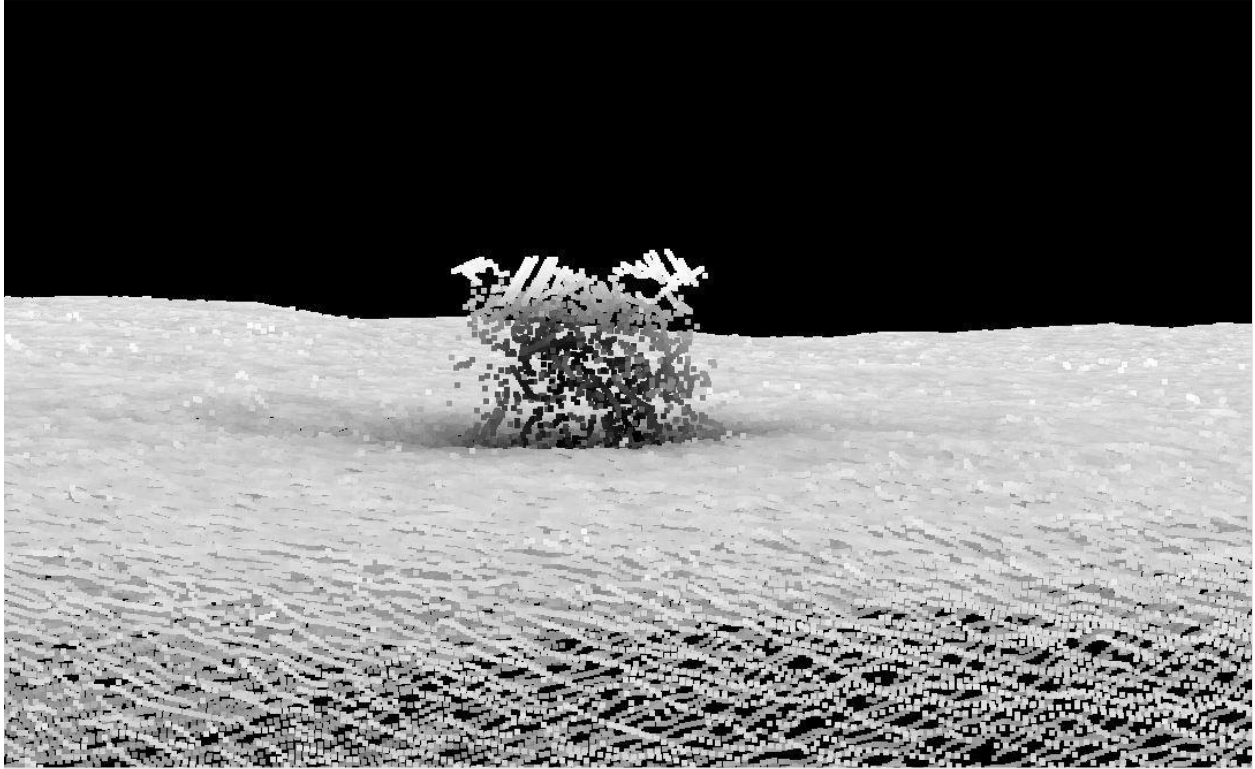
Figure 51 Point cloud imagery of CEFAS seabed instrument.
