Accident

Aircraft Type and Registration:	Piper PA-28-161, G-EKIR	
No & Type of Engines:	1 Lycoming O-320-D3G piston engine	
Year of Manufacture:	1989 (Serial no: 2841157)	
Date & Time (UTC):	22 March 2023 at 1300 hrs	
Location:	Sandtoft Airfield, Belton, North Lincolnshire	
Type of Flight:	Private	
Persons on Board:	Crew - 1	Passengers - None
Injuries:	Crew - None	Passengers - N/A
Nature of Damage:	Left navigation and position lights, casing damaged. Scuffs to paint work on wing tip area	
Commander's Licence:	Private Pilot's Licence	
Commander's Age:	32 years	
Commander's Flying Experience:	105 hours (of which 98 were on type) Last 90 days - 16 hours Last 28 days - 7 hours	
Information Source:	Aircraft Accident Report Form submitted by the pilot

Synopsis

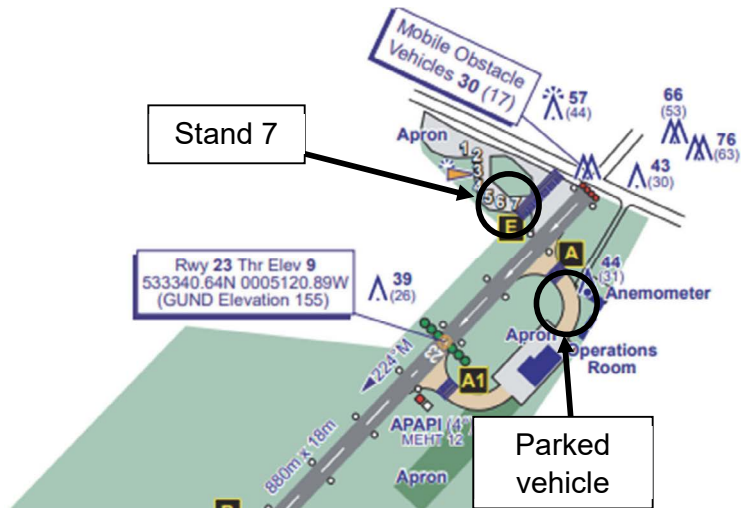
Figure 1

Having flown into Sandtoft Airfield earlier in the day the pilot was preparing for his return flight to Gloucester. Having started the engine, he proceeded to taxi from his parking position (Stand 7) across the runway and along Taxiway A to uplift fuel. There was a vehicle parked on Taxiway A completing a delivery to the cafe.

Map of parking area and site of collision at Sandtoft Airfield

The pilot reported that he felt there was enough room for him to pass the van which was parked on the left side of the taxiway on the curve as he taxied from Stand 7. The vehicle was parked with a gap of around 1 or 2 m from the edge of the taxiway. G-EKIR has a wingspan of 10.70 m and the taxiway width is 15 m. At the time of the collision there was also another aircraft parked partly on the taxiway to the right of G-EKIR. It can be difficult to judge the space available against the wingspan from inside the aircraft. The pilot did not ask for assistance before attempting to pass the van.
