# ***AAIB Bulletin***

# **8/2023**

<b>Aircraft Type and Registration:</b>	Piper PA-28-151 (Modified), G-BOTI	
<b>No &amp; Type of Engines:</b>	1 Lycoming O-320-D3G piston engine	
<b>Year of Manufacture:</b>	1975 (Serial no: 28-7515251)	
<b>Date &amp; Time (UTC):</b>	22 October 2022 at 1330 hrs	
<b>Location:</b>	9 nm final approach into Exeter Airport	
<b>Type of Flight:</b>	Private	
<b>Persons on Board:</b>	Crew - 1	Passengers - 1
<b>Injuries:</b>	Crew - None	Passengers - None
<b>Nature of Damage:</b>	None	
<b>Commander's Licence:</b>	Commercial Pilots Licence	
<b>Commander's Age:</b>	33 years	
<b>Commander's Flying Experience:</b>	331 hours (of which 40 were on type) Last 90 days - 21 hours Last 28 days - 16 hours	
<b>Information Source:</b>	AAIB Field Investigation

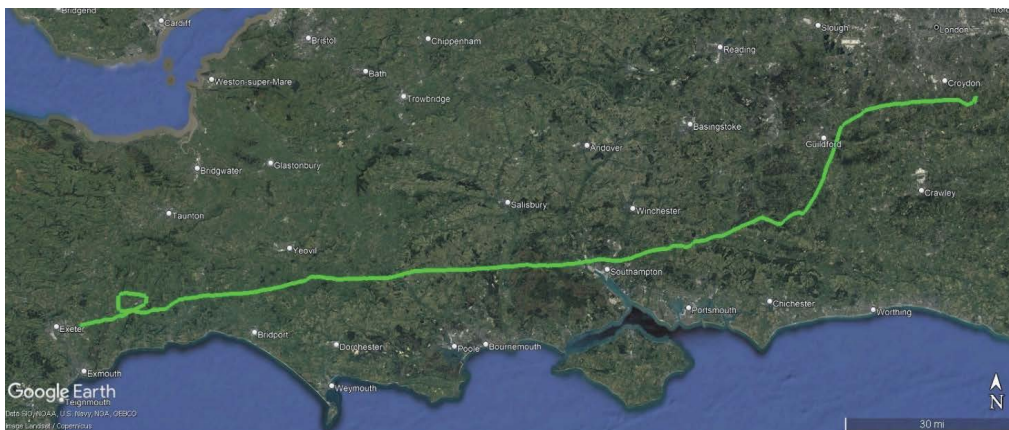
**Figure 1**  
G-BOTI flight path

The flight departed Biggin Hill at 1150 hrs. There was one passenger on board who also held a pilot's licence, although he was not qualified to fly under instrument flight rules (IFR). The pilot flew under IFR outside controlled airspace and navigated enroute between VORs (Figure 1), plotting his position at various points and comparing with navigation software he was using on a tablet device. He was satisfied that the VOR indications on the CDI were correct and the instrument was operating normally.

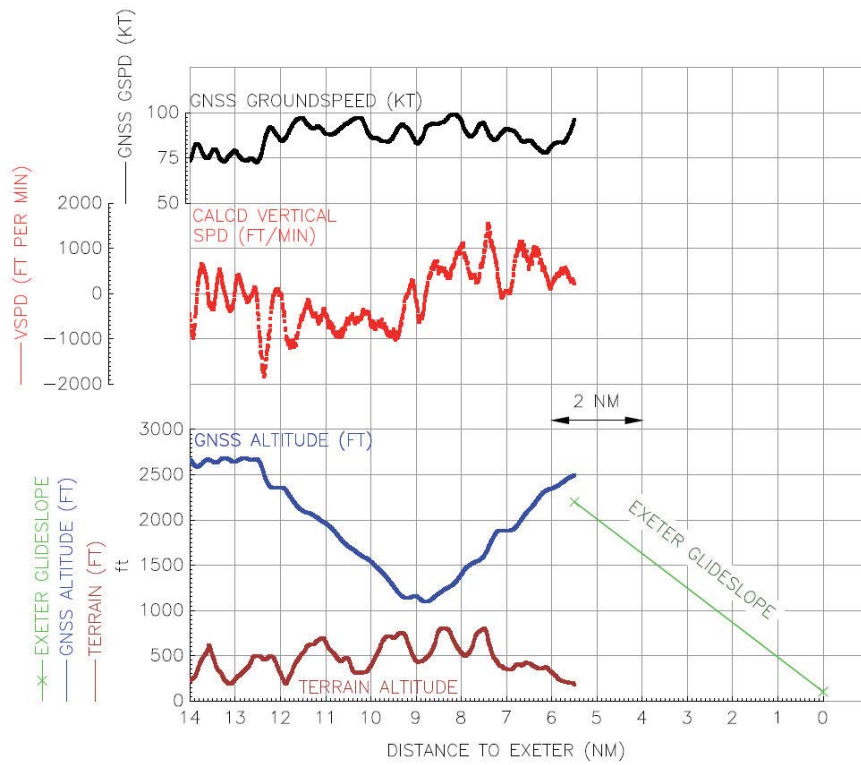
**Figure 2**

The aircraft took off from Biggin Hill at 1150 hrs and climbed to approximately 2,300 ft amsl, tracking towards Exeter. At 1318:11 hrs, while 23 nm from the threshold, the approach controller instructed G-BOTI to descend to 2,600 ft. After this transmission, the approach controller was changed. At 1325:01 hrs, when 12.5 nm from the runway threshold, a descent from 2,600 ft commenced. This initially levelled at 2,300 ft for 10 seconds before continuing (Figure 2).

G-BOTI altitude and track distance from Exeter Airport.  
Green line shows Exeter glideslope

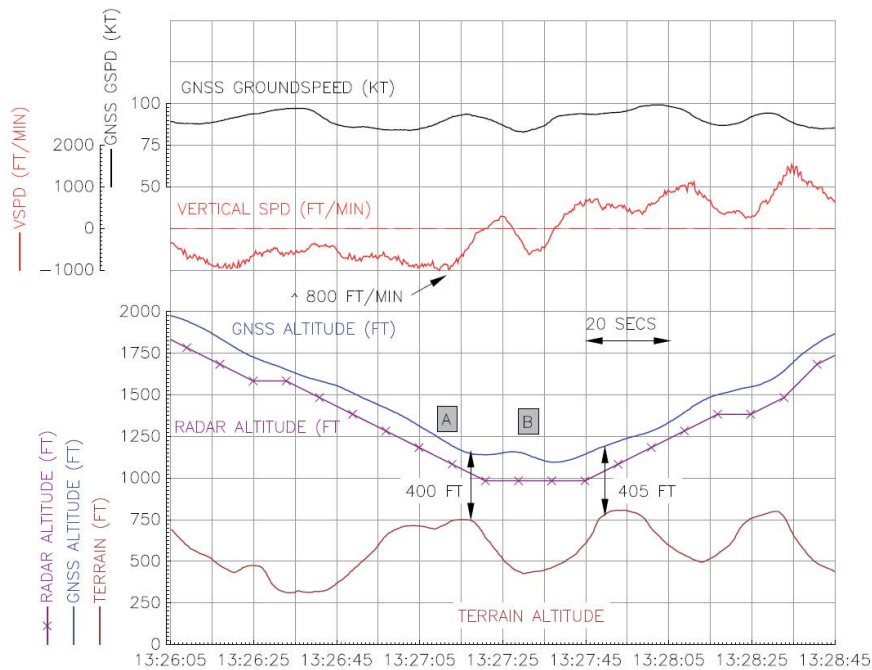
**Figure 3**

At 1327:13 hrs, the aircraft was 9.4 nm from the runway threshold, descending at approximately 800 ft/min (Figure 3, Point A). The approach controller requested the pilot's altitude to which he replied 'ALTITUDE 1,100 DESCENDING'. At this time, the recorded radar altitude was 1,084 ft<sup>2</sup>, the GNSS altitude was 1,155 ft and the terrain was estimated at 751 ft. After this query from the approach controller, the aircraft levelled at approximately 1,150 ft but descended to a minimum GNSS altitude of 1,096 ft. Terrain under the flight path undulated with the minimum clearance, based on GNSS altitude, estimated at 400 ft.

The approach controller asked whether G-BOTI was on the glidepath to which the pilot replied he was. At 1327:29 hrs (Figure 3, Point B), the approach controller stated 'GOLF TANGO INDIA YOU'RE WELL BELOW THE GLIDE PATH LEVEL, CLIMB UP TO ALTITUDE 2,600 FT'. The pilot acknowledged this and commenced a climb. During this, the aircraft's heading became more westerly and the approach controller asked if G-BOTI was established or whether a repositioning was required. The pilot responded with a repositioning request, which the controller facilitated, and the subsequent approach was successful.

G-BOTI recorded data

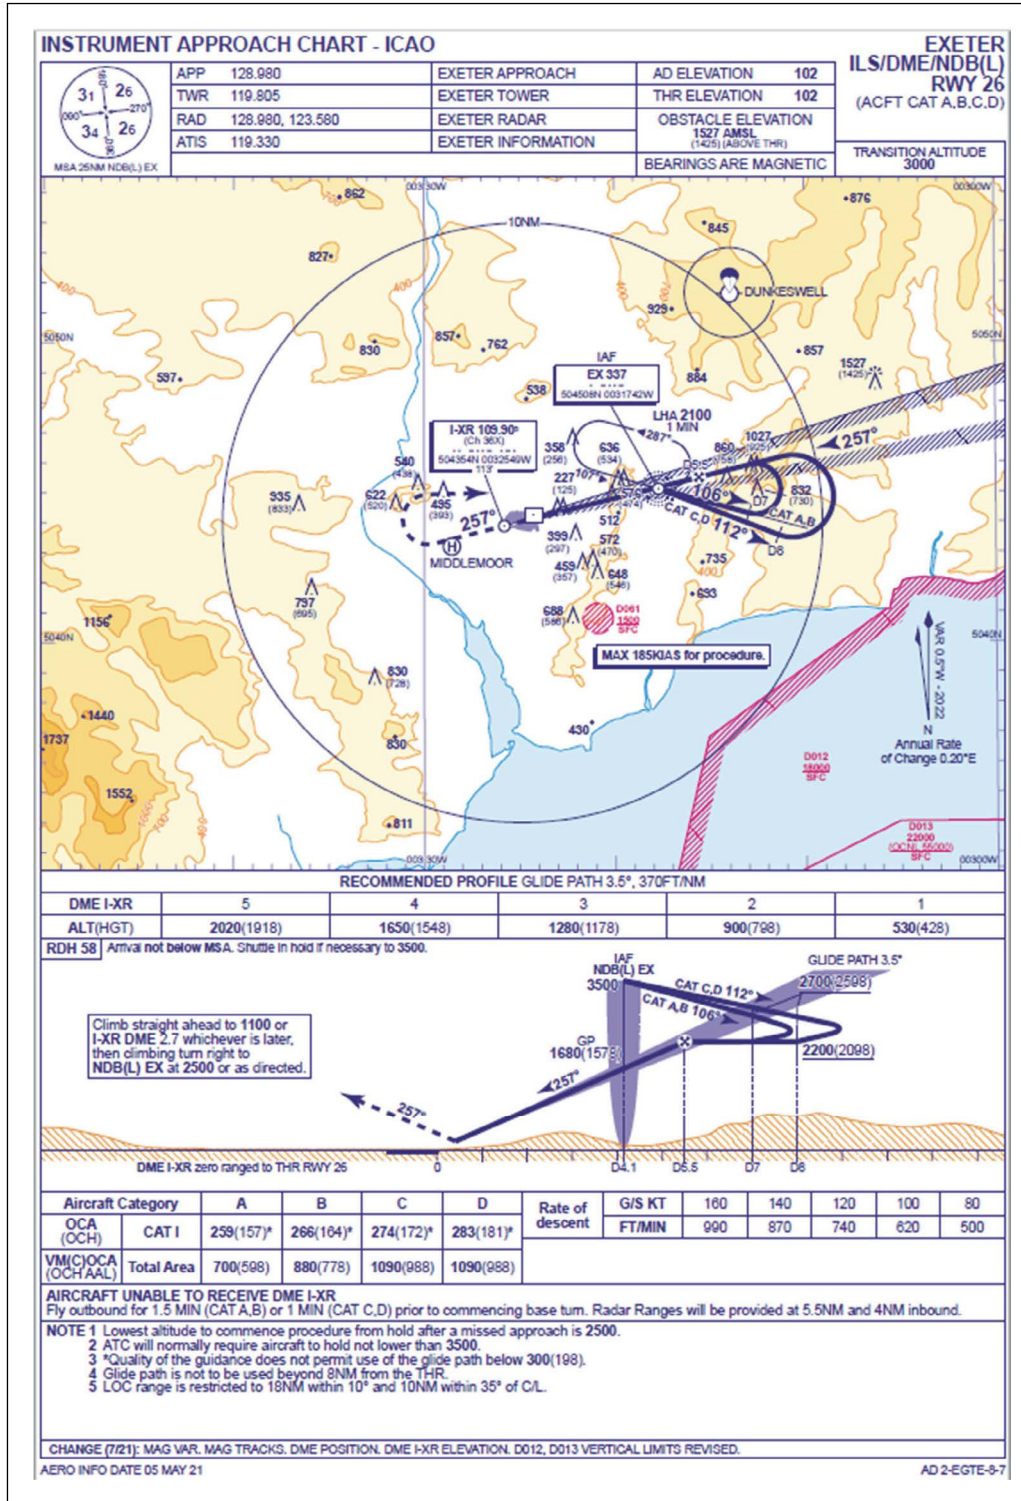
Aerodrome charts, including instrument approach charts, are published under Part 3 of the Aeronautical Information Publication (AIP)<sup>3</sup>. Aerodrome and approach charts can be produced by third parties and are based on the information published in the AIP. Both types of chart should contain the same information but may differ in presentation (Figures 4 and 5).

**Figure 4**  
AIP ILS approach chart for Runway 26 at Exeter Airport

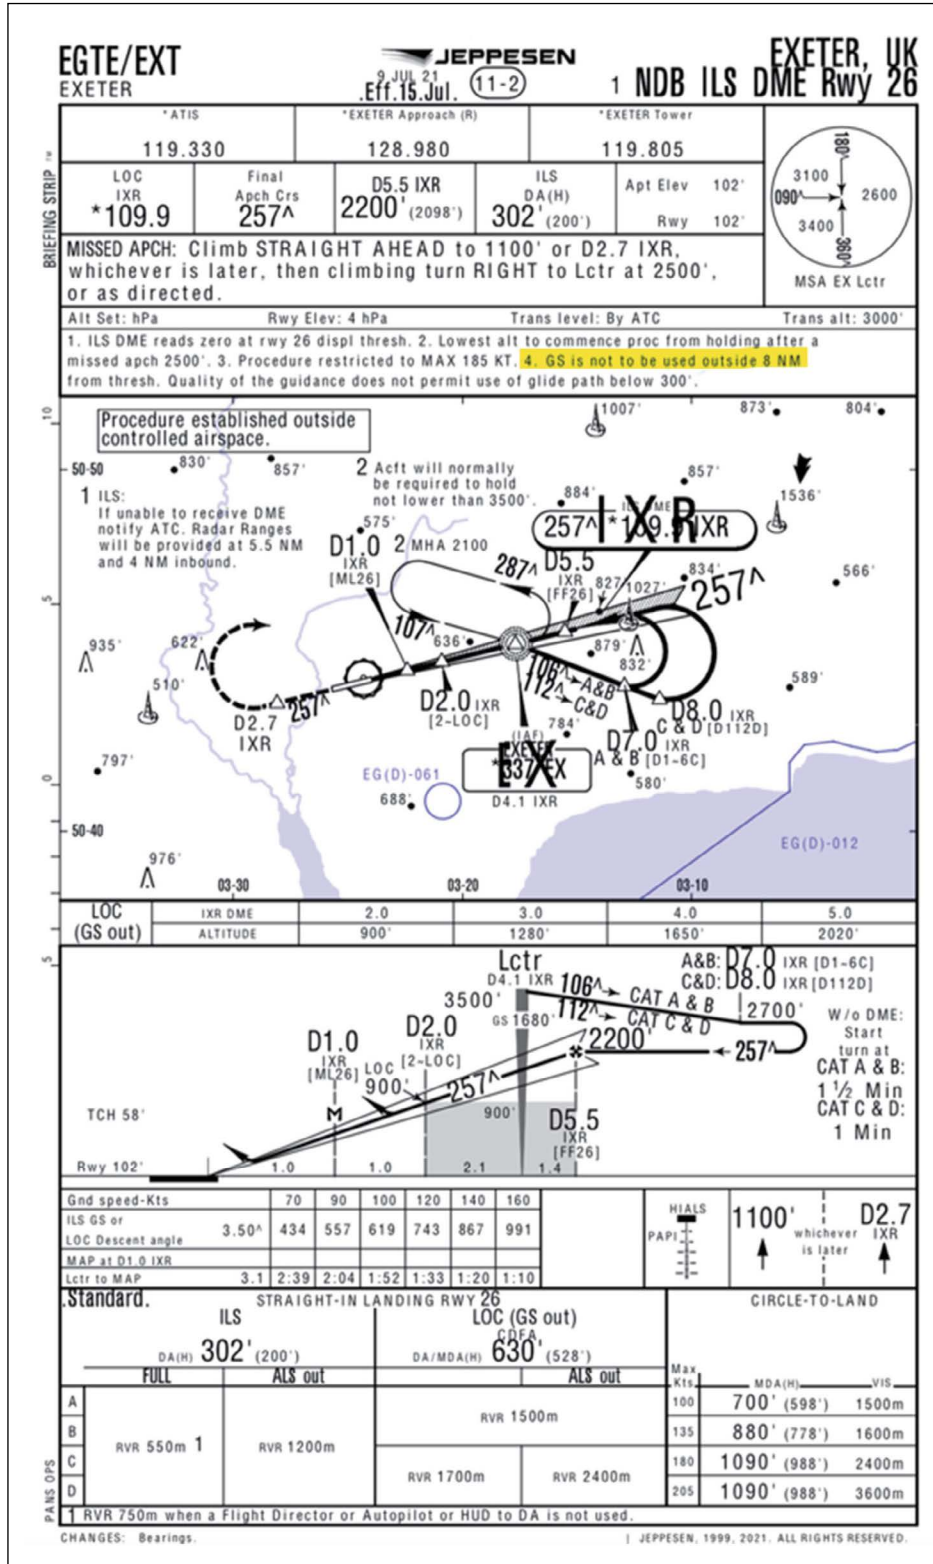
Figure 5 shows the approach plate used by the pilot during the flight. For commencing a straight-in approach from the east, which was the clearance received by the pilot, the descent point is to be determined by DME. For aircraft without DME, there is a published procedural join to the ILS where timings can be used to join the ILS. There is a note which states that the glidepath signal is not to be used beyond 8 nm from the runway threshold<sup>5</sup> (highlighted in Figure 5).

ILS approach chart used by the pilot of G-BOTI

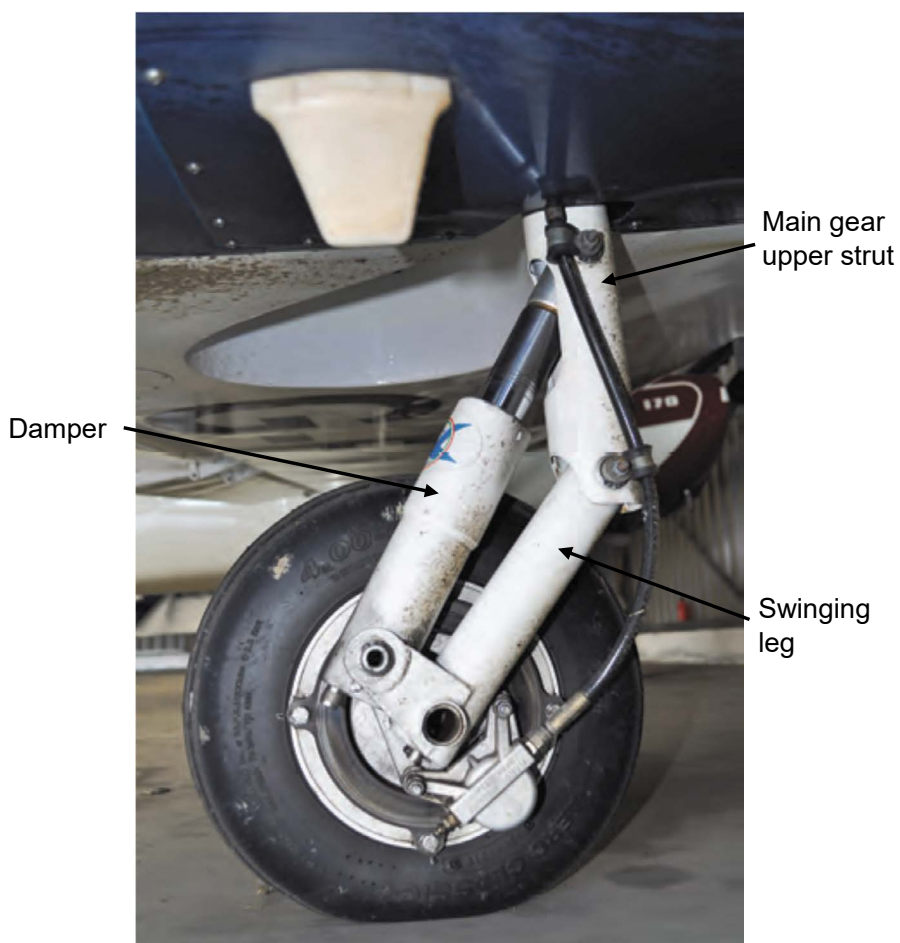
**Figure 2**  
Alpi Pioneer left main landing gear

The main landing gear leg consists of an upper strut which pivots around an axial trunnion when the landing gear is raised or lowered. The 'swinging leg', also referred to as the drag strut, is hinged off the bottom of the upper strut. A damper, which provides the landing gear suspension, is fitted above the swinging leg (Figure 2).

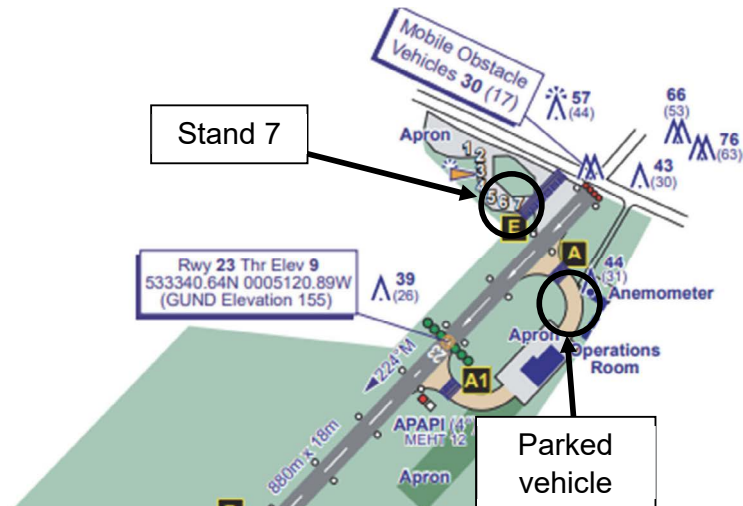
**Figure 1**

Having judged the gap to be sufficient for the aircraft wingspan, the pilot proceeded at a slow walking pace but clipped the port wingtip of G-EKIR on the side and wing mirror of the vehicle. The port wing navigation light and casing were damaged and there was paintwork scuffing to the wing tip area. The vehicle had damage to the right panel and below the right wing mirror. There were no injuries.

Map of parking area and site of collision at Sandtoft Airfield
