## ACCIDENT

<b>Aircraft Type and Registration:</b>	Schleicher ASW 20 L, G-CFRW	
<b>Year of Manufacture:</b>	1978 (Serial no: 20202)	
<b>Date &amp; Time (UTC):</b>	24 September 2022 at 0856 hrs	
<b>Location:</b>	Near Pulborough, West Sussex	
<b>Type of Flight:</b>	Private	
<b>Persons on Board:</b>	Crew - 1	Passengers - None
<b>Injuries:</b>	Crew - 1 (Fatal)	Passengers - N/A
<b>Nature of Damage:</b>	Aircraft destroyed	
<b>Commander's Licence:</b>	UK Part-FCL Sailplanes/Powered Sailplanes Flight Crew Licence	
<b>Commander's Age:</b>	21 years	
<b>Commander's Flying Experience:</b>	454 hours (of which 201 were on type) Last 90 days - 71 hours Last 28 days - 14 hours	
<b>Information Source:</b>	AAIB Field Investigation

## Synopsis

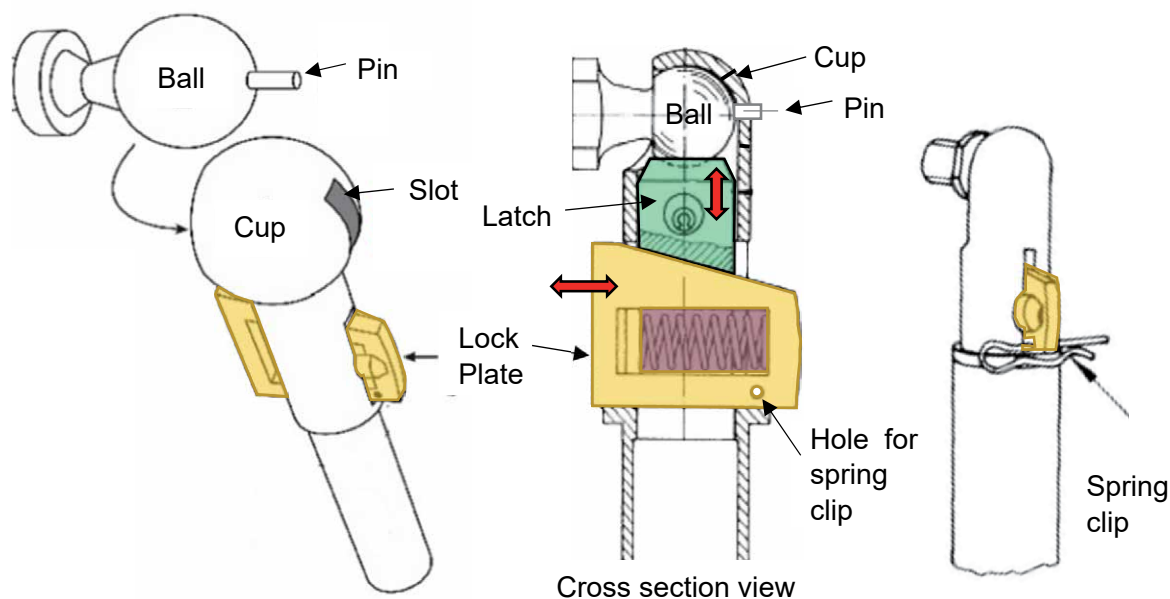
**Figure 7**

The elevator has a ball fitting attached to its lower surface which is inserted into the L'Hotellier cup connector to connect the control pushrod to the control surface (Figure 7).

Pressing the spring-loaded lock plate in allows the latch in the cup to move into the barrel of the connector to make room for the ball to fit into the cup. Once the ball is inserted and the lock plate released, the latch clamps onto the ball holding it in place. To ensure the

latch remains seated against the ball, an 'R' shaped spring clip is inserted into the lock plate to prevent it from dislodging and allowing the latch on the cup to release the ball. The pin on the ball protrudes through the slot in the L'Hotellier cup when properly connected. There are six other manually connected L'Hotellier connections on the ASW 20 for the ailerons, flaps and airbrakes. These L'Hotellier connections are secured with a safety device known as a Wedekind sleeve, and do not use a spring clip, thus the elevator connection was the only control connection on G-CFRW which required the use of a spring clip. The presence of a spring clip is checked as part of the annual maintenance check.

Diagrams showing details of the L'Hotellier cup and ball connection

No spring clip was found in G-CFRW's elevator L'Hotellier lock plate, although there were vertical scratch marks present on the inside of the fin, aft of the vertical tunnel, which may have been evidence of contact with the legs of the spring clip from previous fittings. Spare spring clips were found in a tool roll in the glider's trailer, along with the tool for fitting the Allan bolt<sup>2</sup> to the horizontal stabilizer. A packet of spare spring clips was also found in the pilot's car.

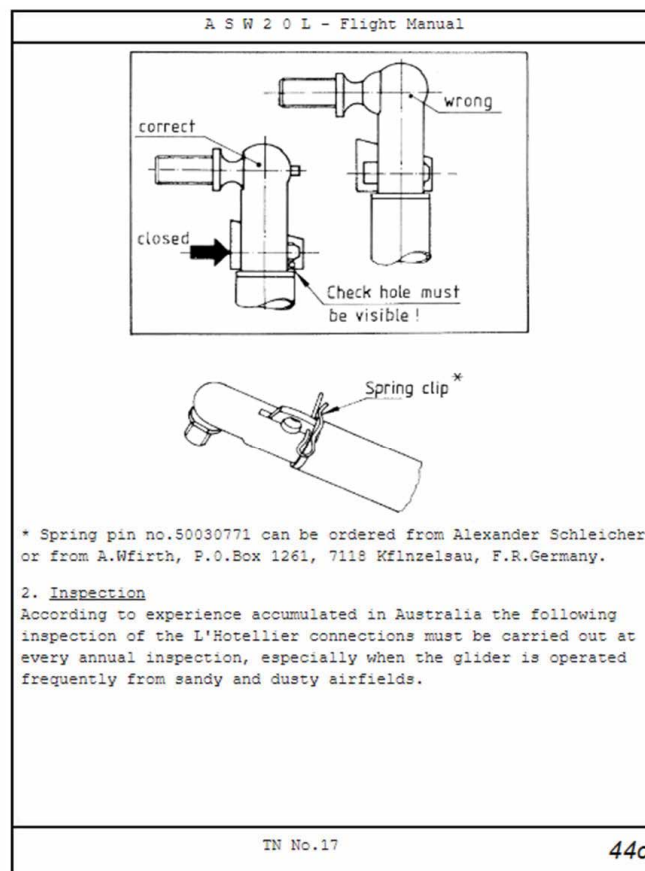
**Figure 9**

No fin sticker was found on G-CFRW or two other exemplar ASW 20 gliders. The manufacturer was not able to provide any information about the fin sticker. Diagrams of the correct and incorrect connection of the L'Hotellier quick-release connectors and location of the spring clip are shown in Figure 9.

Page 44c of G-CFRW's FOM

The ASW 20 L FOM states that the controls should be 'safe tied' by inserting spring clips through holes in the L'Hotellier connector lock plates. The spring clips can only be inserted when the mechanism of the L'Hotellier connector is correctly assembled and attached to their respective flying controls. No spring clip was found in the elevator's L'Hotellier lock plate, although the possibility of it being lost in the accident sequence could not be discounted. The vertical scratch marks present on the inside of the fin may have been evidence of contact with the legs of spring clips previously fitted to the elevator's L'Hotellier lock plate.

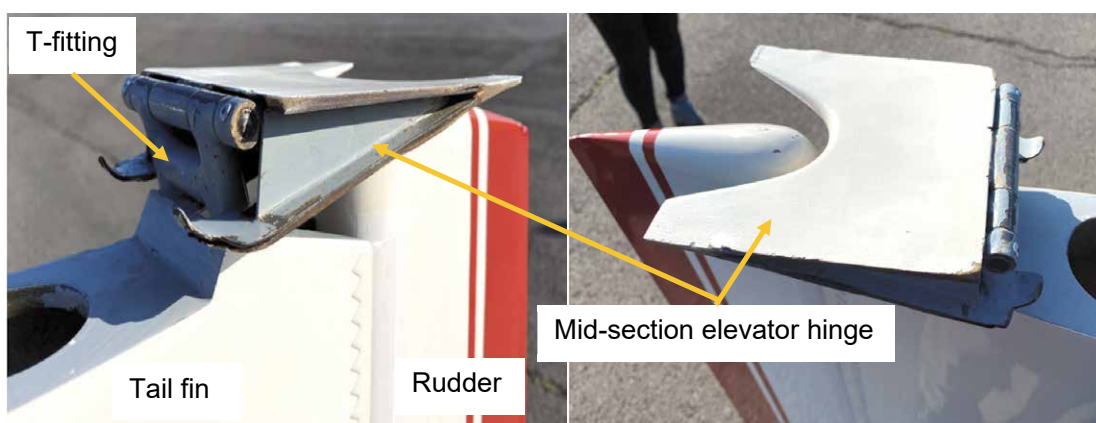
**Figure 10**

The modification replaces a section of the elevator actuating hinge with a 'T-fitting' which is glued onto the tail fin upper surface forward of the elevator pushrod box section. At the top of the T-fitting is a 'bearing mounting' with a mid-section of elevator actuating hinge attached (Figure 10).

Automatic elevator connection showing T-fitting (Left) and mid-section elevator hinge (Right)

On 6 November 1986, the aircraft manufacturer released optional modification ASW 20/20 L Technical Note No 29 which introduced an automatic elevator connection to the ASW 20/20 L aircraft series. The modification also became a factory standard installation on ASW 20 B and C models and subsequent variants.

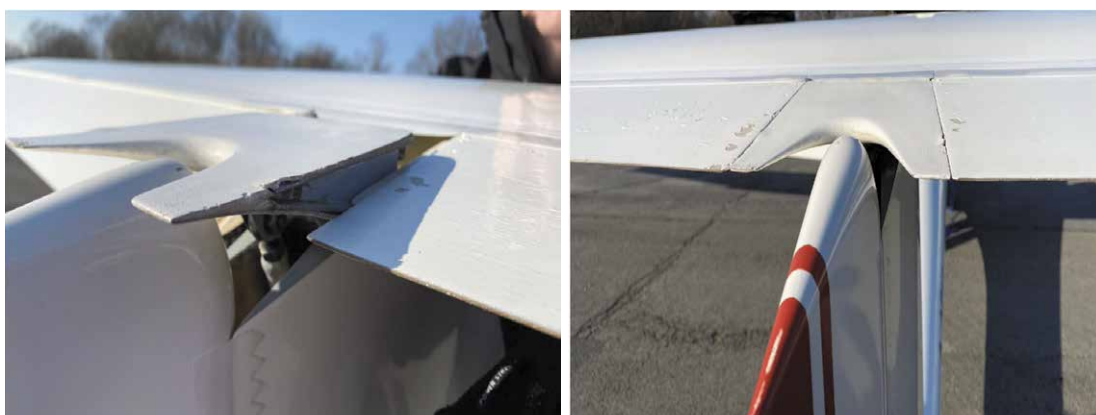
**Figure 11**

This mid-section of elevator hinge is slid into place between elevator hinge ribs as the horizontal stabilizer is mounted onto the tail fin (Figure 11).

Horizontal stabilizer sliding aft onto mid-section elevator hinge (Left) and elevator hinge section in place (Right)

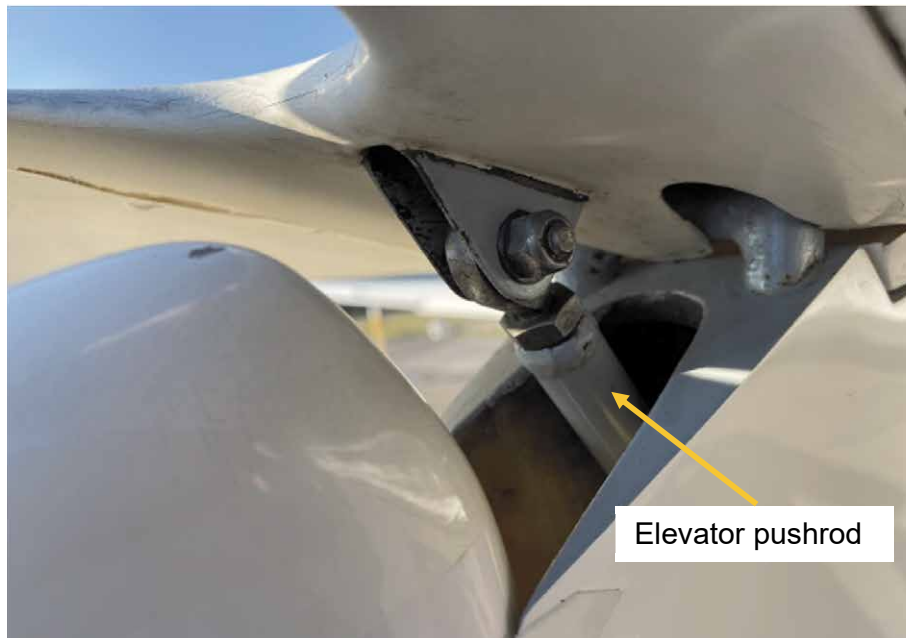
**Figure 12**

To actuate the elevator hinge, an 'elevator pushrod' replaces the L'Hotellier cup connection and is fixed to the elevator control surface by a bracket (Figure 12). The modification may be considered expensive and potentially cost prohibitive by owners when compared to the cost of purchasing the glider. Whilst this optional modification was available, it had not been adopted on the accident aircraft.

Elevator pushrod connection to the elevator control surface
