Rail Accident Investigation Branch

Rail Accident Report

Runaway hand trolley at Ramsbottom, East Lancashire Railway 15 March 2018

Report 18/2018
November 2018

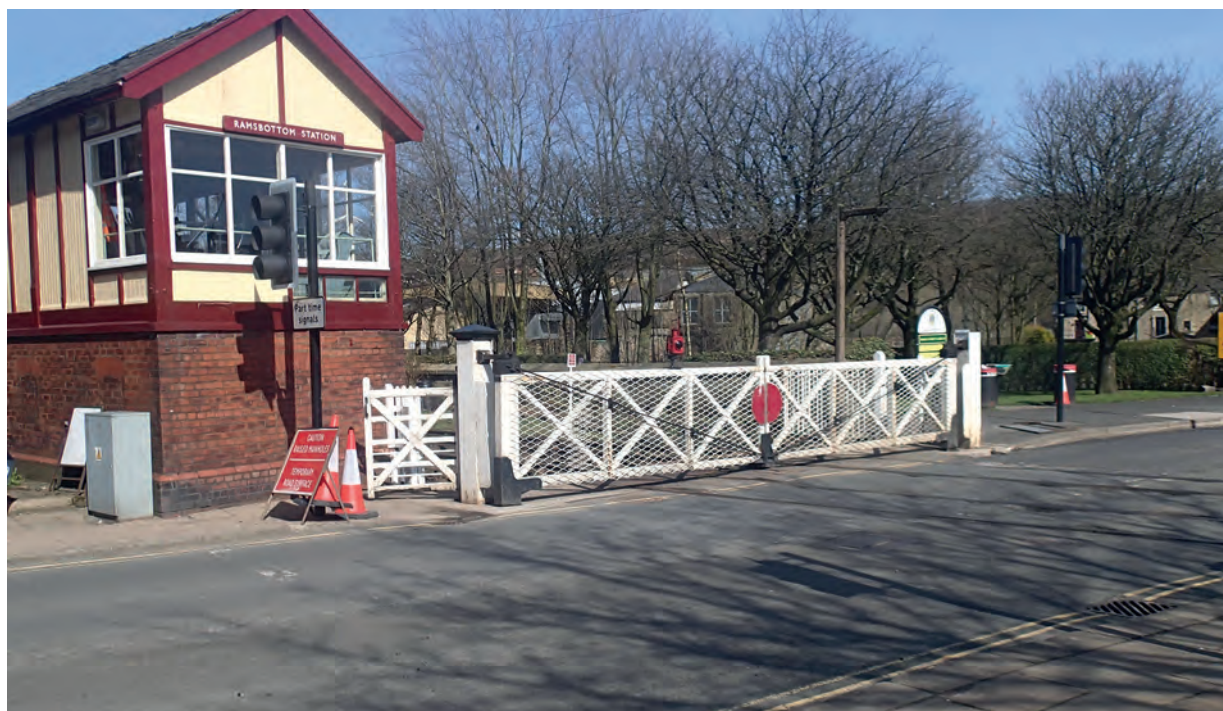
Figure 5: Ramsbottom signal box and level crossing

- 25 The trolley struck the eastern gate on the north side of the crossing. It derailed and some ballast spilled onto the road. The impact damaged the woodwork and the gate mechanism causing the gate to be partially displaced across the road. A passing motorist was forced to alter course to avoid the gate. He stopped briefly and spoke with one of the volunteers.
