Rail Accident Report

Collision at London Waterloo 15 August 2017

Report 19/2018
November 2018

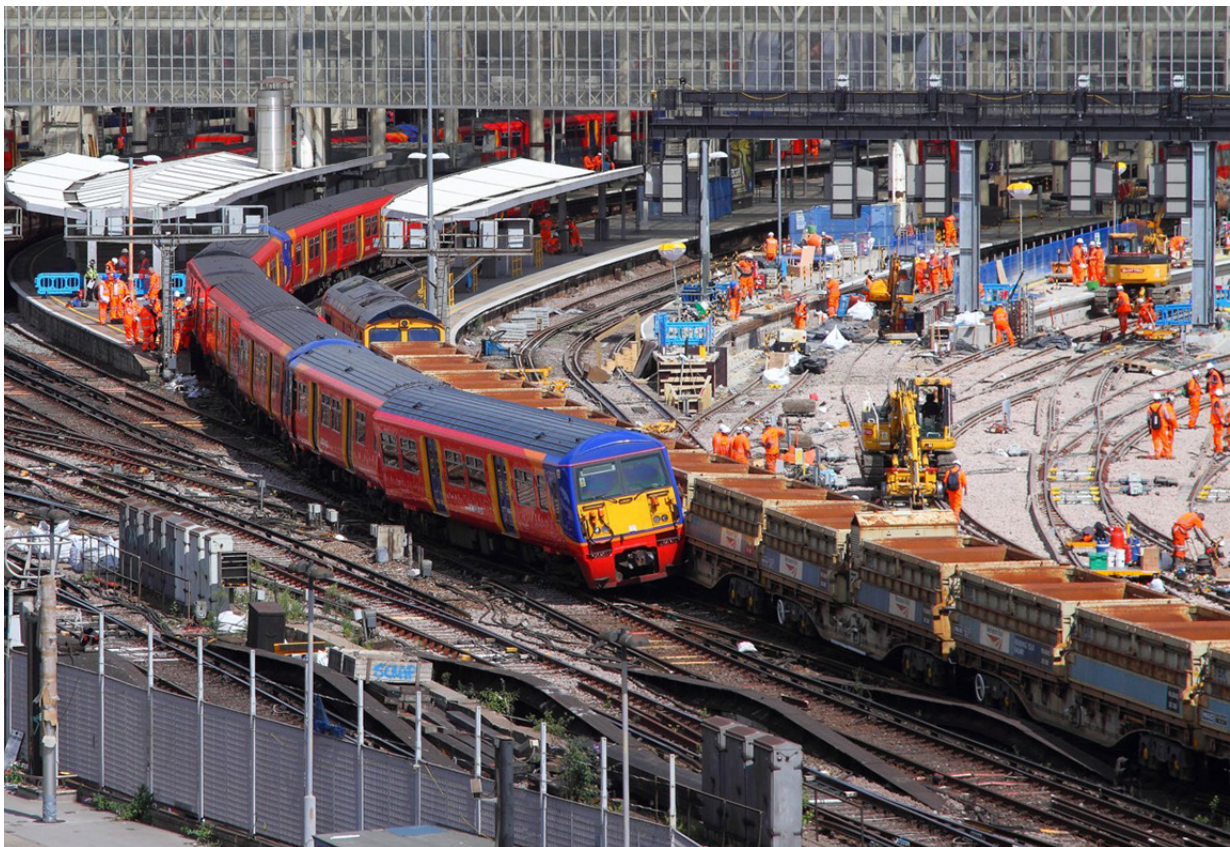
Figure 3: Overview of station and accident (photograph courtesy of Jamie Squibbs)

8 At the time of the accident, platforms 1 to 10 were closed to allow construction of capacity improvement works (figure 3). These included extensions to platforms 1 to 4 and associated changes to trackwork and signalling. Construction work was being undertaken in stages and required testing of signalling and points in the area of the accident near the end of platform 11.

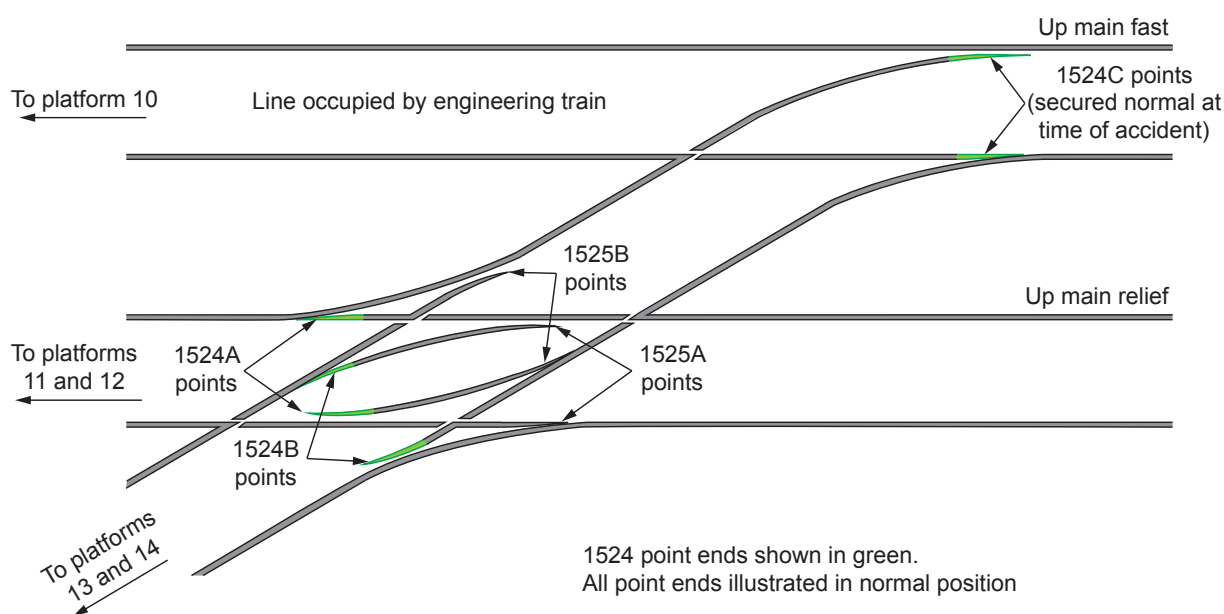
Figure 5: Schematic layout of 1524 points, the accident location

- 22 The three pairs of ends of 1524 points were intended to swing together so that all were in the normal position, or all were in the reverse position. When correctly in the normal or reverse position, the point ends should have been mechanically locked and confirmed to be (ie detected) in this position before a train was permitted to pass over them.

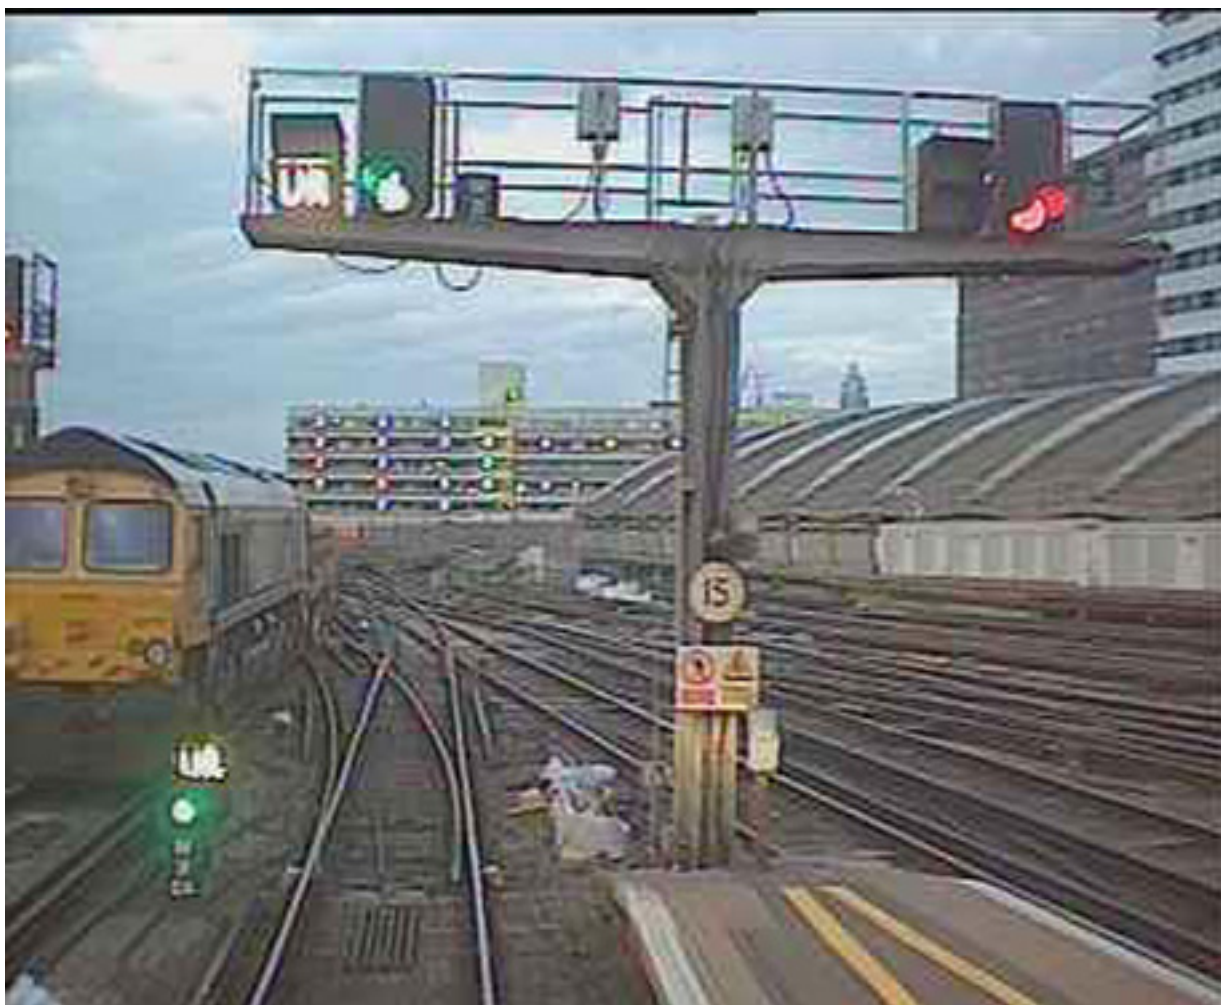
Figure 7: Forward facing CCTV from train 2D03 showing the green signal and 'UR' (up main relief) route indication displayed at high and low levels as it departed from platform 11 (courtesy South Western Railway)

- 84 Images from the passenger train's forward facing CCTV show a green signal with a 'UR' indication displayed adjacent to this (figure 7). This gave the driver authority to proceed out of platform 11 and along the up main relief line, the line running alongside the engineering train. The correct indications for this authority were shown on the signallers' display at Wimbledon area signalling centre (figure 6).
- 85 Less than a minute after the signal turned green, the train was approaching 1524 points and images from the train's CCTV showed the points in an intermediate position between the reverse position and the intended normal position (figure 8).

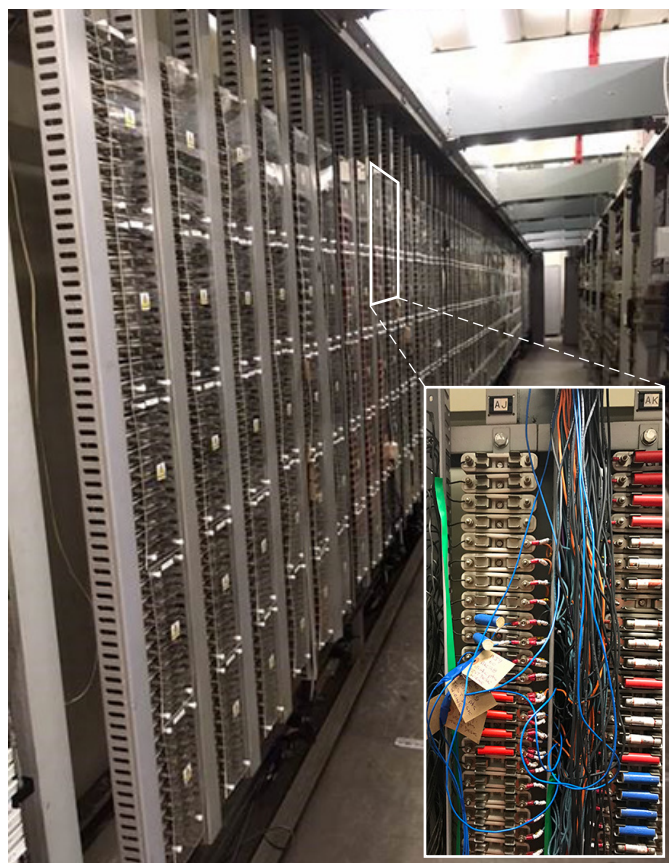
- 57 The detectors on 1524 points are connected by electrical cables to a lineside cabinet (location case W14), and then into the Waterloo relay room (figure 10). Although 1524 points were not physically affected by the upgrade work, the arrangement of the point detection wiring between 1524 points and the relay room was modified when location case W14 was replaced in June 2017 (paragraph 59).

Figure 10: Waterloo relay room with inset including connections from 1524 points and associated fuse holders as detailed in figure 19

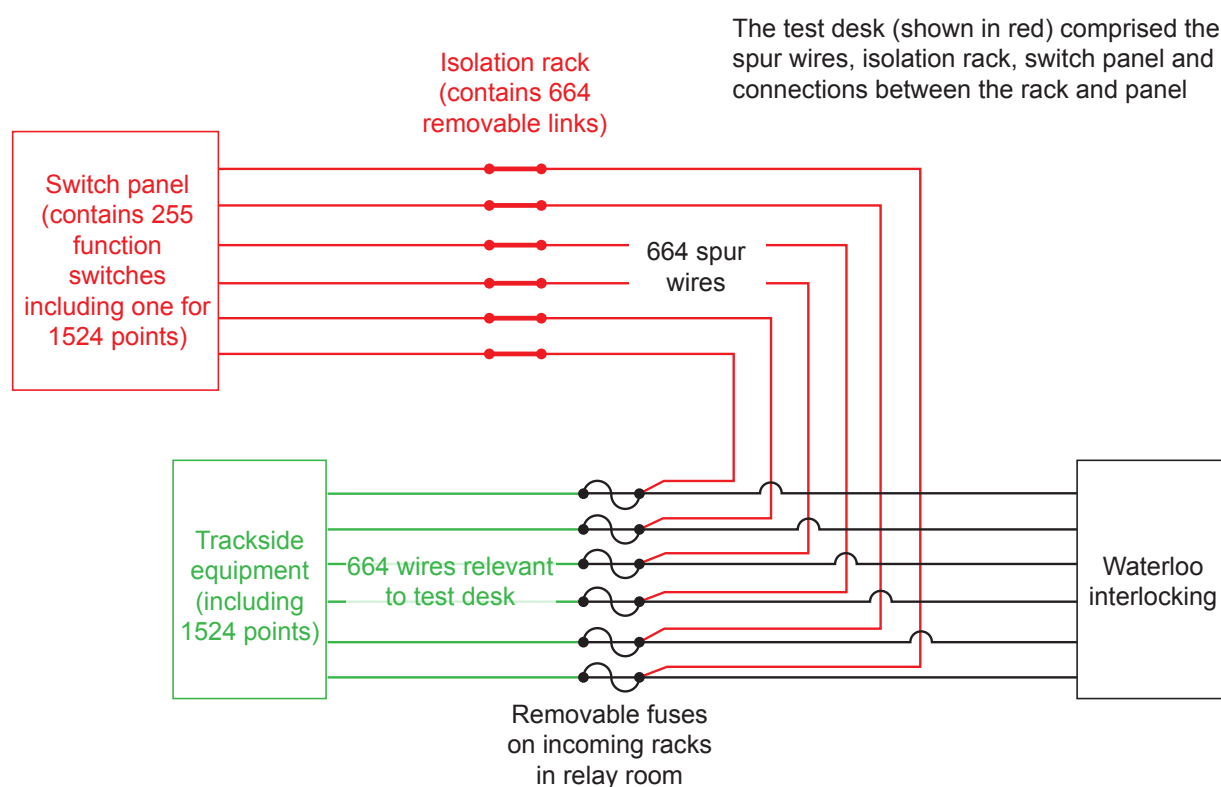
Figure 11: Block diagram of the test desk and connections

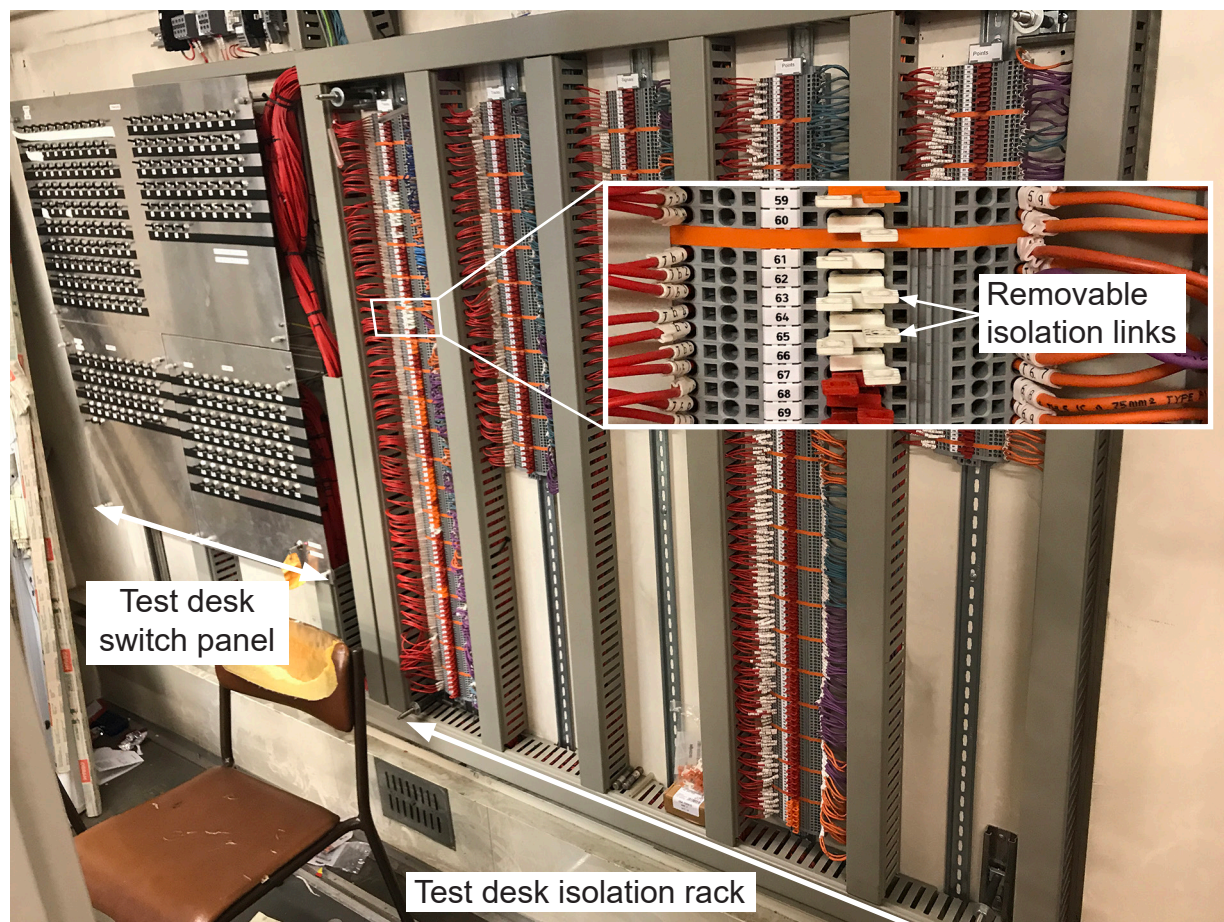
Figure 12: Test desk switch panel and isolation rack in Waterloo relay room. White links are conductive, red and orange links are dummy (isolating) links which are fitted to prevent unintentional fitting of conductive links.

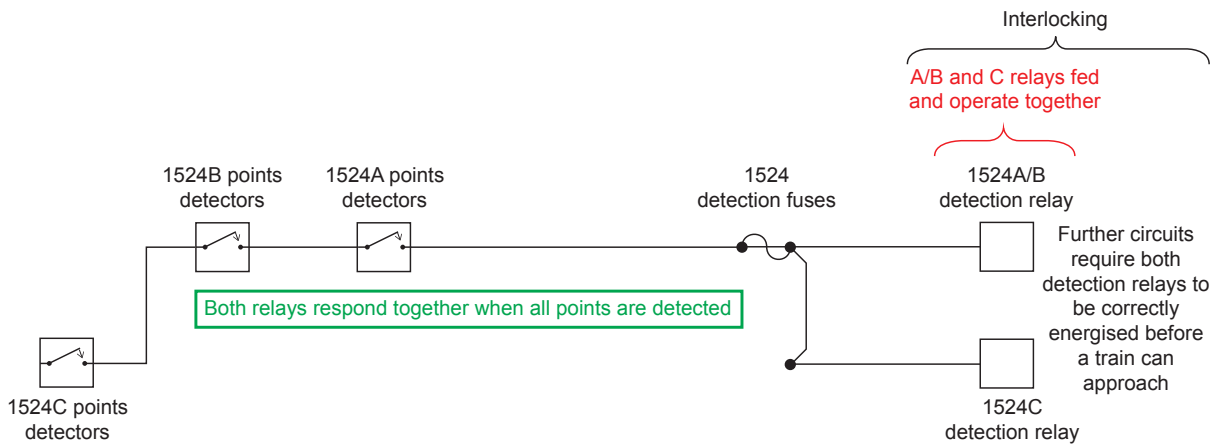
- 91 Before the works began, the point detectors for each of the three ends were wired in series, meaning that all three ends had to be in the same position before any current was returned to the normal or reverse detection relays (figure 13). This current was then used to energise the appropriate relays designated 1524A/B and 1524C. Although designated A/B and C, these relays were fed by detection circuits passing through all three point ends. Further circuitry in the interlocking required the detection relays to be energised before signals could display a proceed aspect to permit trains to approach 1524 points.

Figure 13: 1524 points detection before work began

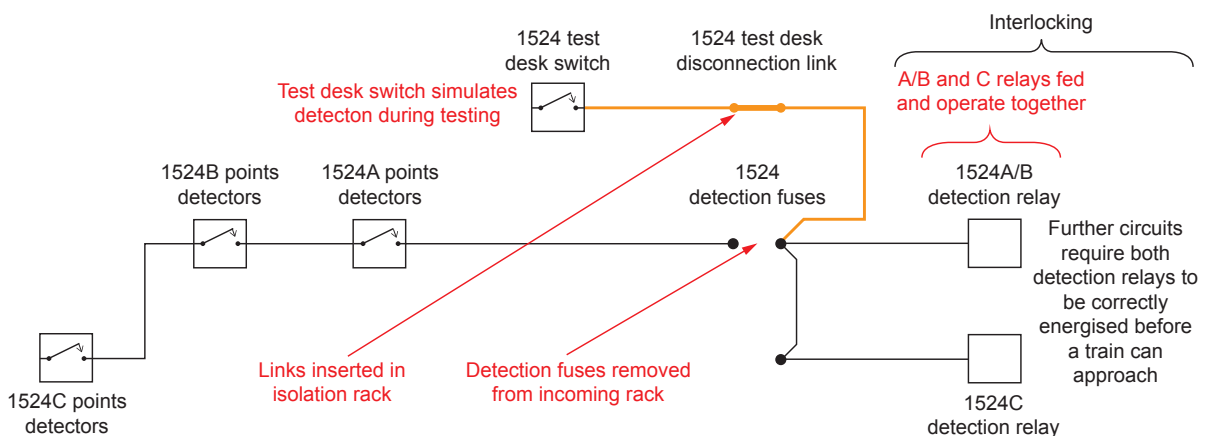
- 92 When the test desk was installed in August 2016, spur wires were attached to the detection fuse terminals which fed both 1524A/B and 1524C detection relays. When used to simulate the operation of 1524 points, the test desk correctly energised these relays (figure 14).

Figure 14: 1524 points in test mode, before location case W14 was replaced

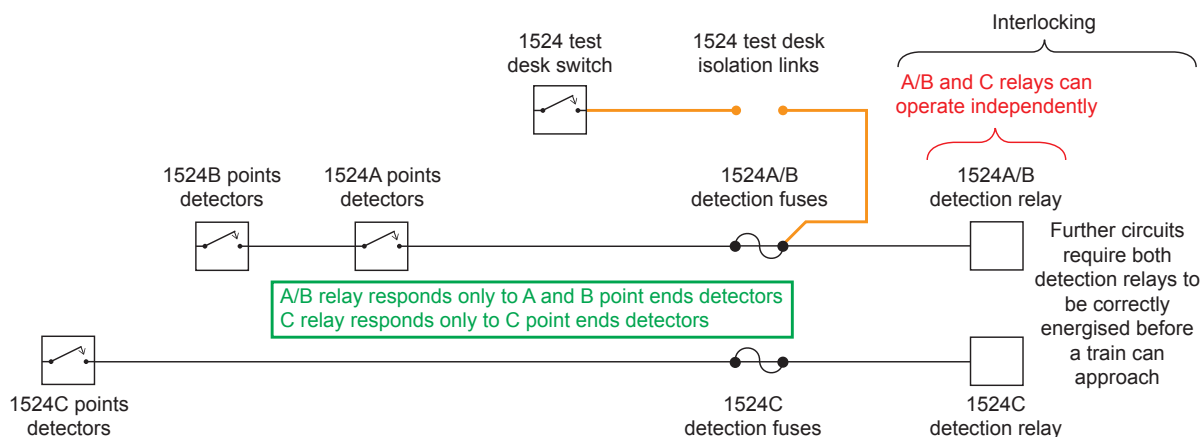
- 93 The detection wiring from 1524 points passed through location case W14. When this was replaced in June 2017 (paragraph 71), the wiring was altered so that A and B detection circuits energised only 1524A/B detection relays and the C end detection circuits energised only 1524C detection relays (figure 15). As before, further circuitry required both detection relays to be energised before trains were permitted to approach 1524 points.

Figure 15: 1524 points detection after location case W14 was replaced (no uncontrolled wiring)

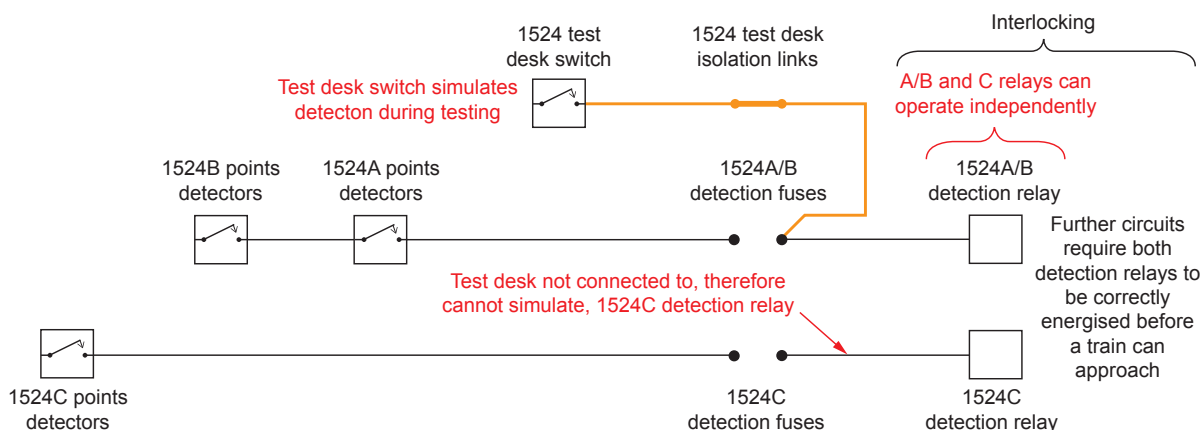
- 94 These modifications to the wiring of 1524 points detection (paragraph 71) did not affect the safety functions provided by the interlocking but did mean that the test desk no longer simulated the detection of 1524 points correctly because 1524C point ends were no longer connected to it (figure 16). This would not be apparent until testers required the test desk to simulate the position of the points.

Figure 16: 1524 points in test mode after replacement of location case W14 (no uncontrolled wiring)
