Rail Accident Investigation Branch

Rail Accident Report

**Self-detrainment of passengers onto lines that were still open to traffic and electrically live at Lewisham, south-east London
2 March 2018**

Report 02/2019
March 2019

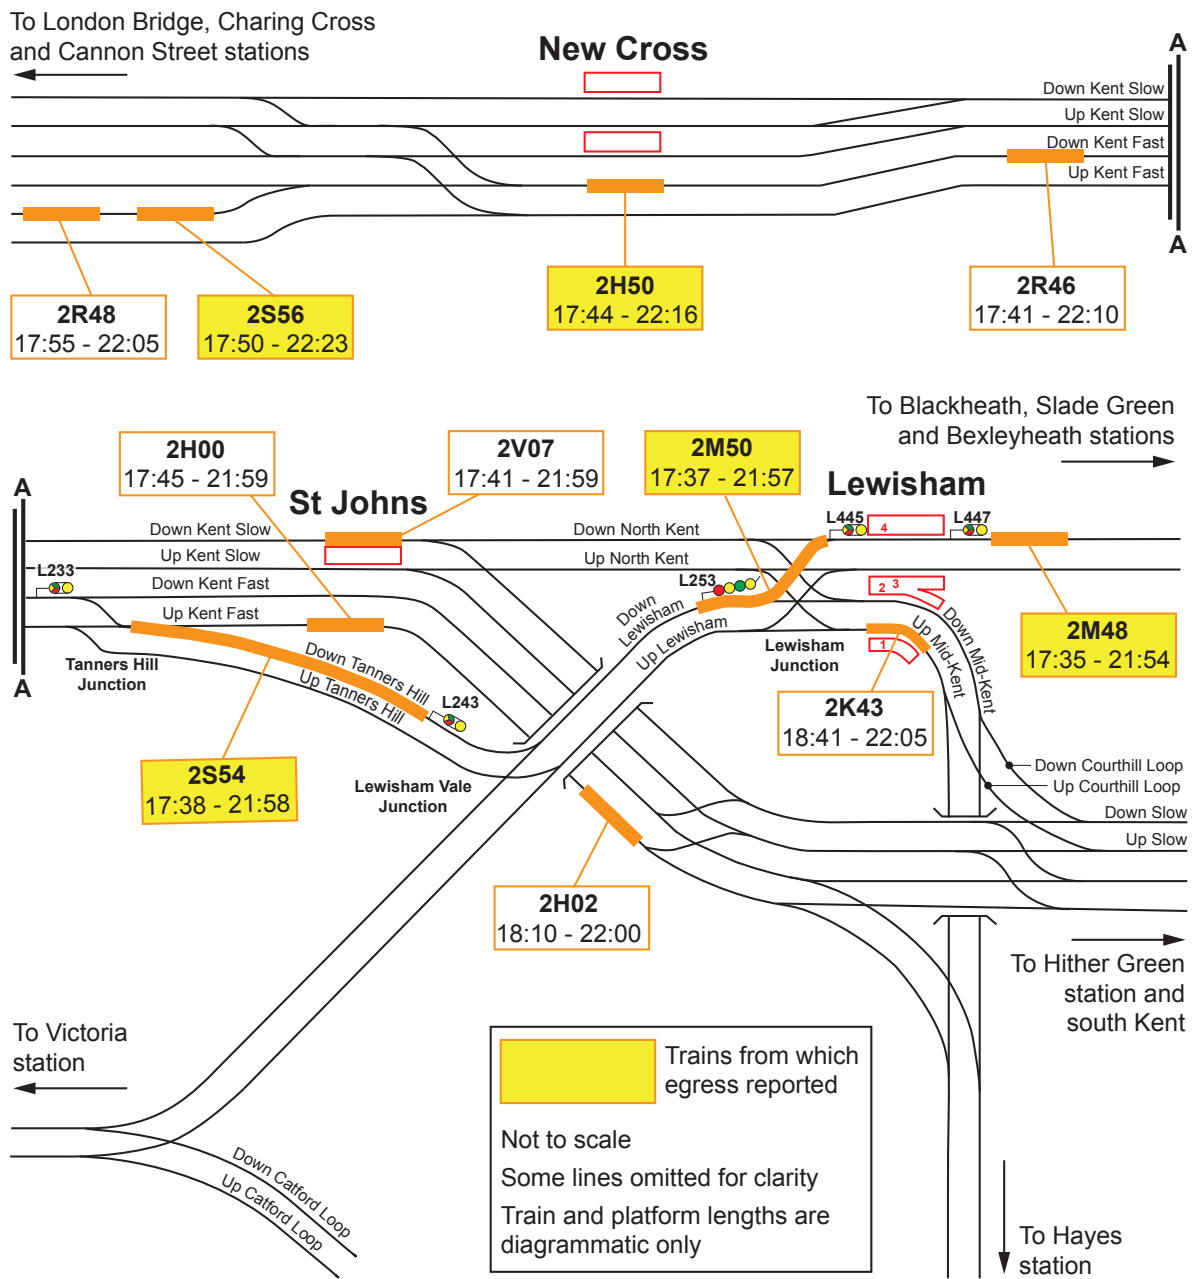
- 9 Lewisham station is located around seven kilometres (four and a half miles) south-east of central London, within a complex arrangement of railway junctions. Four lines pass through the station. Figure 2 shows the layout of the track in the area.

Figure 2: Track layout of Lewisham station and the lines approaching from London. The figure shows the key signals, the position of the stranded trains and the time over which they were at a stand, and where passenger egress was reported.

166 A total of ten trains became stranded as a direct result of the problems encountered by train 2M48 at Lewisham (paragraph 4). The majority were unable to move for around four and a half hours, and records indicate that passengers got out and went on to the track from at least five of them (figure 2). Although conductor rails were only electrically live when the first passengers on trains 2M50 and 2S54 got out, the detraining of a large number of passengers onto the track is, in general, potentially unsafe, particularly in wintry conditions. Passengers climbed down from open train doors in the dark, many unaided and some carrying their possessions, onto terrain that was covered with snow which hid inherent slip, trip and fall hazards. Therefore, it is fortunate that there were no instances of serious injury.

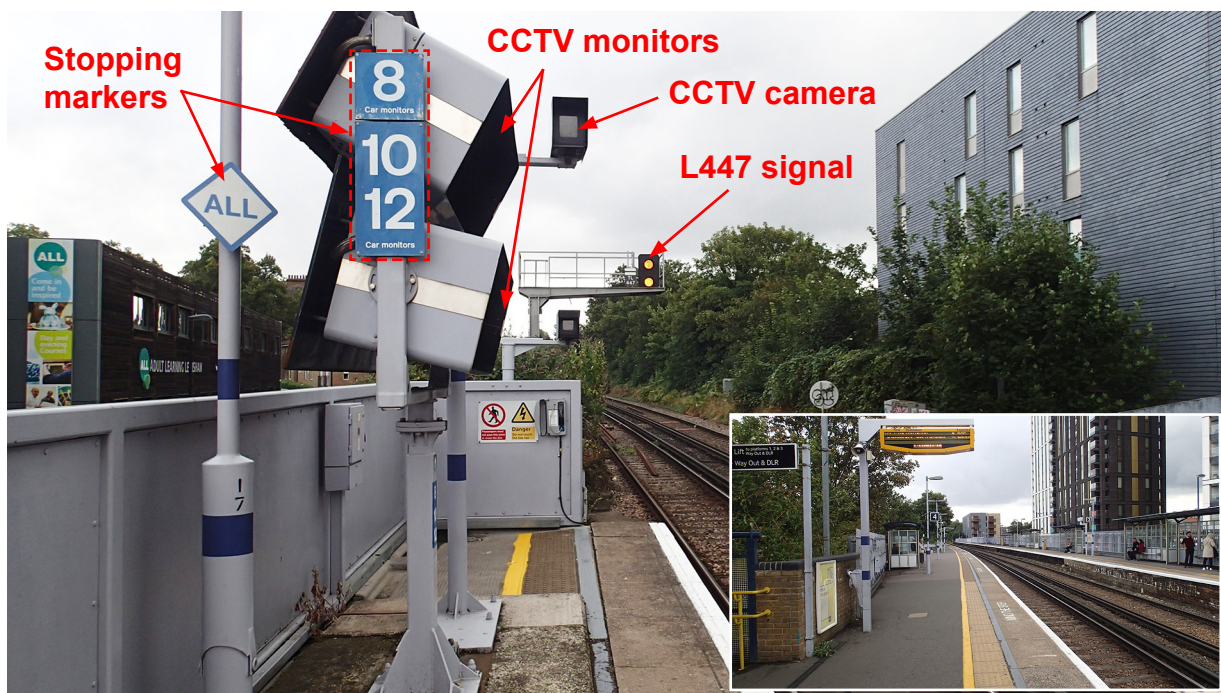
10 Platform 4 is on a left-hand curve and is fitted with closed-circuit television (CCTV) cameras and monitors for driver-only operation trains (figure 3). This means that, independent of their train's length, all the drivers have to stop in the same position so that they can check the platform CCTV monitors and confirm the safety of the passenger doors before departing. The CCTV monitors are located adjacent to the stopping markers at the end of the platform furthest from Lewisham Junction.

Figure 3: Platform 4 at Lewisham viewed in direction of travel of trains 2M48 and 2M50, showing the stopping markers, CCTV equipment and the general platform curvature
