Rail Accident Investigation Branch

Rail Accident Report

**Fatal collision between a tram and a pedestrian,
near Saughton tram stop, Edinburgh
11 September 2018**

Report 09/2019
July 2019

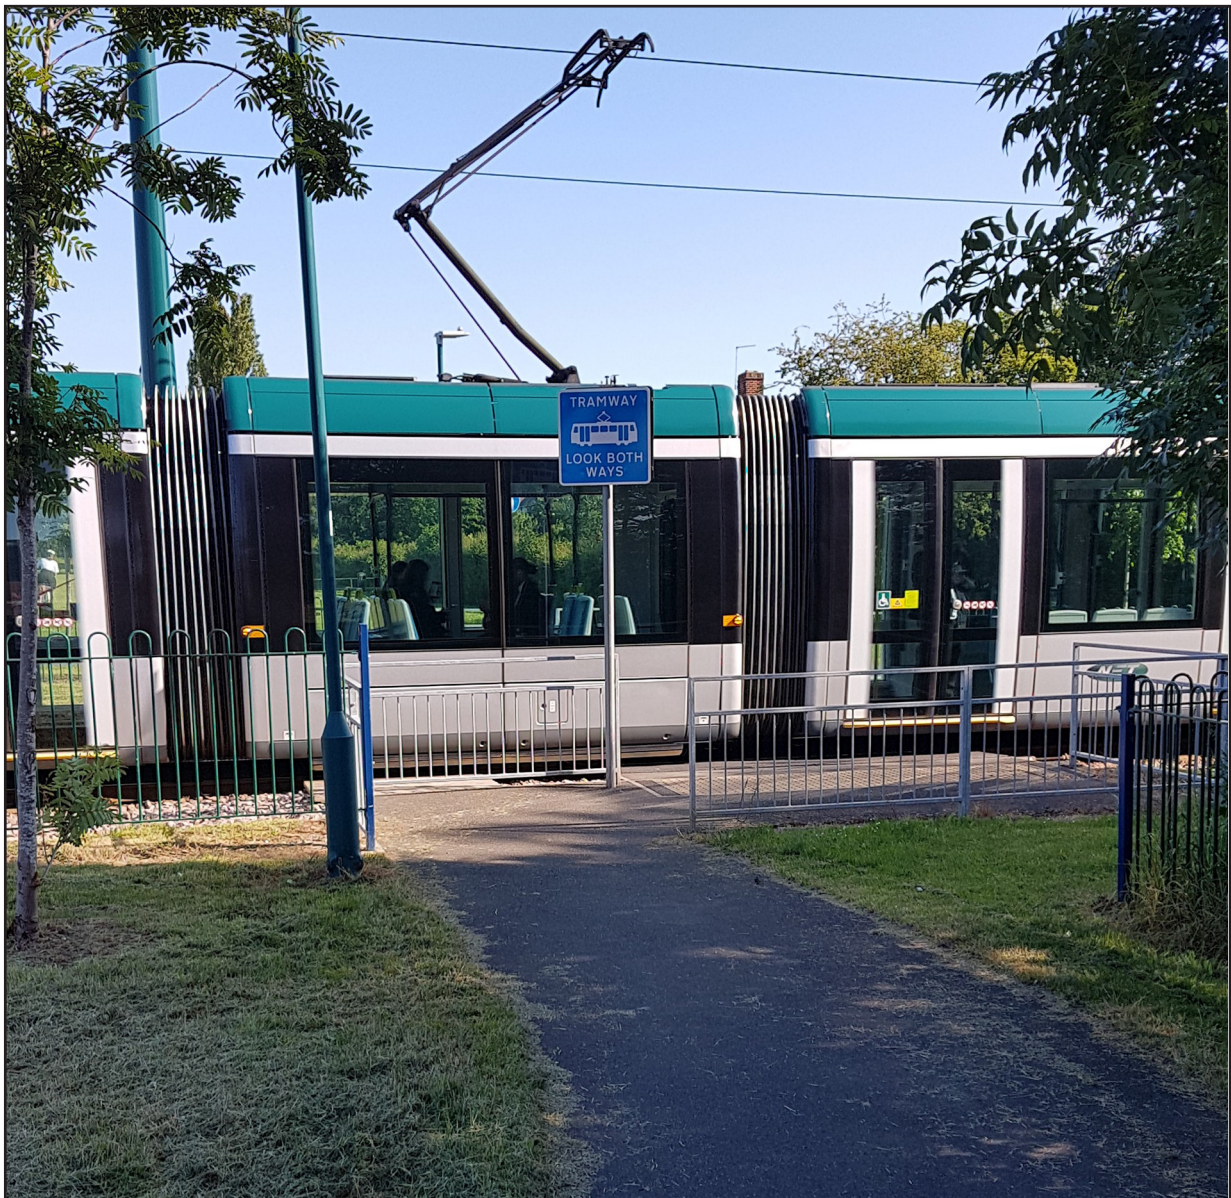
- 78 The RSP2 guidance stated that fencing or pedestrian guard rails should be provided where necessary, to guide pedestrians to face oncoming trams before they cross the track, although specific situations are not described. Chicane fencing has been used at some locations on other tramways to make pedestrians visually aware that they are entering an area of increased danger, make them alter their walking pattern and turn them to face approaching trams on the nearest track (figure 12).

Figure 12: An example of chicane fencing on a footpath crossing on the Nottingham tram system. The tram in the picture is travelling on the closer of the two tracks from right to left.
