Rail Accident Report

**Serious operational irregularity at Bagillt user worked crossing, Flintshire, involving an abnormally heavy road vehicle
17 August 2018**

Report 11/2019
August 2019

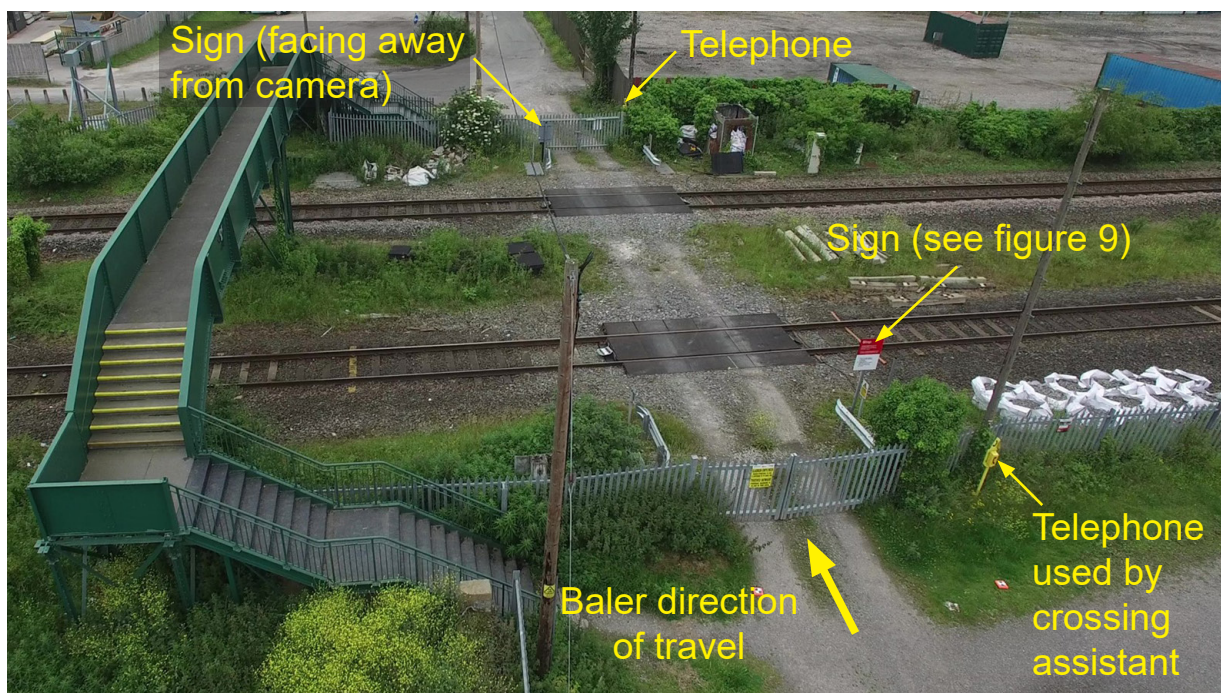
Figure 5: Telephones and signs at Bagillt UWC-T

- 16 Bagillt UWC-T has a pair of gates on each side of the railway situated 24.5 metres apart (figure 4). The crossing is equipped with a telephone outside each pair of gates which connect to the signaller's workstation supervising the crossing (figure 6, paragraph 19). Signs positioned inside the gates on both sides of the crossing tell users with vehicles or animals that they must telephone the signaller to obtain permission before opening the gates, crossing the railway and closing the gates. Vehicle users are required to obtain permission because sighting distances along the railway are not sufficient for users to see trains in time to determine if it is safe to cross.

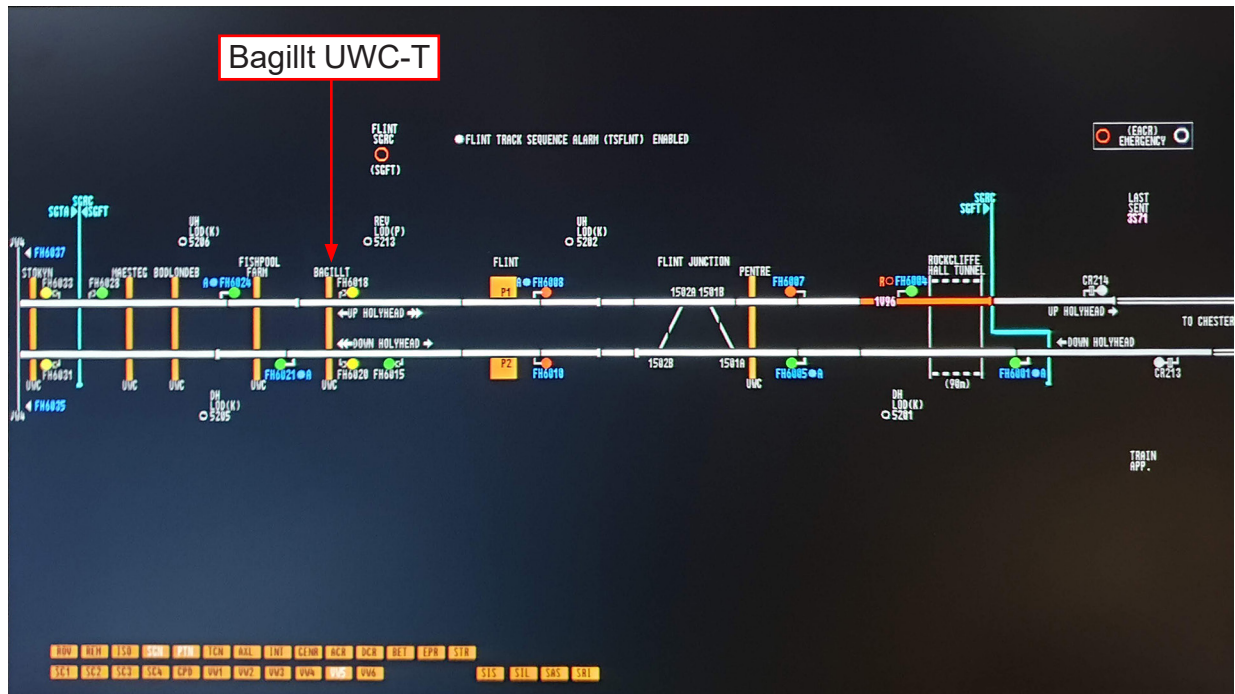
Figure 7: Rhyl workstation display screen showing Bagillt UWC-T (image does not exactly reproduce colours shown on screen)

- 19 Bagillt UWC-T is supervised by the signaller at the Rhyl workstation located in the WROC in Cardiff (figure 6). This workstation controls approximately 45 route-kilometres of the Chester to Holyhead railway including Flint station. The signaller controls train movements in both up and down directions by using a pointer to click on symbols in a track layout displayed on display screens. The track layout shows the individual sections of track which change from white to red when occupied by a train (figure 7). The track layout display is not to scale and does not include any indication of distances between features on the display.

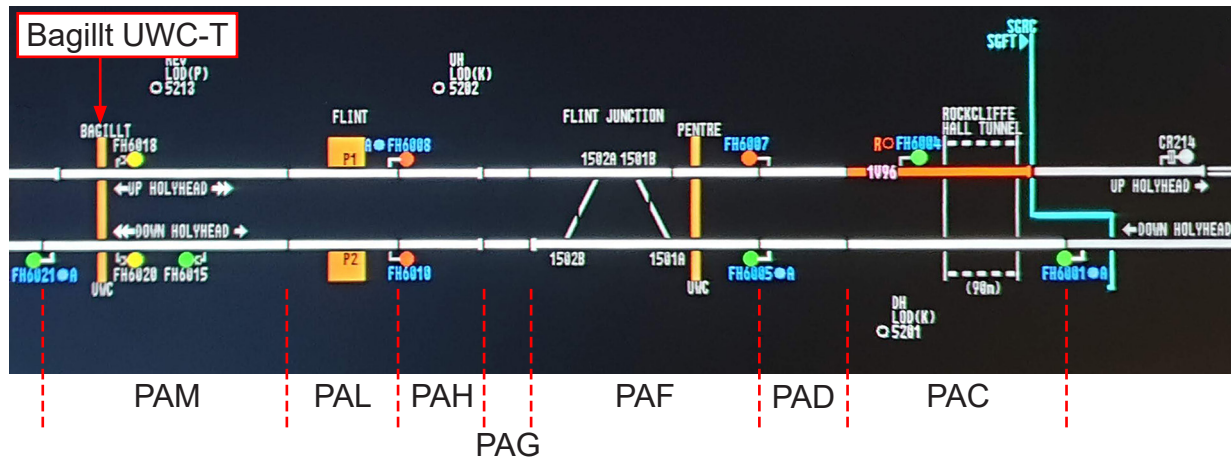
Figure 8: Rhyl workstation display annotated to show track section designations

- 43 On the basis of the most likely sequence of events (table 3), the evidence indicates that the signaller gave the user permission to cross between 2 minutes 30 seconds and 2 minutes 17 seconds before the front of the train arrived at the crossing. Signalling data shows that the first of these times corresponds to the rear of the train being in section PAC and the front in section PAD. The second time corresponds with the entire train being in section PAD.

- 124 During the incident at Bagillt, the crossing user requested two minutes to cross the railway. The signaller stated that his decision point for a down train in these circumstances would be just after the train had entered section PAD (figure 8). This is when a train is approaching signal FH6005 and before it reaches Flint station and then Bagillt UWC-T, which is 3.2 km (2 miles) beyond the station.
