Rail Accident Investigation Branch

# Rail Accident Report

**Signal passed at danger at Loughborough  
South Junction, Leicestershire  
26 March 2020**

Report 10/2020  
November 2020

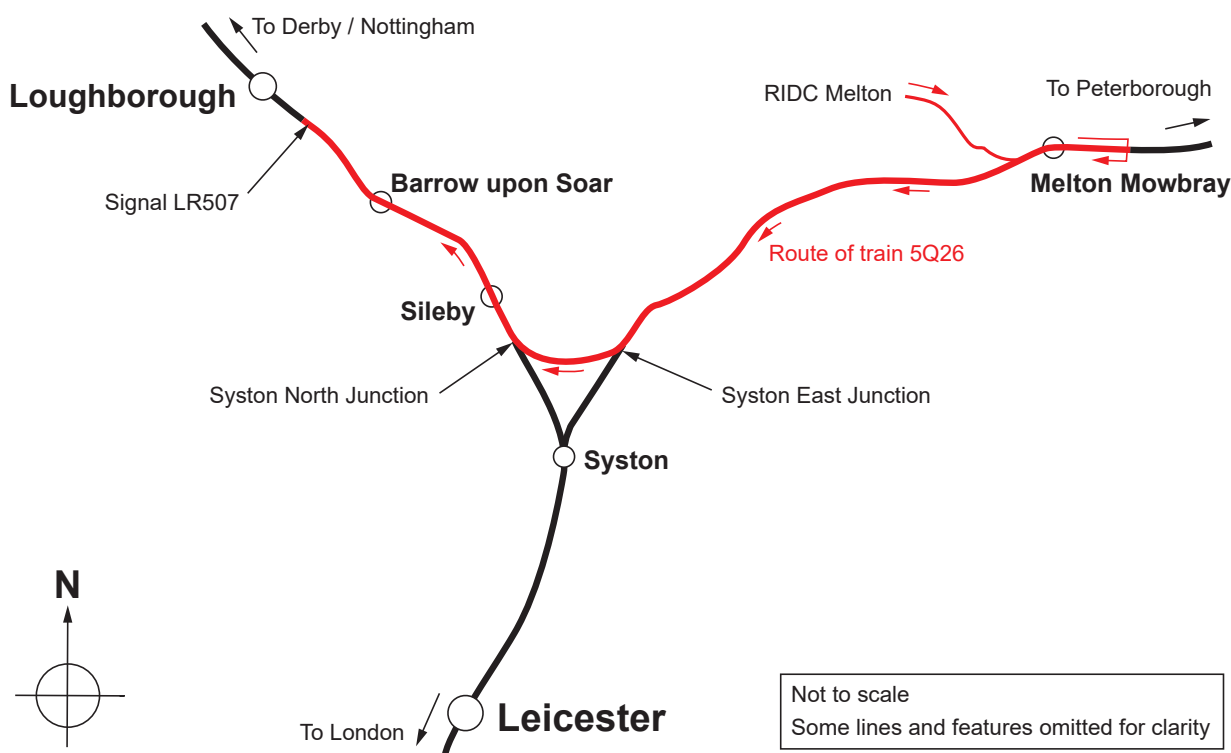
Figure 4: The route of the train

- 26 Train 5Q26 departed RIDC Melton at 09:23 hrs, 34 minutes before its scheduled departure time, and moved to a goods loop outside Melton Mowbray station, where it reversed direction. The train was held in the loop for 45 minutes to allow other services to pass through, and departed from Melton Mowbray at 10:38 hrs, two minutes before its scheduled departure time. It travelled under clear signals towards Syston East Junction where it braked for the 10 mph (16 km/h) speed restriction there. At Syston, the train joined the Midland main line around 7 miles (11 km) south of Loughborough and accelerated northwards (figure 4).

- 27 Witness evidence suggests that there was nothing remarkable about the journey from Melton Mowbray, and nothing to indicate any problem with the train's braking capability.
