Rail Accident Investigation Branch

# Rail Accident Report

## **Derailment of a freight train near Wanstead Park, London 23 January 2020**

Report 12/2020  
November 2020

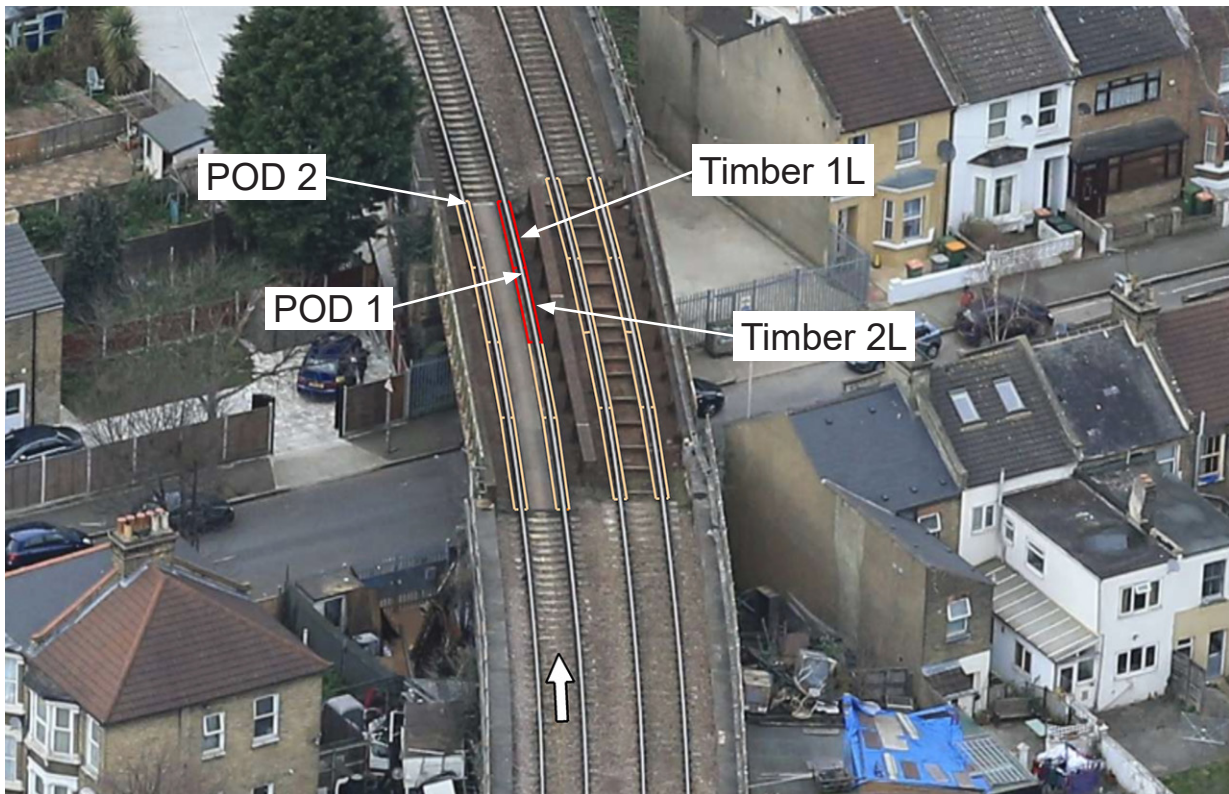
- 50 The up line across bridge 456 was supported by four longitudinal timbers under each rail, each about 6 metres long and laid end to end. The combined length of just over 24 metres was sufficient to cross the bridge and extend a few metres onto the embankment at each end, a feature known as a flying end. This was to provide a transition between the relatively stiff bridge deck and the more flexible ballasted embankment. In the direction of travel, the timbers were numbered R4 to R1 supporting the left-hand rail (cess rail) and 4L to 1L supporting the right-hand rail (six-foot rail). The initial derailment occurred close to the joint between timbers 2L and 1L at the location marked POD 1 on figure 12.

Figure 12: Bridge 456 showing the eight longitudinal timbers on each deck. The timbers associated with the derailment are numbered 2L and 1L.

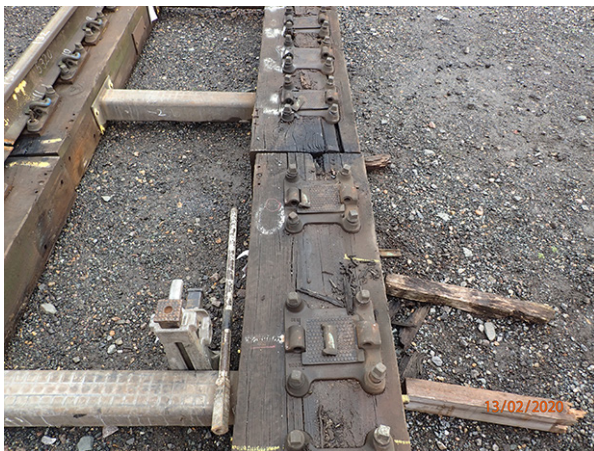
62 Following the accident, the up line longitudinal timbers were removed from bridge 456 in four panels, each panel comprising the left-hand and right-hand timber with the transoms and tie bars connecting them. They were taken to a secure site and laid out for examination by RAIB, an independent timber specialist commissioned by RAIB and Network Rail (figure 16 and figure 17). The panels were dismantled in controlled stages during the examination.

Figure 16: Longitudinal timbers laid out for examination following removal of the right-hand (six-foot) rail. Timber 2L is nearest the camera with 1L beyond it.

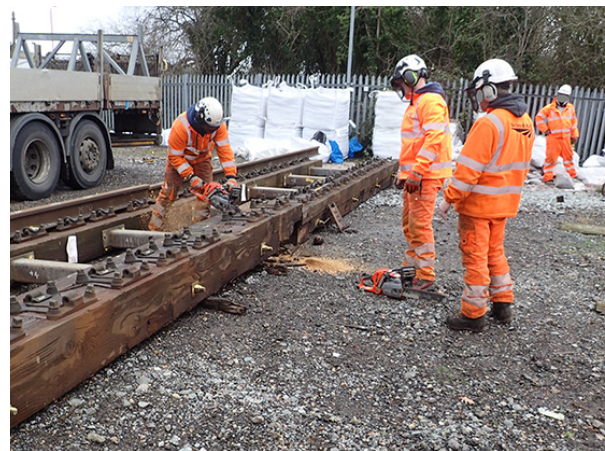
Figure 17: Timber 2L being cut into sections for examination

63 The section of timber 2L supporting the track at the point of derailment (figure 18 and figure 19) was cut into sections and examined. It was found to be saturated with water and extremely soft. A long probe was pushed into the wood at several locations without meeting resistance and part of the timber disintegrated while being moved during the examination. There was evidence of baseplate screw holes having been plugged and re-drilled, indicating that a previous attempt had been made to restore the track gauge at this location. This method of re-gauging can only be regarded as a temporary measure in softwood as there is often insufficient sound material to withstand the forces imposed.

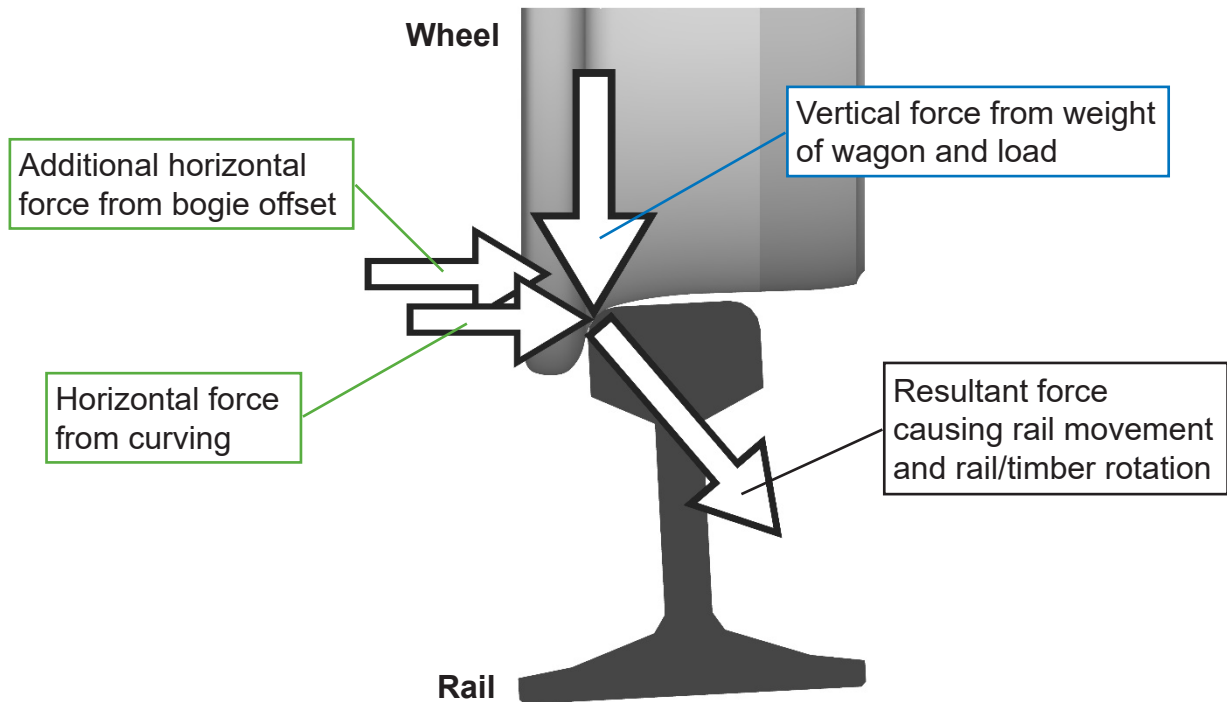
113 Evidence that wagon 3415's trailing bogie was imposing a high lateral force (figure 35) on the right-hand rail is provided in the following paragraphs by considering wheel flange wear over the previous three years. Curving behaviour under cant excess suggests that the right wheel flange of the trailing bogies of each wagon would have been close to, and probably in contact with, the outer (right-hand) rail (paragraph 46).

Figure 35: Simplified diagram showing forces acting from wheel to rail to cause rail movement and rotation

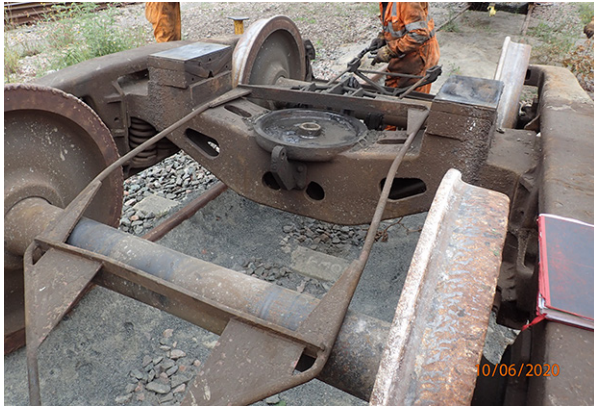
- 116 A detailed inspection of the 1-4 end bogie, undertaken by RAIB before the wagon body was lifted from the bogie, found that the bogie centre pivot, provided to allow bogie rotation when the wagon goes around curves, was offset by 7 mm to the right of the wagon body centre-line. This suggested an issue with the bogie pivot so RAIB and VTG carried out further examinations of this centre pivot, and the 2-3 end bogie centre pivot, after the body was lifted from the bogies.

Figure 36: The 1-4 end bogie and bogie centre pivot after removal from wagon 3415

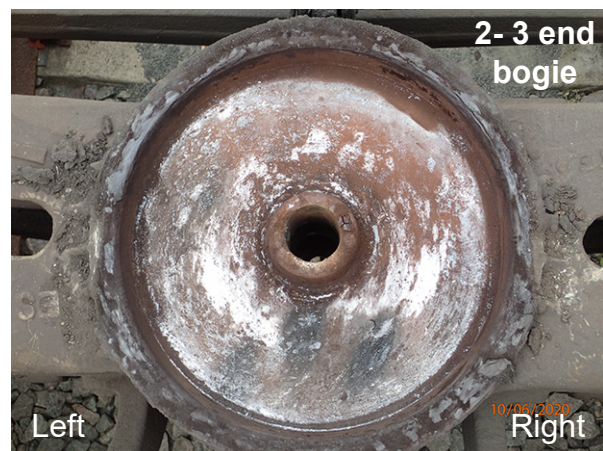
Figure 39: The 2-3 end bogie centre pivot

118 Examination of the bogie centre pivot attached to each bogie found a difference in the wear patterns, with uneven contact apparent on the 1-4 end, but relatively uniform contact on the 2-3 end (figure 38 and figure 39).

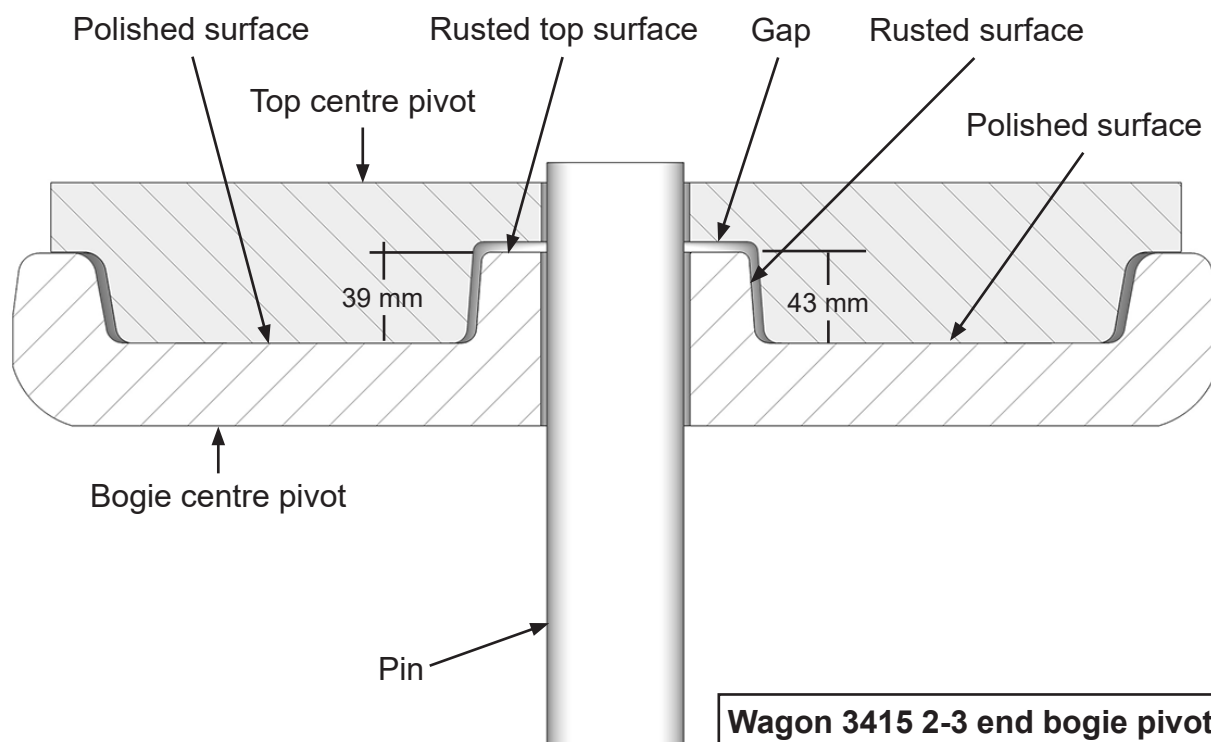
119 The bogie centre pivots incorporate a central upstand, 40 mm high and 108 mm diameter with a 63 mm diameter hole to contain a pin. The upstand fits into a recess in the top centre pivot. On the 2-3 end, the top centre pivot recess measured 43 mm deep, into which the 40 mm high upstand could fit without making contact at the top when the large horizontal faces of the castings were in contact. On the 1-4 end, the recess was also 43 mm deep, but it contained a 5mm thick plug of hardened debris-impregnated grease which had the effect of reducing its depth to 38 mm (figure 40 and figure 41). The grease plug pressed against the top of the upstand and carried part of the load intended to be carried on the large horizontal faces. This prevented the bearing from being correctly seated on the horizontal surfaces (figure 42 and figure 43).

Figure 43: Diagram showing the correctly seated 2-3 end bogie centre pivot

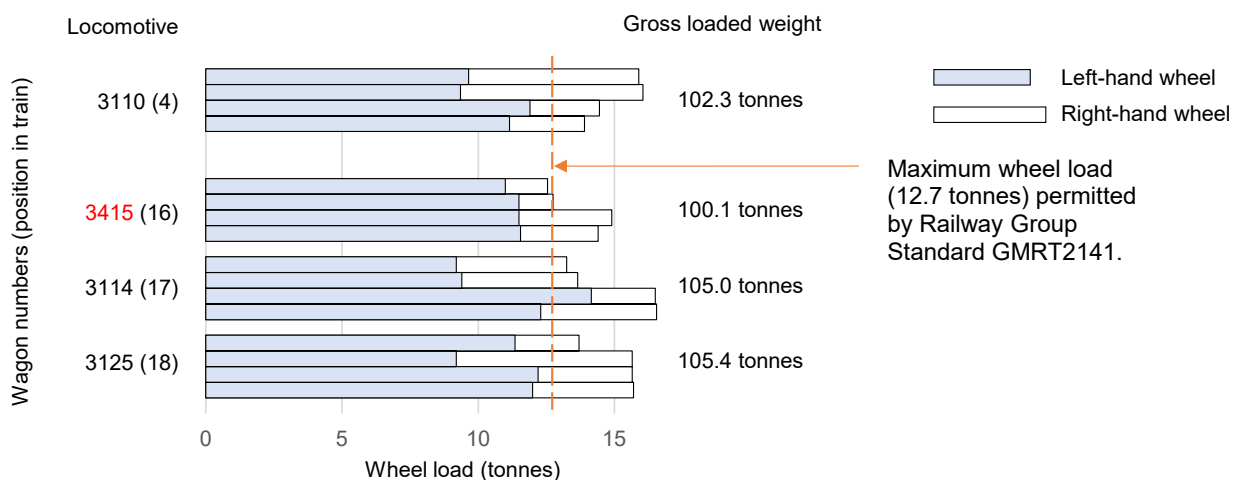
125 The wagons were loaded at Barking using a 360° excavator with a weighing facility, working from the right-hand side of the train. This method of loading, and the nature of the clayey material involved, contributed to the payload in every wagon being off-set towards the right-hand side when the train left Barking on 23 January. Wagon 3415 did not exceed the maximum gross vehicle weight, but the load was concentrated towards the rear right corner of the wagon. The load on the leading and trailing wheelsets on the trailing bogie weighed 26.4 tonnes and 25.95 tonnes respectively, both exceeding the 25.4 tonne RA10 limit (paragraph 56). In addition, the payload was off-set so that the two right-hand wheels on this bogie were carrying over 6 tonnes more than the left-hand wheels with a maximum wheel load of 14.9 tonnes, which can be compared to the 12.7 tonnes carried if the maximum permitted vehicle load is distributed equally between all wagon wheels (figure 44). The maximum wheel load is also defined by Railway Group Standard GMRT2141 ‘Permissible track forces and resistance to derailment and roll-over of railway vehicles’ as not exceeding 124.5 kN. This is equivalent to a wheel load of 12.7 tonnes.

Figure 44: Wagon loading

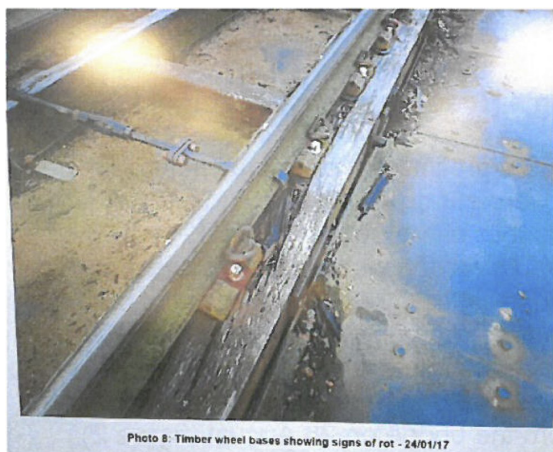
Prior to the line reopening after an eight month electrification blockade in February 2017, the newly-appointed Infrastructure Maintenance engineer (IME) sent an email to the RAM [Track] proposing that advantage be taken of the blockade to gain access and renew timbers. The RAM [Track] did not take the proposal forward, apparently due to budget constraints. The line reopened with tie bars fitted and a 20 mph emergency speed restriction. The poor condition of the longitudinal timbers is illustrated in a photograph dated January 2017 (figure 3) which shows the disintegration of the top surface.

Figure 3: photograph dated January 2017
