Rail Accident Investigation Branch

Rail Accident Report

Runaway and derailment of a wagon at Clitheroe, Lancashire 9 March 2020

Report 16/2020
December 2020

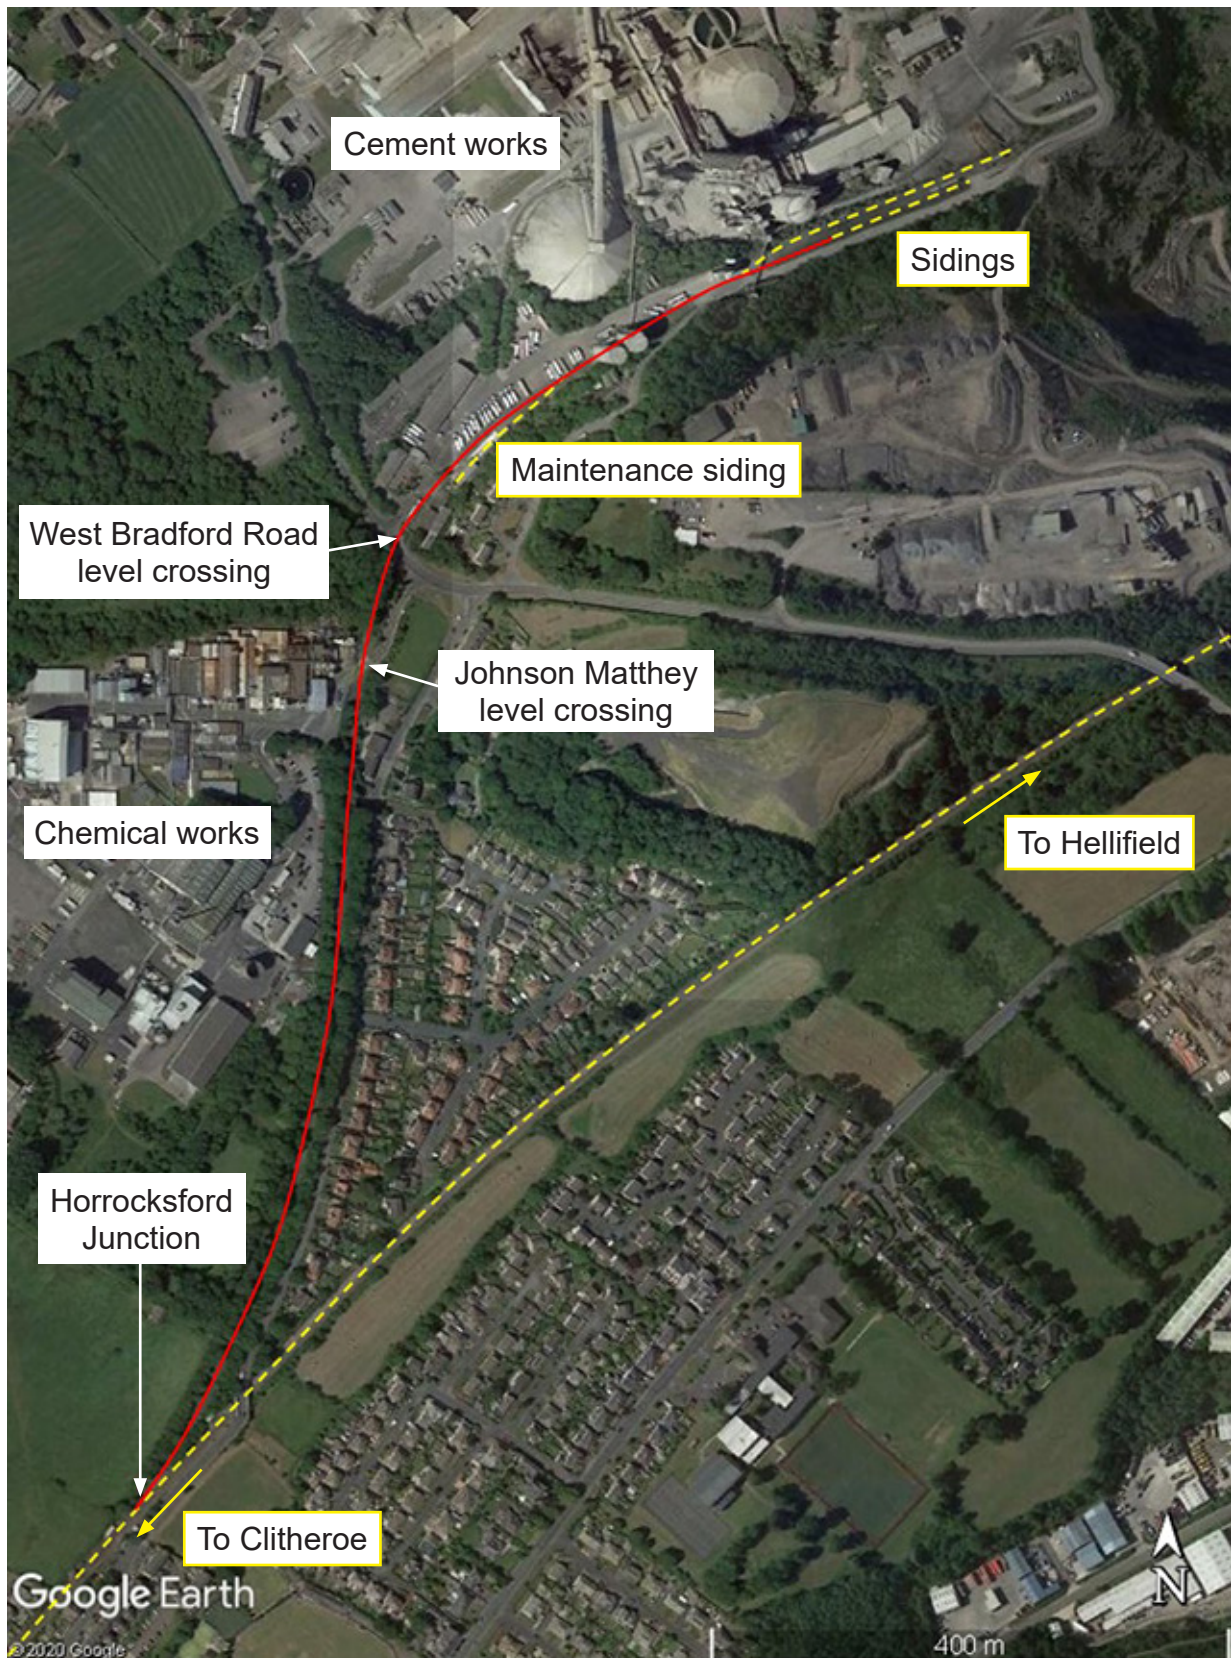
Figure 2: Google Earth view of the path taken by the runaway wagon

- 3 At about 08:16 hrs on 9 March 2020, a loaded wagon ran away from a siding located within the cement works in Clitheroe, Lancashire (figure 1). The wagon left the works and continued to run away on the falling gradient towards Horrocksford Junction, where the branch line to the cement works connects to the main railway line (figure 2).

- 4 As it ran away, the wagon broke through the gates at the exit from the cement works and ran over West Bradford Road level crossing (figure 2) causing two cars to stop. A short distance later, the wagon also passed over Johnson Matthey level crossing (figure 2) which was clear of pedestrian and road traffic. Neither level crossing had its manually activated warning equipment switched on before the wagon passed over it (see paragraph 10), so users had no warning of the approaching wagon.

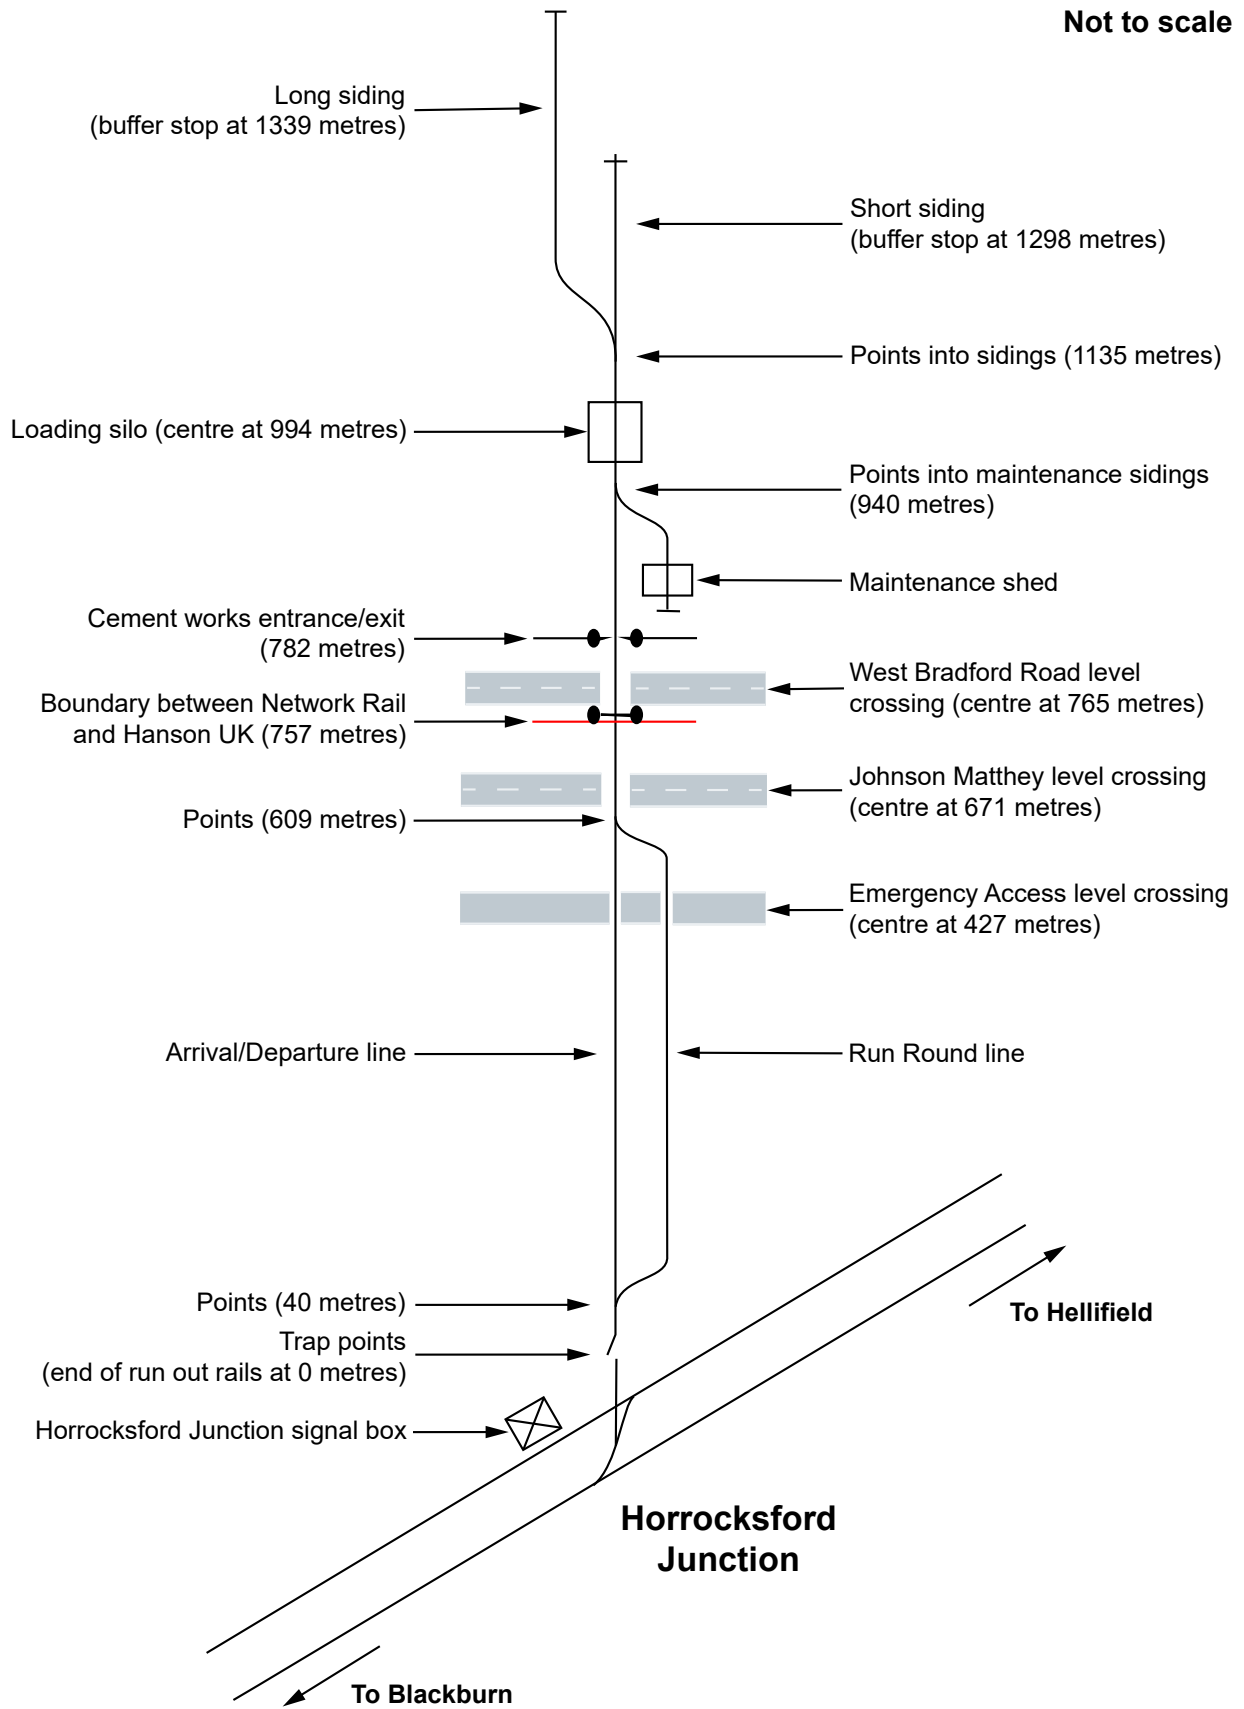
Figure 5: The level crossings and track layout on the branch line from Horrocksford Junction to the cement works and within it

8 At Horrocksford Junction, a single track leads onto the branch line. About 40 metres from the trap points (figure 3), the branch line then becomes double track for about 570 metres (figure 5). This provides a long loop for locomotives to run round trains and propel them (by pushing from behind) into the cement works. Beyond this loop, the railway continues as a single track into the cement works. The boundary where ownership of the infrastructure changes from Network Rail to Hanson UK (figure 5) is located about 0.5 miles (800 metres) from Horrocksford Junction.

- 9 Inside the cement works there are three sidings (figure 5). The first of these is the maintenance siding which is located between the site's entrance and the loading silo. This is used for wagon maintenance and stabling Hanson UK's two shunting locomotives. The remaining two sidings, referred to as the long siding and the short siding, are at the far end of the cement works.

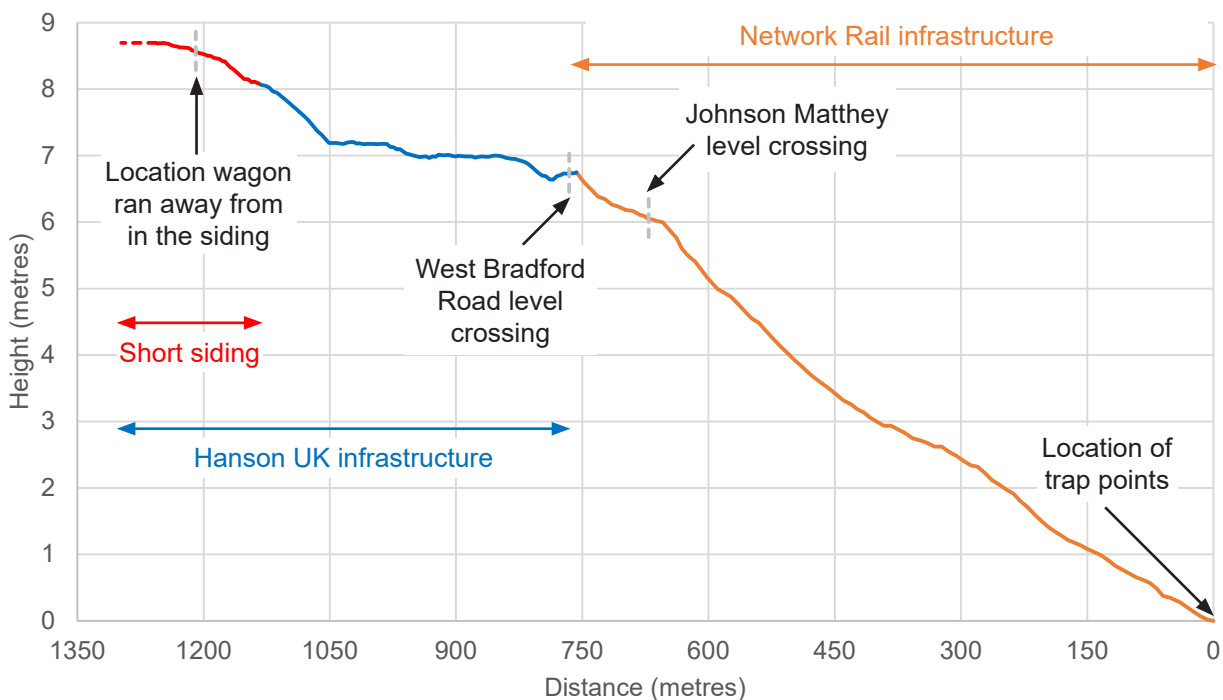
Figure 6: The track gradient profile from the siding where the wagon ran away from to the trap points at Horrocksford Junction

- 12 The track gradient falls towards Horrocksford Junction for almost all the path taken by the runaway wagon. The gradient profile measured by RAIB is shown in figure 6.

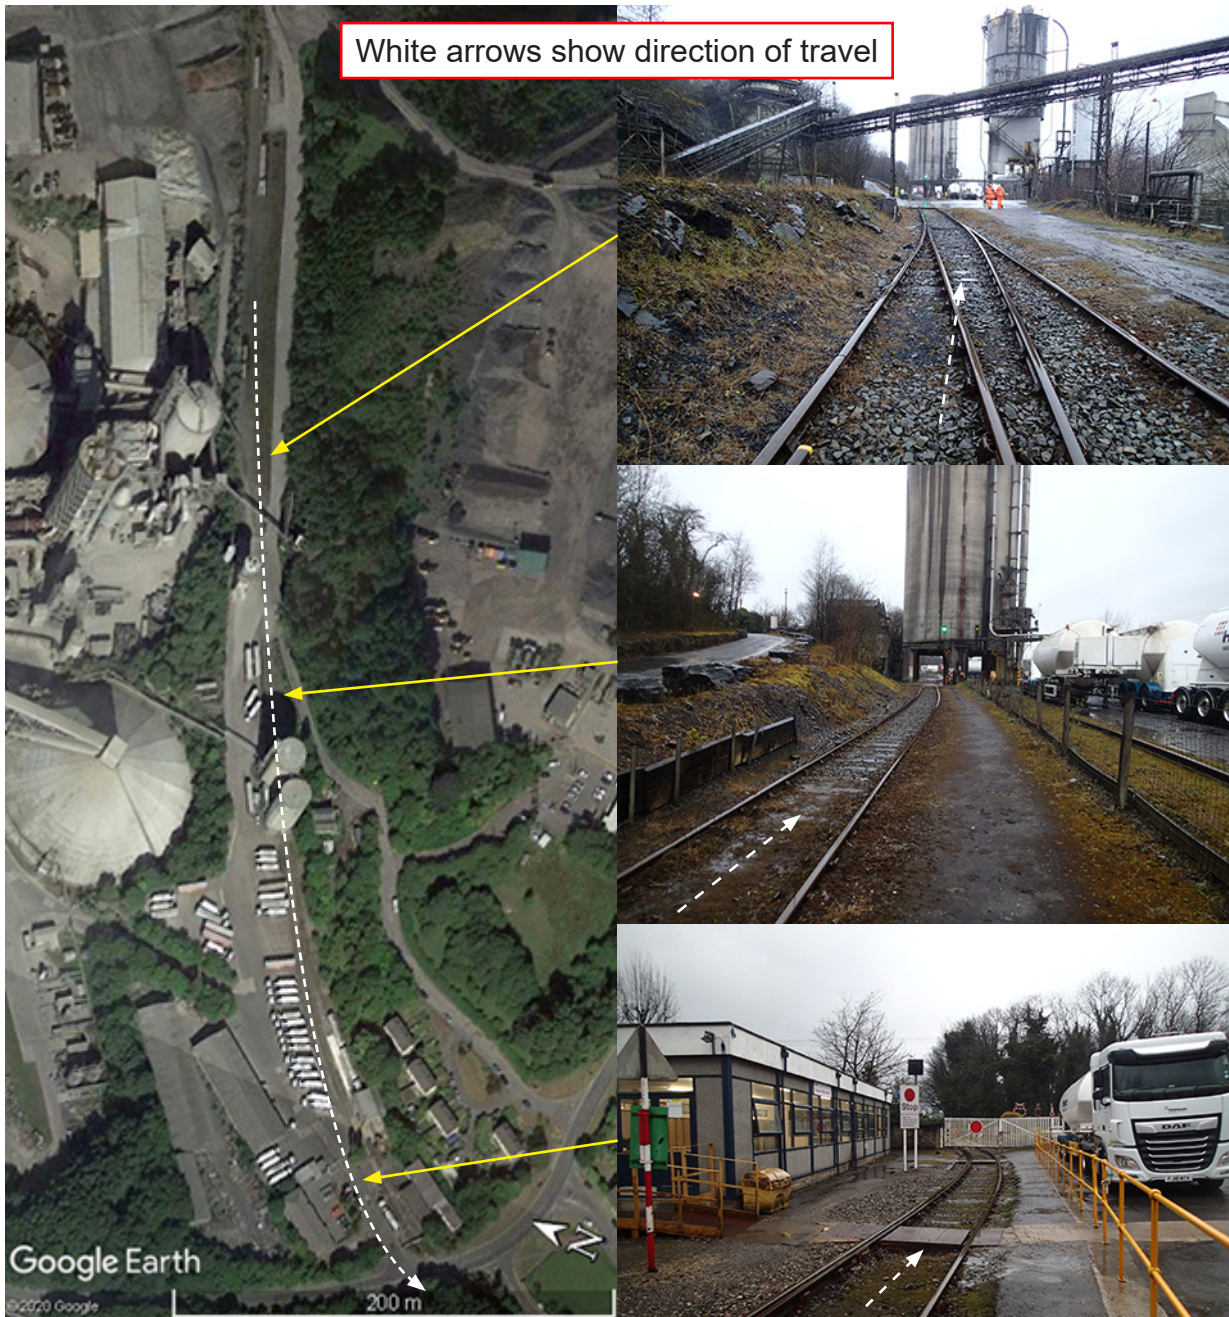
Figure 8: The path taken by the wagon through and out of the cement works

- 39 RAIB calculated that at about 08:16 hrs wagon VTG10601 began rolling very slowly out of the short siding, through the loading silo and towards the exit of the cement works (figure 8). At 08:20 hrs the assistant train manager signed out at the main entrance to the cement works and set off in his car along West Bradford Road. As he approached West Bradford Road level crossing, he noticed two cars, one on each side, stopped at the level crossing. As he got closer to the level crossing, he caught a glimpse of the rear of a wagon heading away, towards the Johnson Matthey level crossing. After driving over the West Bradford Road level crossing, he immediately turned right onto the private road leading to the Johnson Matthey level crossing to catch up with the wagon.

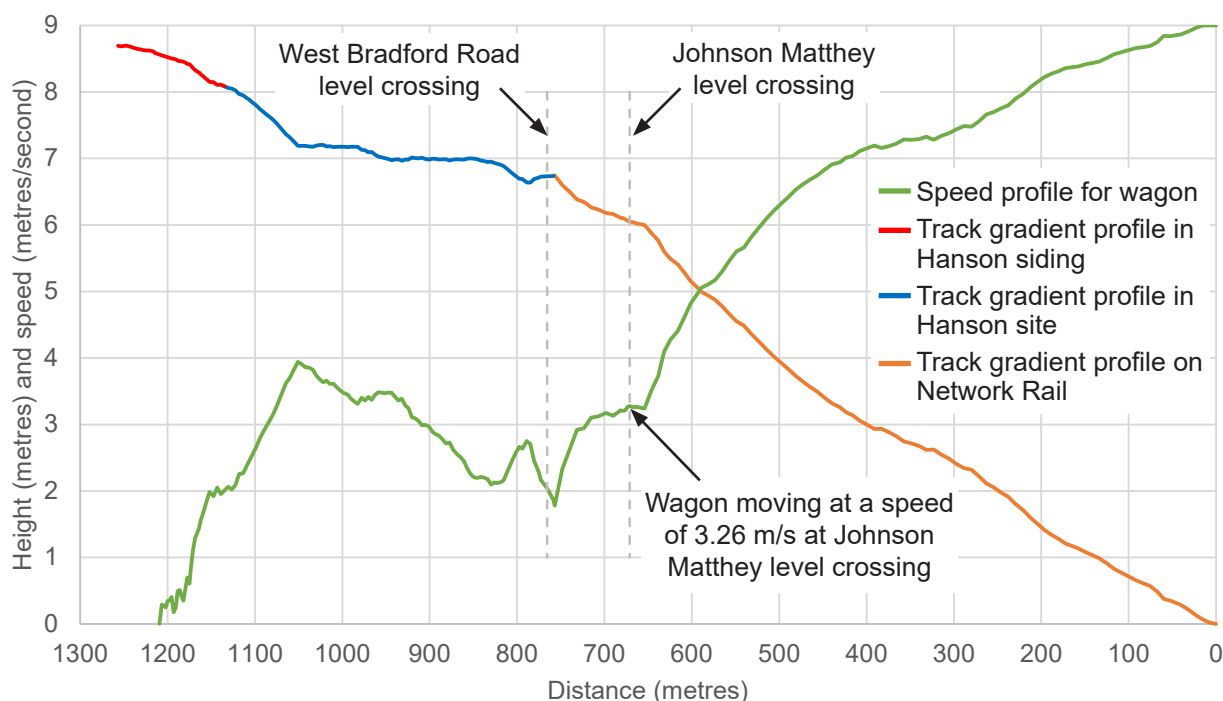
Figure 12: The calculated speed profile for a wagon running away from the short siding

- 56 Further calculations using the measured track gradient profile found that if the wagon ran away from any of the four points within this seven metre length of track and the brake force achieved by the handbrake was 1,515 Newtons, the wagon's speed would be 3.26 m/s (7.3 mph / 11.7 km/h) when it arrived at the Johnson Matthey level crossing (figure 12). This supported the findings from the initial brake force calculation (paragraph 53) which had used an average gradient.

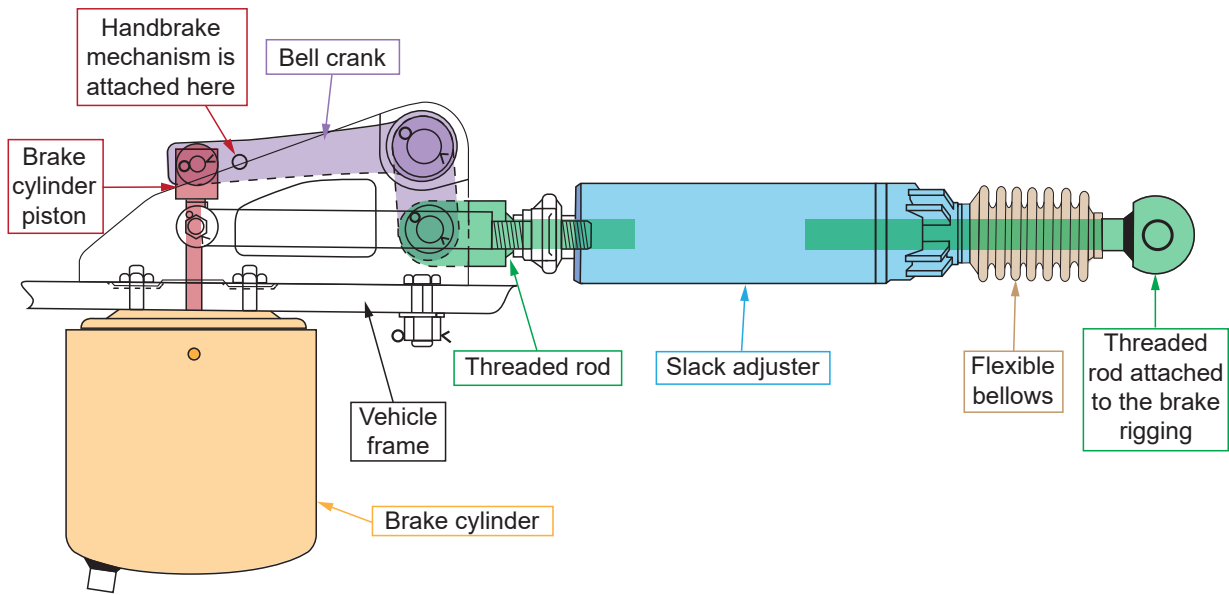
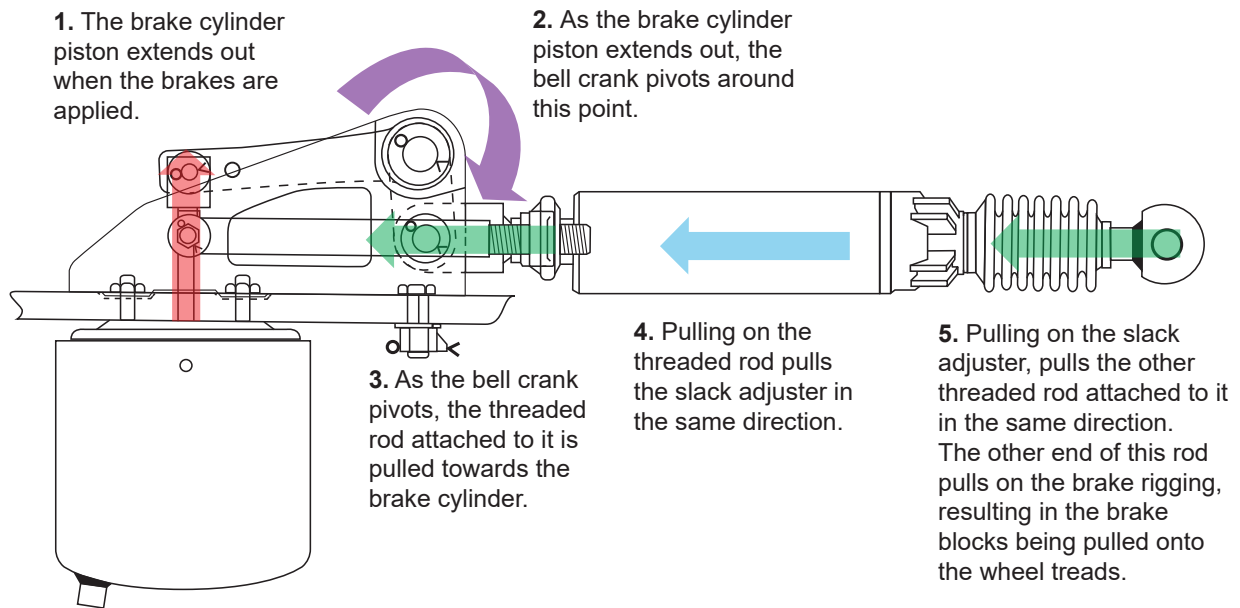
Figure 13: The brake system components from the brake cylinder piston to the brake rigging

- 60 As the handbrake wheel is turned on a PCA wagon, the handbrake mechanism turns a screwed thread and pulls on the brake cylinder piston. As this piston is pulled out of its brake cylinder, its movement translates through a bell crank into a longitudinal movement which pulls, via the slack adjuster (see paragraph 65), on the brake rigging (figure 13). If the handbrake wheel is turned further, the piston is pulled out a correspondingly greater distance, which should result in a greater pull on the brake rigging. This in turn should cause the brake rigging to pull the brake blocks harder onto the wheel treads, generating a greater brake force.

- 63 During further tests, which were set up to include a very wide gap between the brake blocks and wheel treads, RAIB established that the handbrake wheel could only be turned a maximum of $7\frac{1}{2}$ turns before the handbrake mechanism reached the limit of its movement. In this position, the number of screw threads and position of the brake cylinder piston were the same as found after the accident (figure 10). Given that the wagon's brakes were fully applied by the air brake when the ground staff applied the handbrake, the brake blocks were already pulled against the wheel tread by the air brake. Therefore, RAIB's tests suggest that the ability of the ground staff to turn the handbrake wheel by $7\frac{1}{2}$ turns on the day of the accident meant that the movement in the handbrake mechanism was not restricted by the brake blocks being pulled against the wheel treads, but that the ground staff had instead reached, or got very close to, the limit of movement of the mechanism itself.

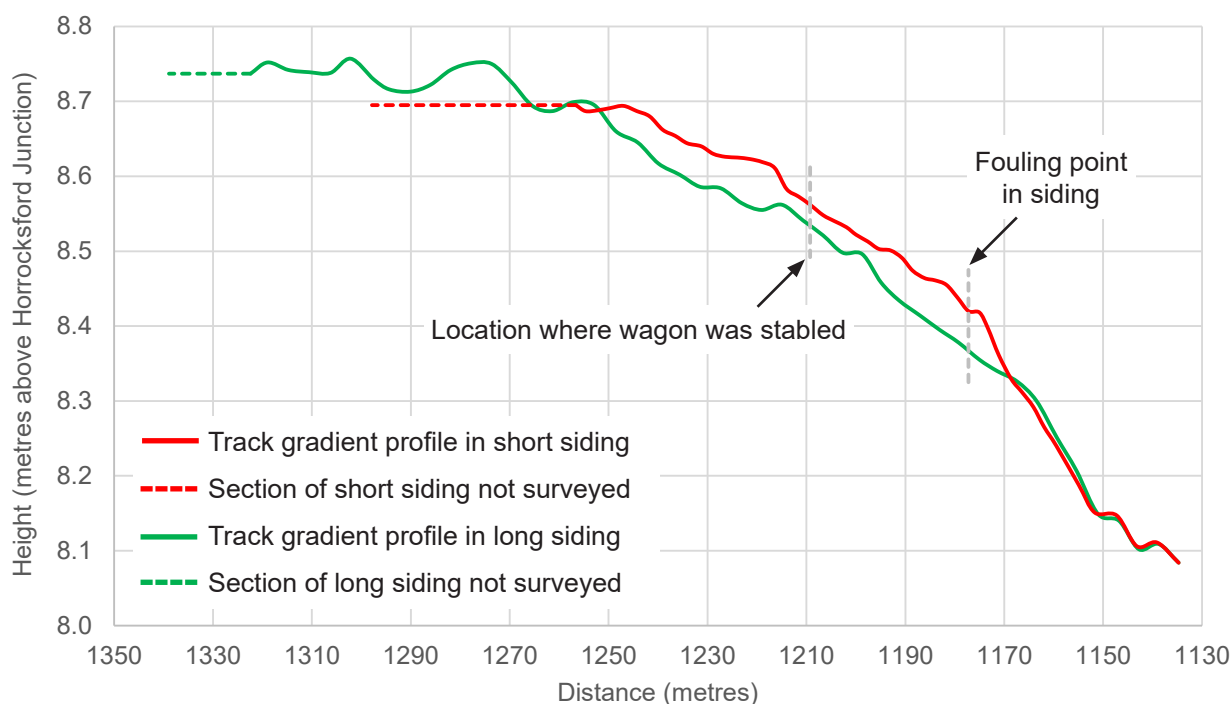
Figure 16: The gradient profile in the long and short sidings

- 80 When the GB Railfreight ground staff stabled wagon VTG10601 on its own in the short siding, they left the wagon on an average gradient of 1 in 233, falling in the direction of the exit to the cement works (figure 15).
