Rail Accident Investigation Branch

Rail Accident Report

**Person struck by a train at Eden Park station,
south-east London
26 February 2020**

Report 01/2021
February 2021

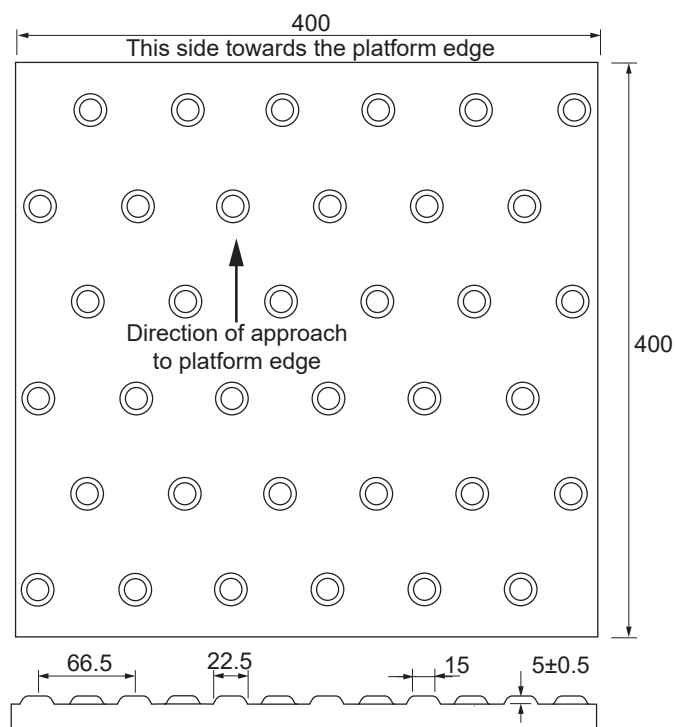
Figure 4: Profile and plan view of tactile surfaces at mainline stations

- 40 The DfT guidance requires tactile surfaces for use at the edge of station platforms (referred to as tactile surfaces in the remainder of this report) to be made up of 400 mm squares, each having rows of flat-topped domes (blisters, 22.5 mm outer diameter and 5 mm in height). The blisters are spaced at intervals of 66.5 mm and each row is off-set so a blister in the second row will appear halfway between blisters in the first row (figure 4). The guidance required the whole surface to be more than 500 mm from the platform edge, and of a colour that would provide a good contrast with the platform surface.
