# Rail Accident Report

**Fatal accident at Waterloo Underground station,  
London  
26 May 2020**

Report 05/2021  
September 2021

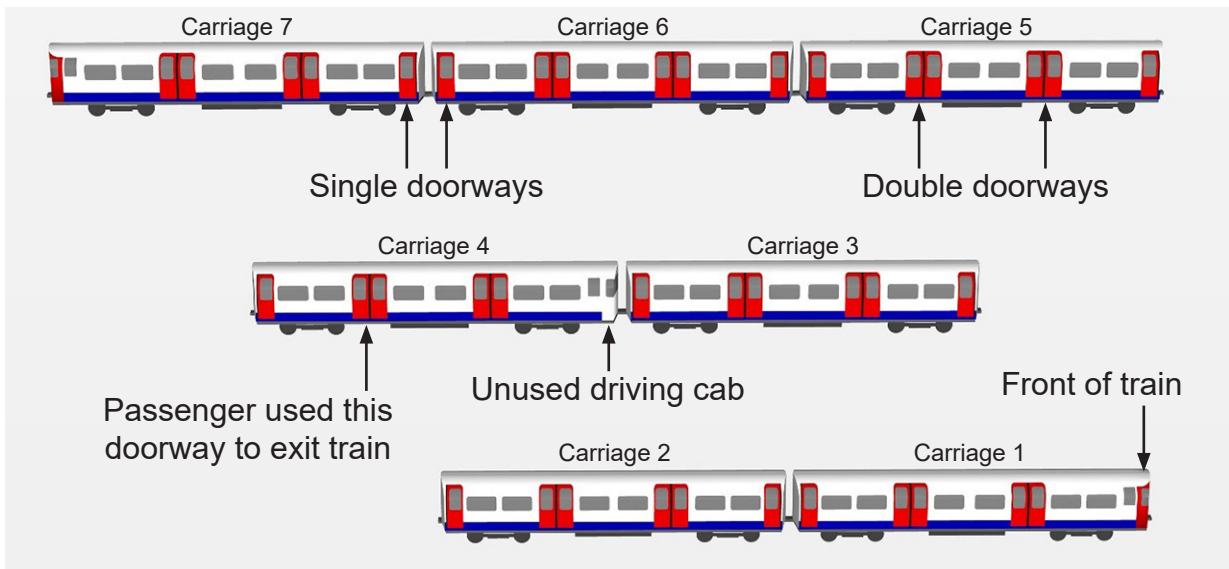
Figure 4: Arrangement of passenger saloon doors on 1972 tube stock trains

- 10 Both trains were formed of 1972 tube stock and consisted of 3-carriage and 4-carriage units operating as 7-carriage trains. Each carriage is about 16 metres long with two double doorways approximately one-third and two-thirds of the way along the carriage length, and single doorways at each end. The fourth carriage of the incident train incorporated a driving cab, so did not have a single doorway at the leading end (figure 4).

- 23 It has not been possible to determine if this announcement was made before the passenger alighted and, if so, whether it prompted him to get off the train. However, 176 seconds after the train had stopped, the passenger left the train from the rear set of double doors of carriage 4 (the fourth carriage from the front of the train, figure 4). After taking two steps on the platform, moving away from the train, the station CCTV shows the passenger becoming unsteady on his feet, stumbling backwards, and falling into the gap between the platform edge and the mid-point of carriage 4. He fell entirely below the level of the platform at a position where the curvature of the platform is particularly tight and so the gap between the platform and the side of the train was particularly wide (paragraph 6).
