Rail Accident Investigation Branch

# Rail Accident Report

## **Freight train derailment at Sheffield station 11 November 2020**

Report 07/2021  
October 2021

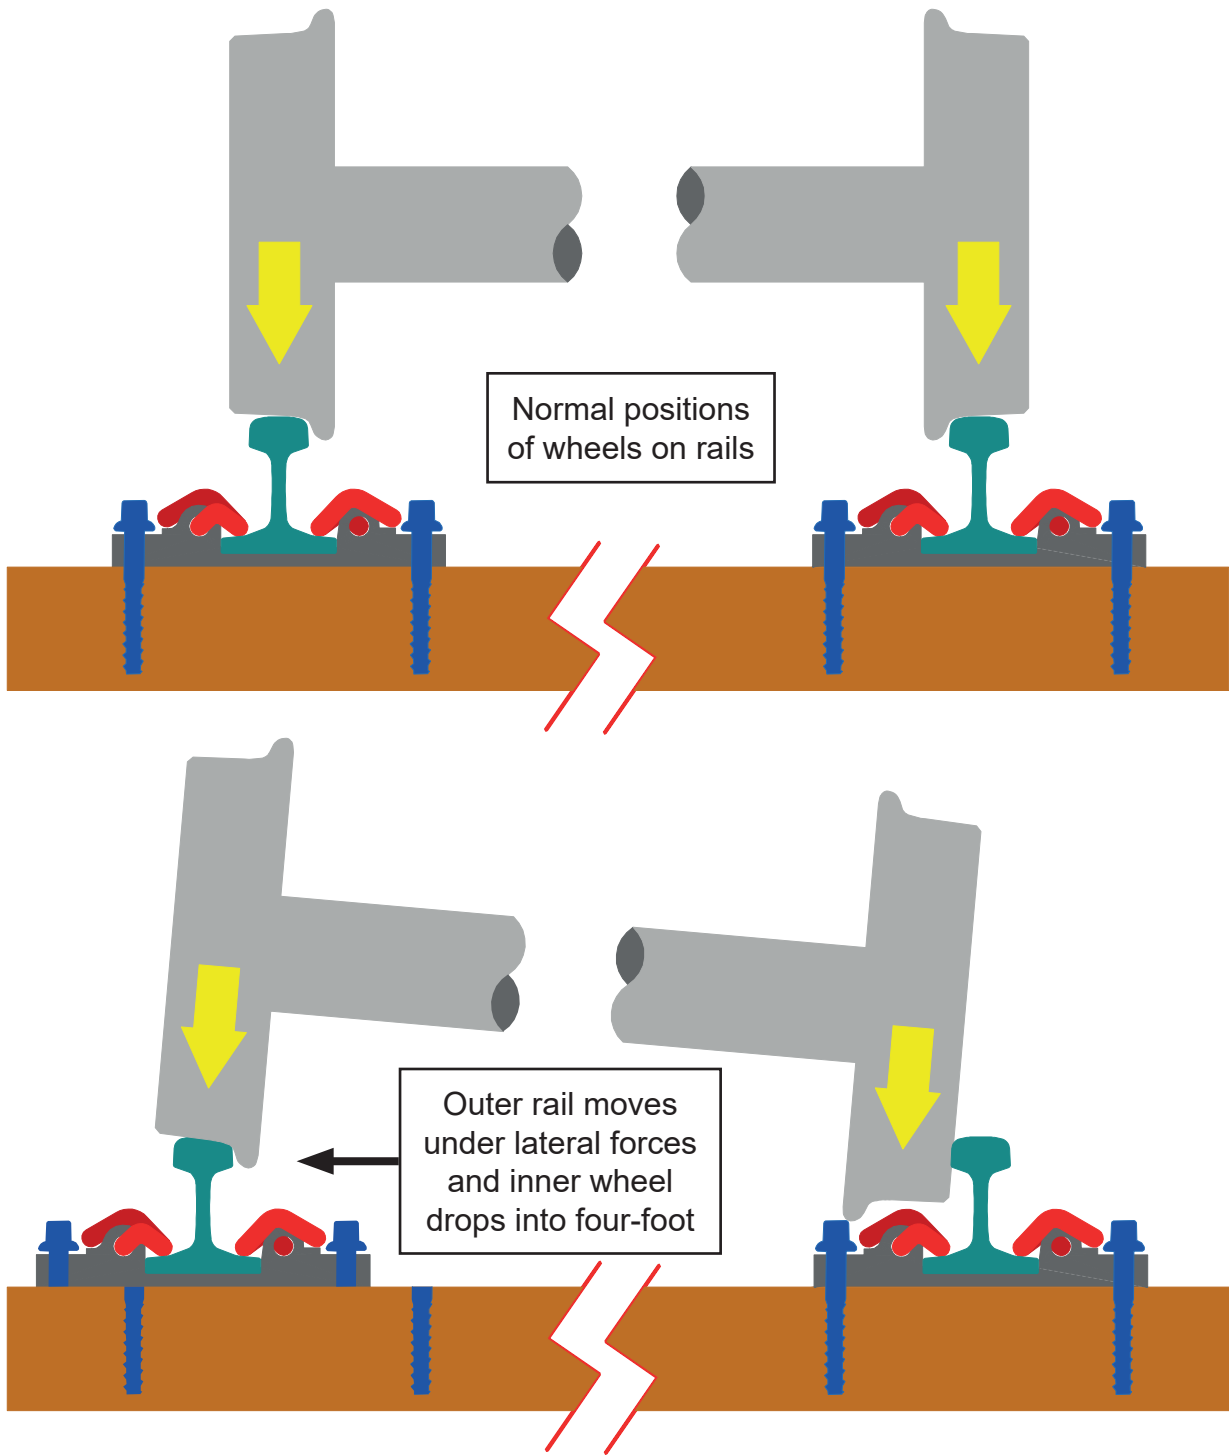
Figure 6: Sketch of the derailment in 4062 points

- 20 As the twelfth wagon in the train passed through 4062 points, its leading wheelset derailed, with the right-hand wheel (in the direction of travel) dropping into the gap between the two rails (known as the 'four-foot'), due to the distance between the rails (or 'gauge') having become too wide (figure 6). This occurred between the crossing and the switch rail of 4062 points (figure 7).

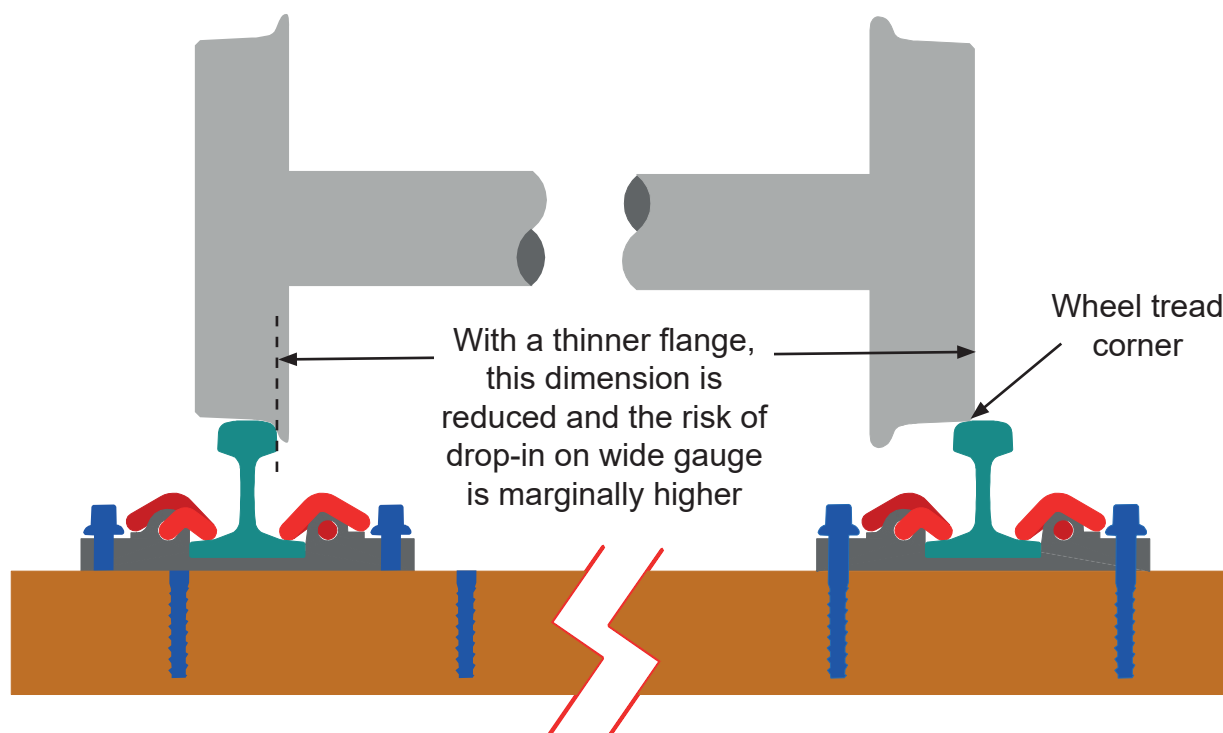
Figure 11: Illustration of the possible effect of a narrower wheel flange

- 35 It was noted that the wheel flanges on the left-hand wheels on both wheelsets were slightly thinner than those on the right-hand wheels (figure 10). However, they were all well within the acceptable maintenance specification limits. It is possible that a thinner left-hand wheel flange could result in the wheelset being positioned slightly further to the outside rail on a right-hand curve, such as at the point of derailment. This means that the associated wheel tread corner on the right-hand wheel would also be positioned slightly closer to the four-foot on the right-hand rail, and so be fractionally more at risk of derailment (figure 11). The estimated difference in position on the twelfth wagon is only about 1-2 mm.

- 36 Wagon 12 ran in the same train, in the same orientation, and by the same route through Sheffield station, on the two nights prior to the derailment. This suggests that the slightly thinner wheel flanges were unlikely to be a significant factor in the derailment.
- 37 RAIB also examined wagons 10, 11 and 13 and found no defects. In addition, the maintenance records indicated that maintenance activities for all the wagons inspected had been carried out by their due dates and that there were no outstanding defects.
- 38 RAIB obtained data from the wheel impact load detector system at Grindleford, that the train had passed over between Hope and Sheffield. This recorded no abnormal weight distribution that would indicate uneven loading or a problem in the wagons' suspensions.

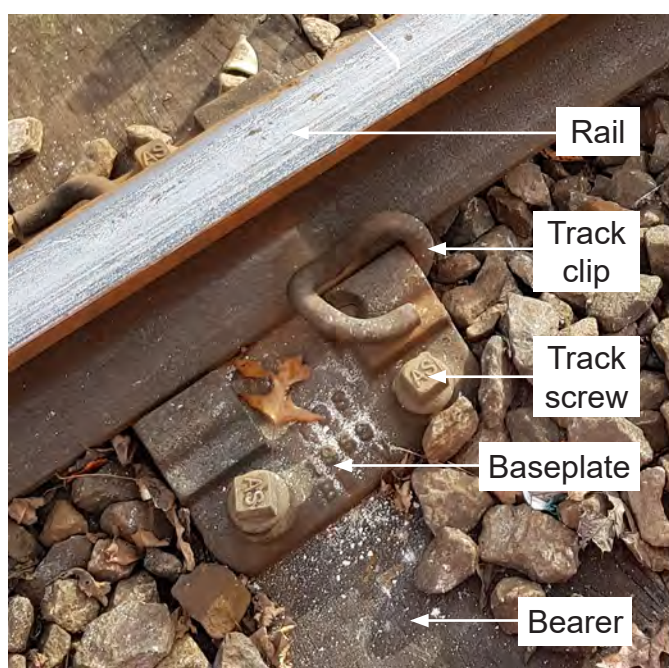
Figure 12: Illustration of rail secured to bearer by baseplates, clips and track screws

- 41 The track at the derailment location, inside the length of 4062 points, consisted of flat-bottomed rail held on metal baseplates by spring 'Pandrol' type clips (figure 12). Each of the baseplates was secured to timber bearers by three track screws, with most of the baseplates having two track screws on the four-foot side of the rail, and the third on the outside.

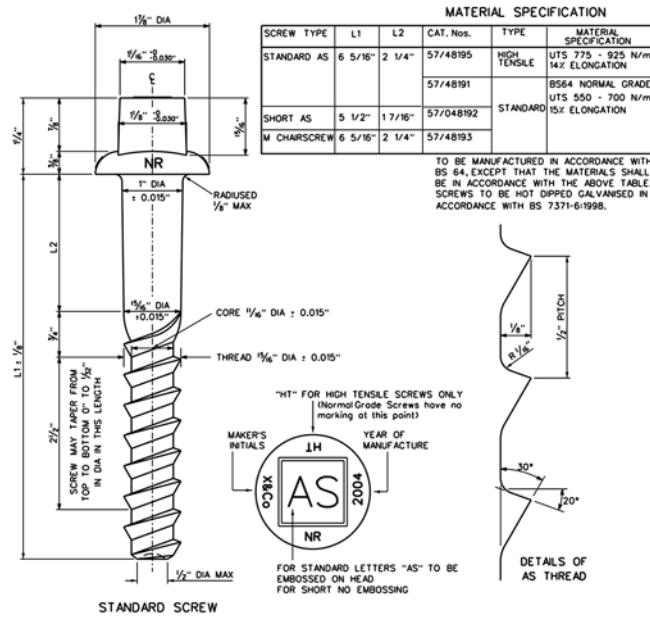
Figure 13: Extract from Network Rail drawing of AS track screws

- 42 All the track screws in the vicinity of the derailment were Network Rail approved standard grade AS track screws, to Network Rail drawing RE/PW/43. This drawing specifies the dimensions, materials and markings for such screws (figure 13). All were marked as having been manufactured in 2005 or 2006.

- 45 This identified that the screws were largely compliant with the specifications in the drawing (figure 13). One screw (from bearer -1) had slightly reduced mechanical properties. However, because this screw was among the last to fail, it is unlikely that its characteristics contributed to the failure of any of the other compliant screws. The study also concluded that all the screws had failed as a result of cyclical unidirectional bending, leading to fatigue cracking, followed by a mechanical overload failure of the residual material thickness.

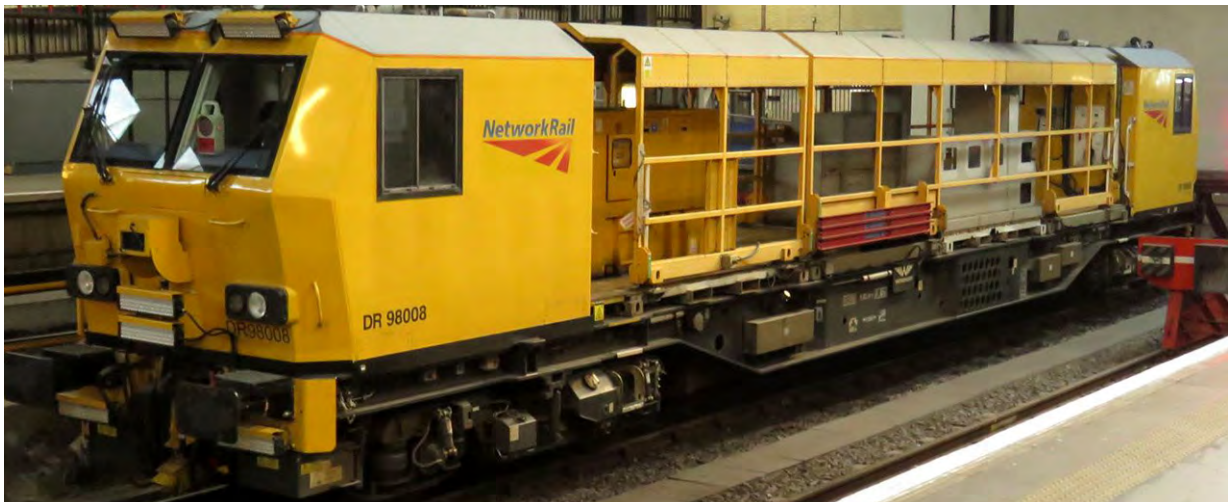
Figure 18: Network Rail's MPV based track recording vehicle (image courtesy of Brian Creasey)

**73 No dynamic geometry measurements had been recorded at 4062 points for 15 months prior to the derailment. This is a probable factor.**

- 74 'Dynamic track geometry' is a term used to describe the geometry of track as trains pass over it, and so includes any changes resulting from the wheel loading from a train. Network Rail uses track measurement trains to measure dynamic track geometry across the network on a routine basis. However, most of these are unable to record some characteristics, for example gauge, at low speed, and they only take a single defined route when passing through stations. As a result, there are many areas in stations and other locations with complex track layouts where dynamic geometry does not get fully recorded by the track measurement trains. Network Rail has a single multi-purpose vehicle (MPV) that is equipped to be used for dynamic geometry measurement in such locations (figure 18).

- 75 The MPV was scheduled to visit Sheffield station every three months, to record the track geometry for all through lines and terminal platforms. However, no recording runs had been made by the MPV since November 2019, because it had been out of service for overhaul and upgrading.
