Rail Accident Investigation Branch

# Rail Accident Report

## Collision between road-rail vehicles near Ramsden Bellhouse, Essex 2 May 2021

Report 09/2022  
September 2022

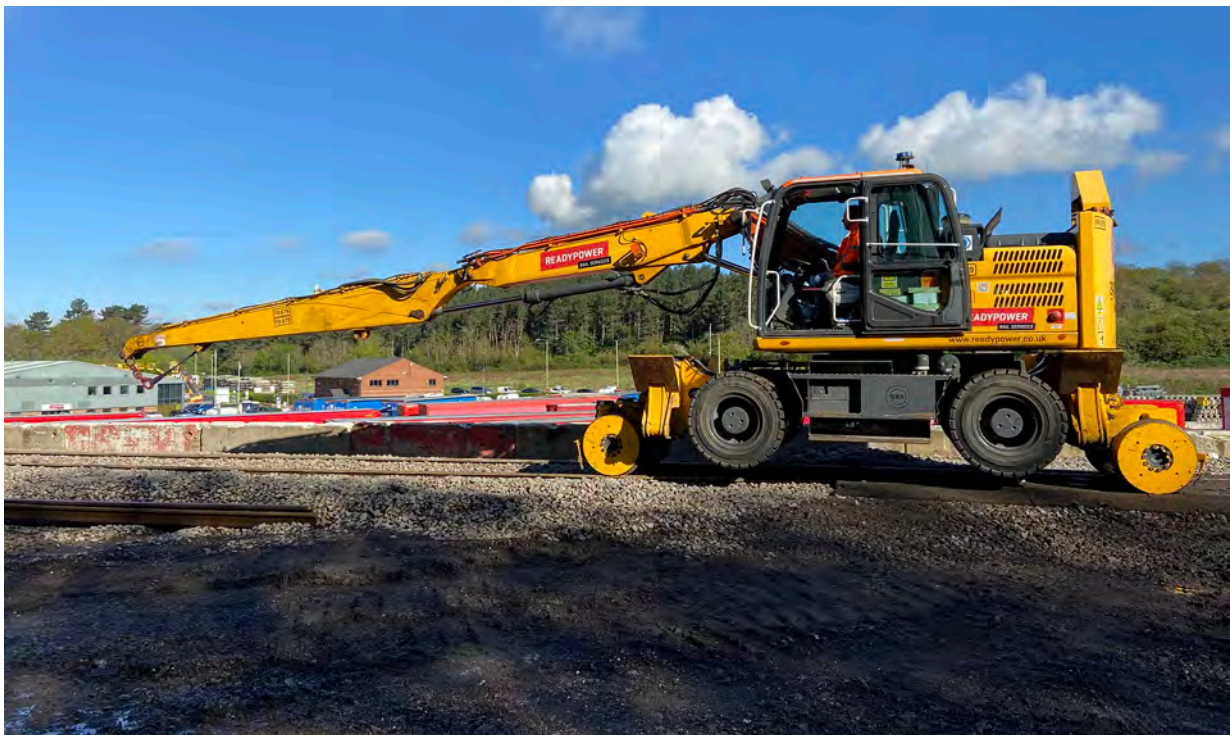
14 The crane involved was a Doosan Ultimate 270 road-rail machine equipped with a 5.5 metre 'long reach dipper' arm, rigged for lifting operations (figure 5).

Figure 5: The crane involved in the collision during brake testing
