# Rail Accident Report

## **Wrong side signalling failure and derailment at Dalwhinnie, Badenoch and Strathspey 10 April 2021**

Report 10/2022  
September 2022

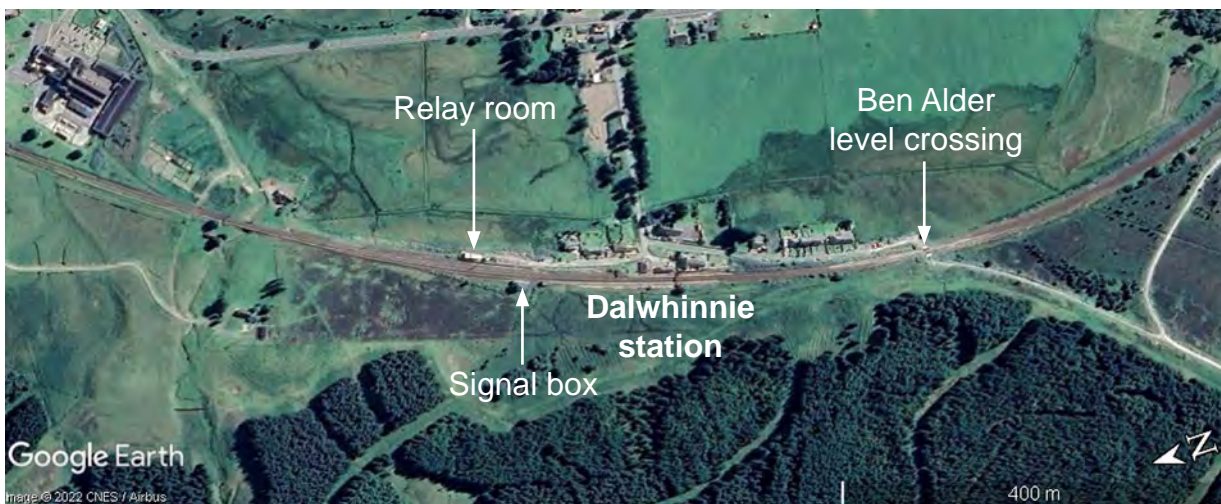
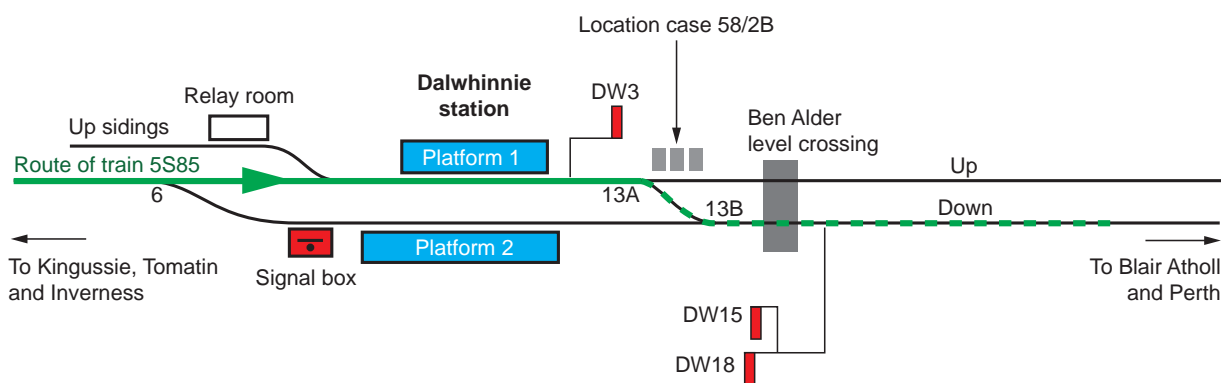
13A point end correctly set for up line

Figure 2: Layout of the railway at Dalwhinnie station showing the route of the train. The lower diagrams shows 13 points in the correct and incorrect (as encountered by the train) positions.

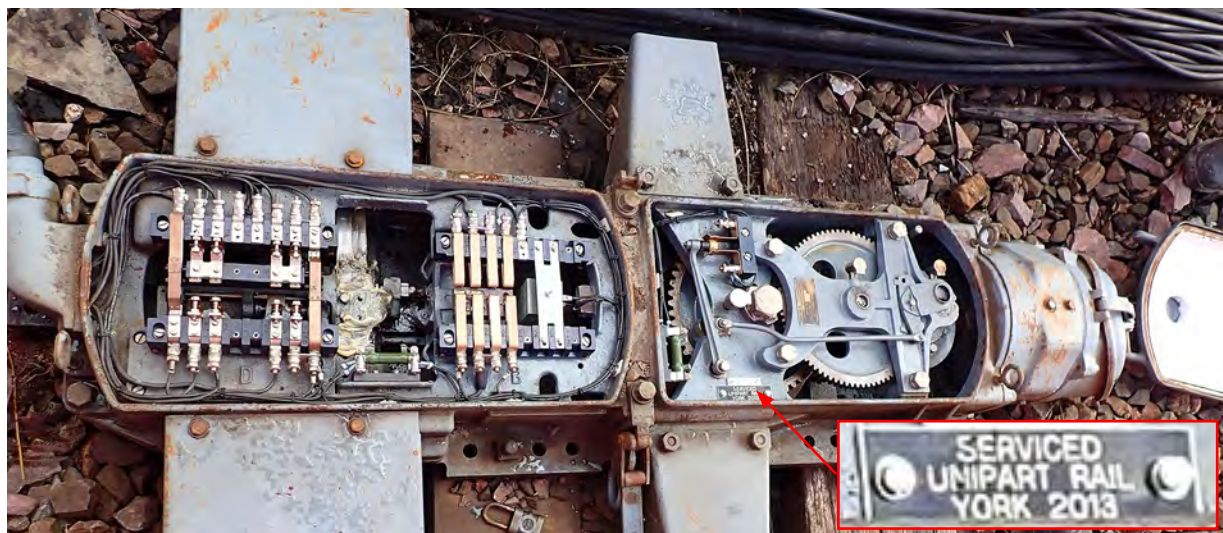
- 17 The point ends at 13 and 6 points are operated by GRS 5E type electromechanical point machines (figure 5). The required position of the points is called by the signaller and controlled by the interlocking<sup>5</sup> in the Dalwhinnie relay room located near the up sidings (figure 2). Relays in lineside location case 58/2B provide local control of the point machines at 13 points and indications to the interlocking of the detected position of the switch rails (see appendix B).

Figure 5: GRS 5E type point machine installed at 13A point end, with covers removed. Inset shows the plate fitted when it was last reserviced

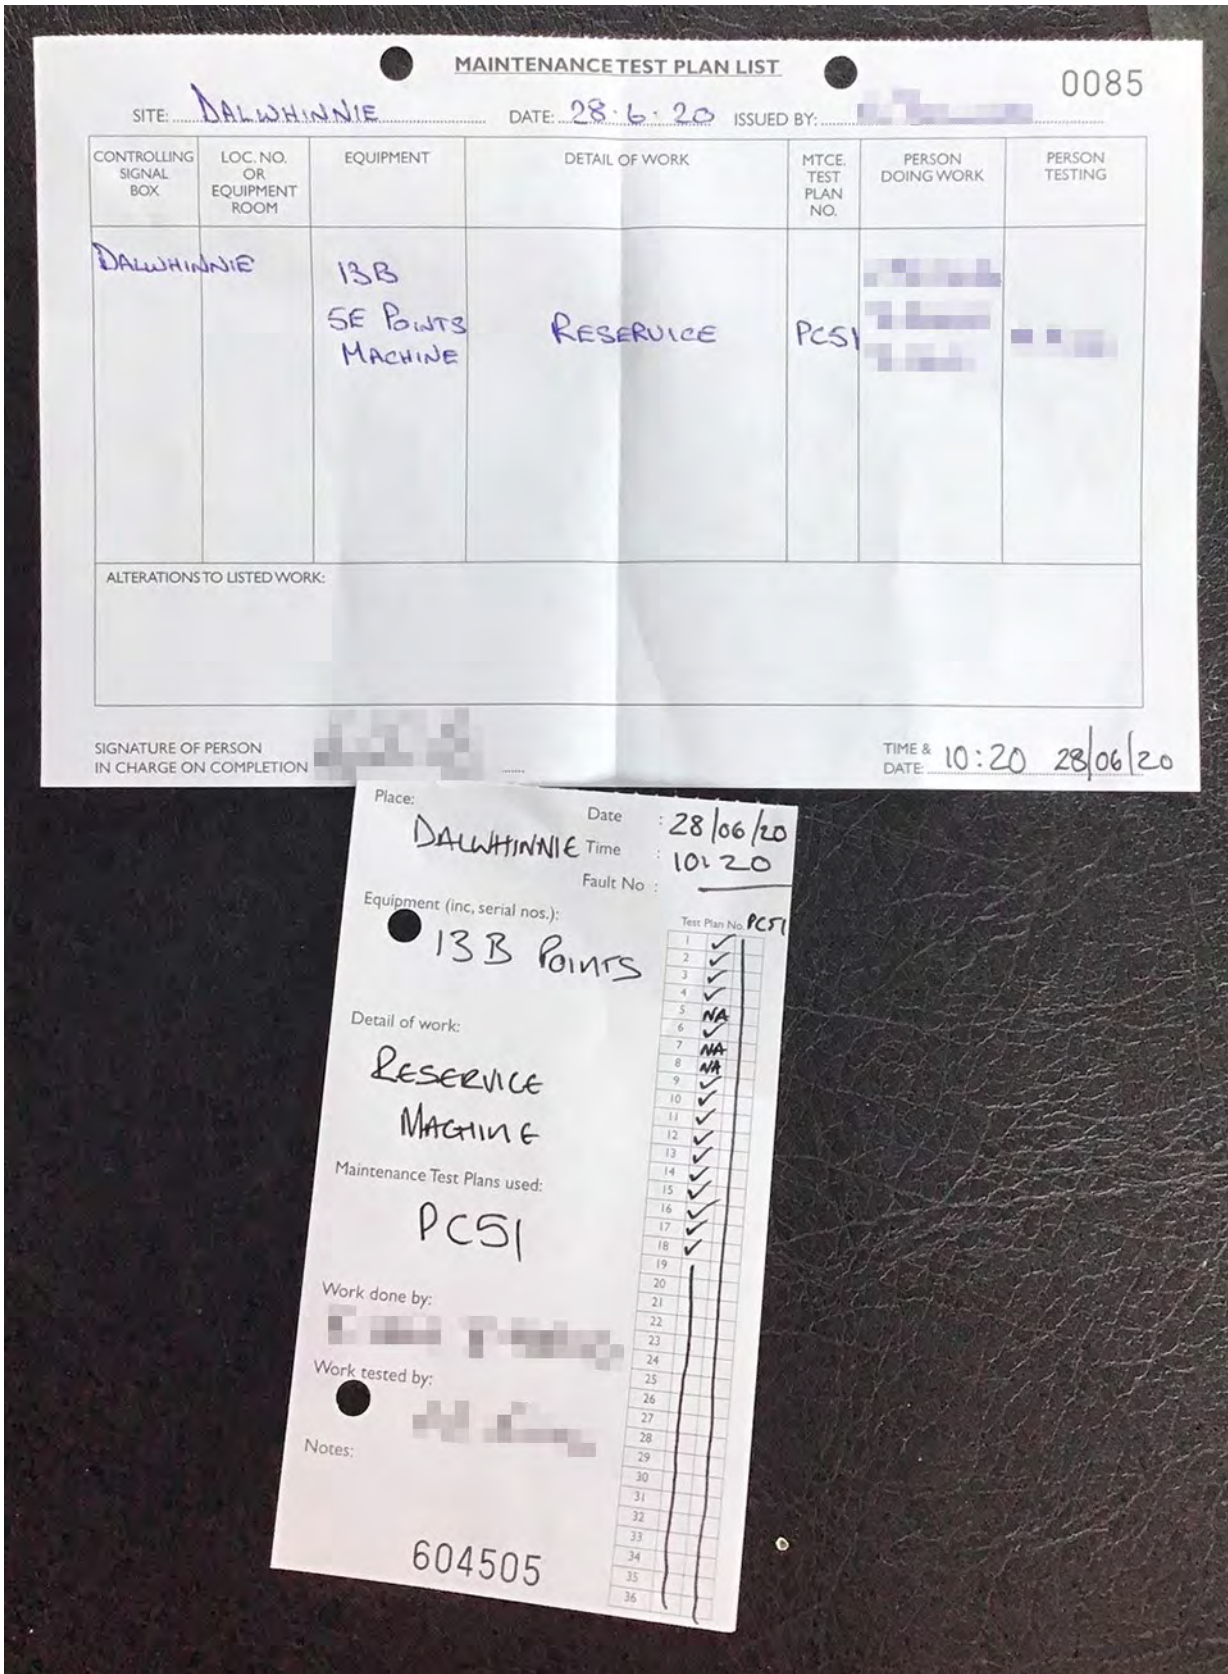
- 37 The maintenance tester incorrectly believed that he had now completed all the tasks on the maintenance test plan. He filled in both the SMTH log sheet (see paragraph 53, and also footnote 24) and the maintenance test plan list (paragraph 28). The documents record a time of 10:20 hrs (figure 6). This is the time when he would have been in the relay room. However, the maintenance tester recalled completing the documents when he was back in his vehicle, which was sometime later.

Figure 6: Completed SMTH log sheet and maintenance test plan list (photograph courtesy of Network Rail)

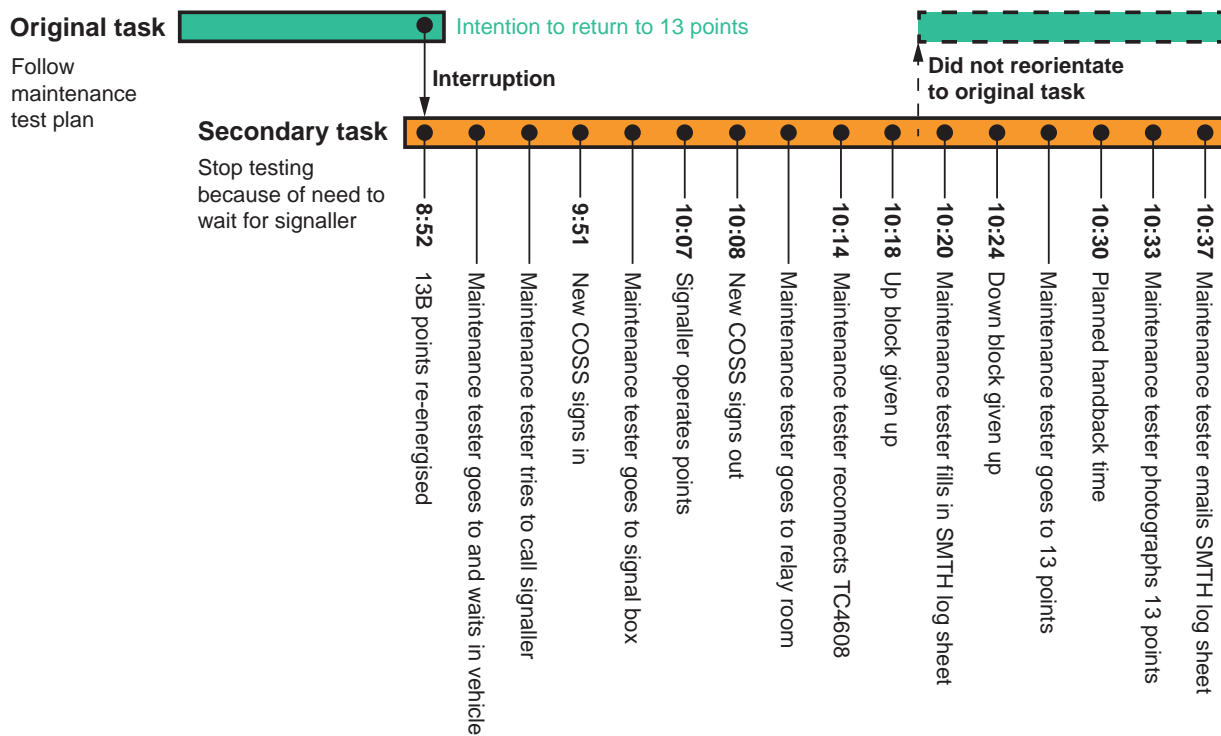
RAIB found a variety of evidence supporting that the interruption had likely captured the maintenance tester's attention and reasons for him not re-orientating correctly (see paragraphs 142 to 150). Figure 15 shows a timeline which summarises the relevant actions, and how they relate.

Figure 15: Timeline of events relating to the renewal of the 13B point machine and the interruption resulting from the need to wait for the signaller to book on duty

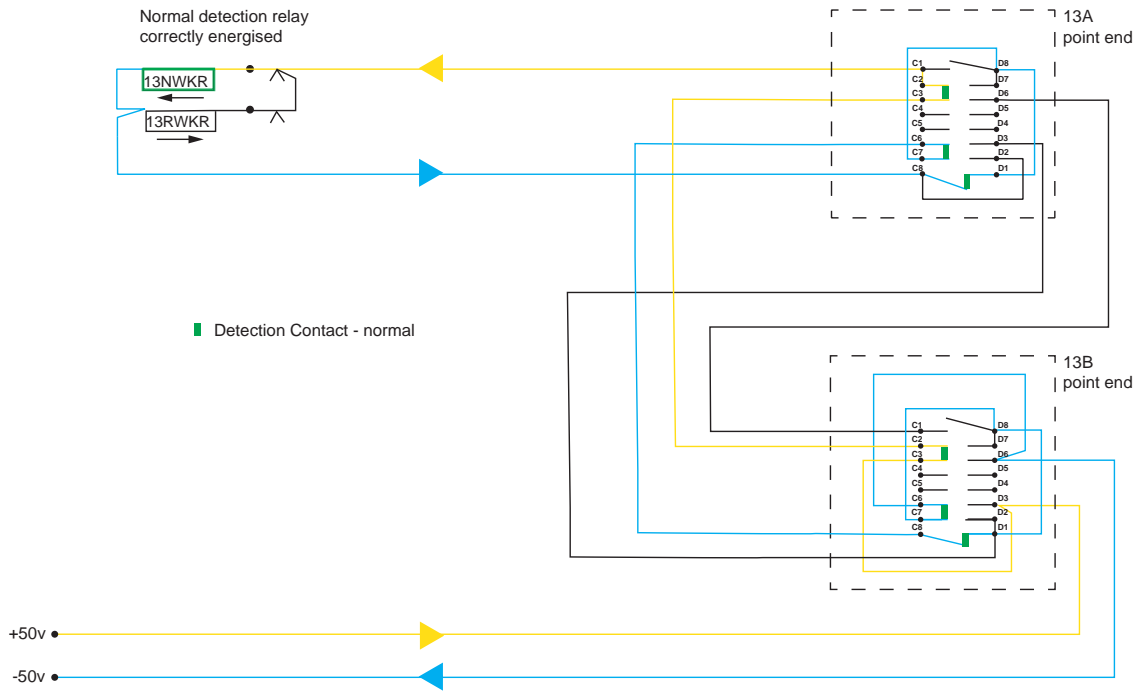
- B5 Figure B1 shows a simplified diagram of the detection circuit associated with 13 points. The detection contacts are contained inside the point machines and are wired in series between each point end. The detection contacts need to be made, in either the normal or reverse position, in both point machines for the appropriate detection relay (13NWKR or 13RWKR) to energise. This should only occur when the associated switch rails are in the correct position.

Figure B1: Simplified diagram of the detection circuit associated with 13 points as designed (showing switch rails detected in normal position at both point ends)

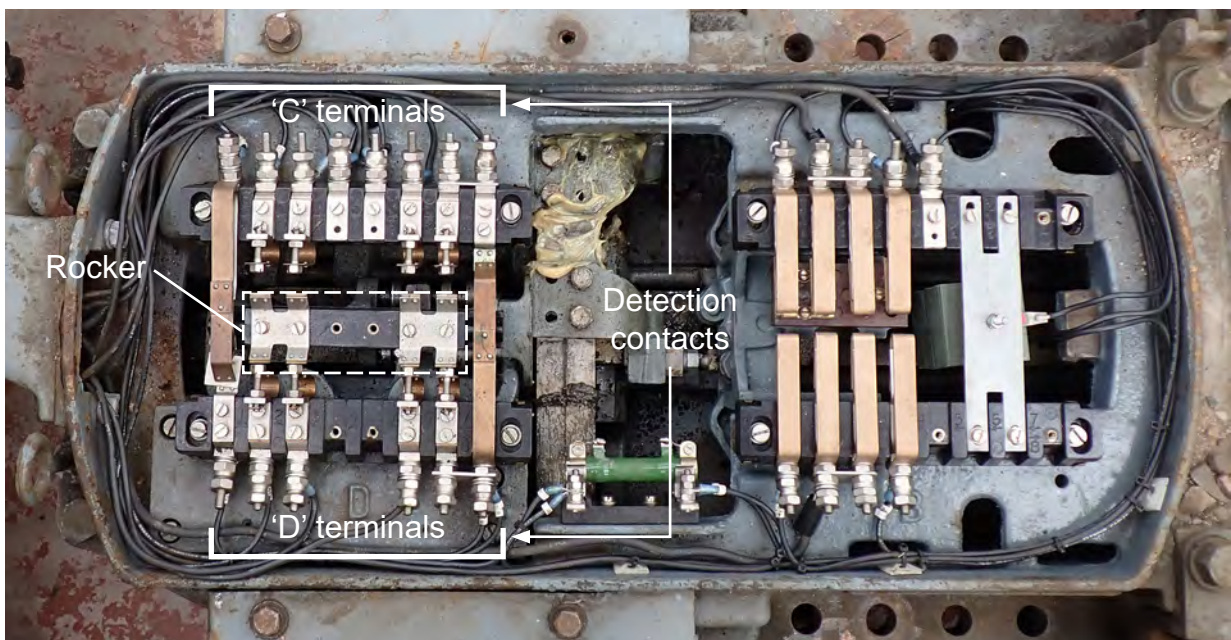
B6 On a GRS 5E type point machine, detection contacts comprise two metal H-shaped pieces which are attached to a rocker. The rocker moves from one side to the other side depending on the position of the switch rails. For 13 points, when detection is obtained in the normal position, the H-shaped pieces are in contact with fixed springs connected to the terminals designated by prefix ‘C’; for detection in the reverse position, they are in contact with springs connected to terminals designated by prefix ‘D’ (figure B2). If detection is lost, a back contact of the appropriate detection relay energises the respective points calling relays (13ANWR and 13BNWR, or 13ARWR and 13BRWR) to command the points to move back to the required position, in an attempt to regain detection.

Figure B2: GRS 5E type point machine detection contacts

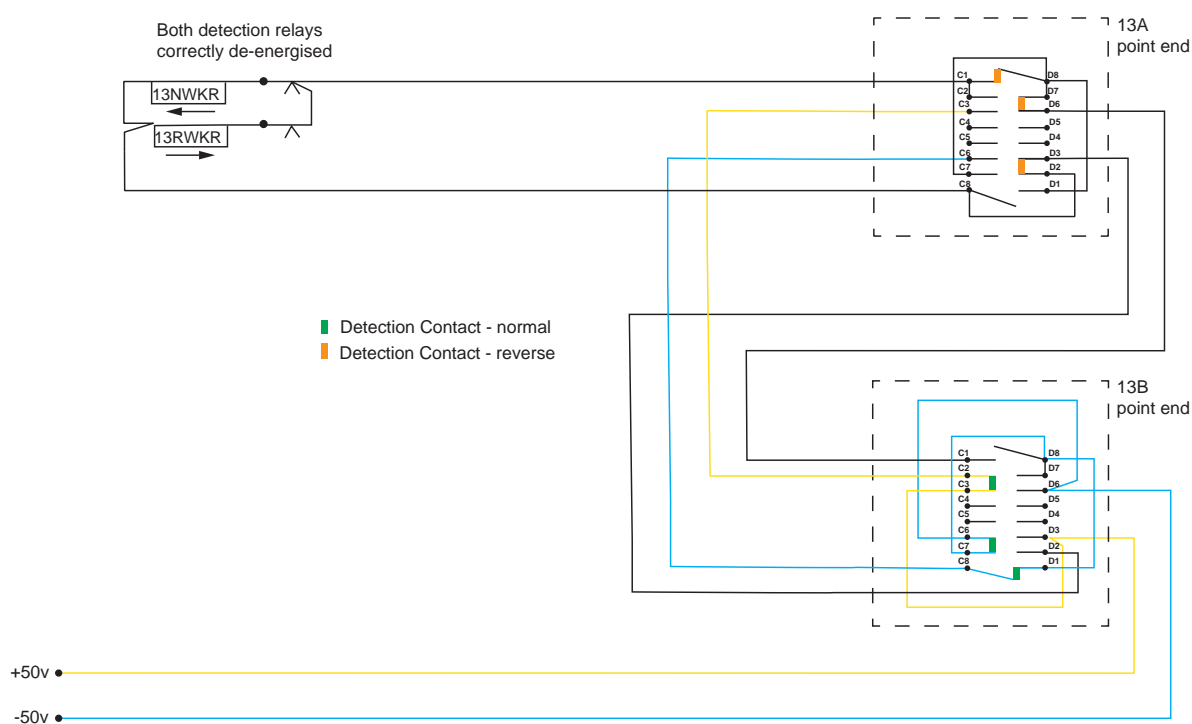
- B9 With the switch rails at 13A point end in the reverse position, and those at the 13B point end in the normal position (paragraph 81), 13 points were out-of-correspondence. For this condition, analysis of the as-designed circuit shows that neither of the detection relays should have energised (figure B3). However, with the two additional conductors in the point machine at 13B point end (between terminals C1 and C2; and C8 and D2) detection relay 13NWKR is incorrectly energised (figure B4).

Figure B3: As-designed detection circuit for 13 points showing 13A point end reverse and 13B point end normal – neither detection relays energise
