# AIRCRAFT ACCIDENT REPORT 1/2023

Report on the accident to  
**Leonardo AW169, G-VSKP**  
at King Power Stadium, Leicester  
on 27 October 2018

Report on the accident to  
Leonardo AW169, registration G-VSKP  
at King Power Stadium, Leicester  
on 27 October 2018

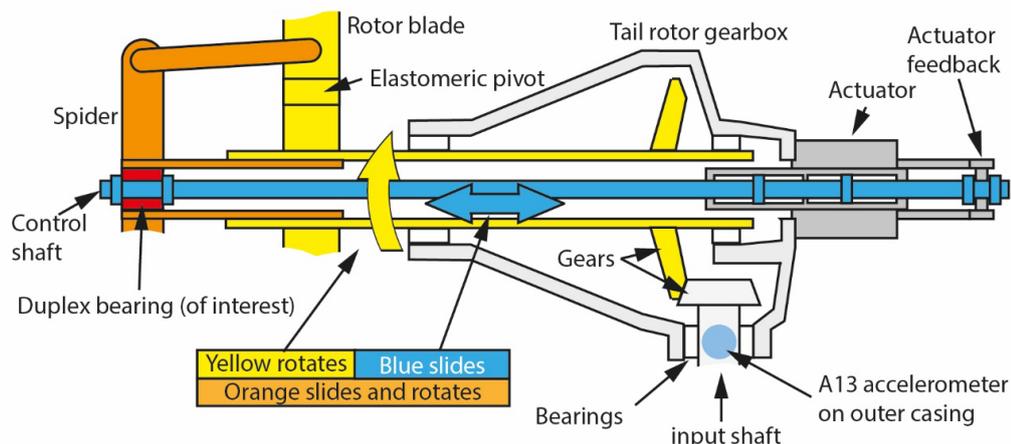
**Figure 18**

There is also a biaxial accelerometer on the tail rotor gear box for the purpose of monitoring the rotor track and balance. None of these were positioned to monitor for problems in the duplex bearing as there was no requirement to do so. The location of the accelerometer meant that vibrations generated by the duplex bearing were obscured by the vibration of other components between the bearing and accelerometer.

Simple schematic of the tail rotor gearbox showing the relative locations (viewed from forward looking aft) of the vibration sensing accelerometer and the failed critical duplex bearing. Not to scale.

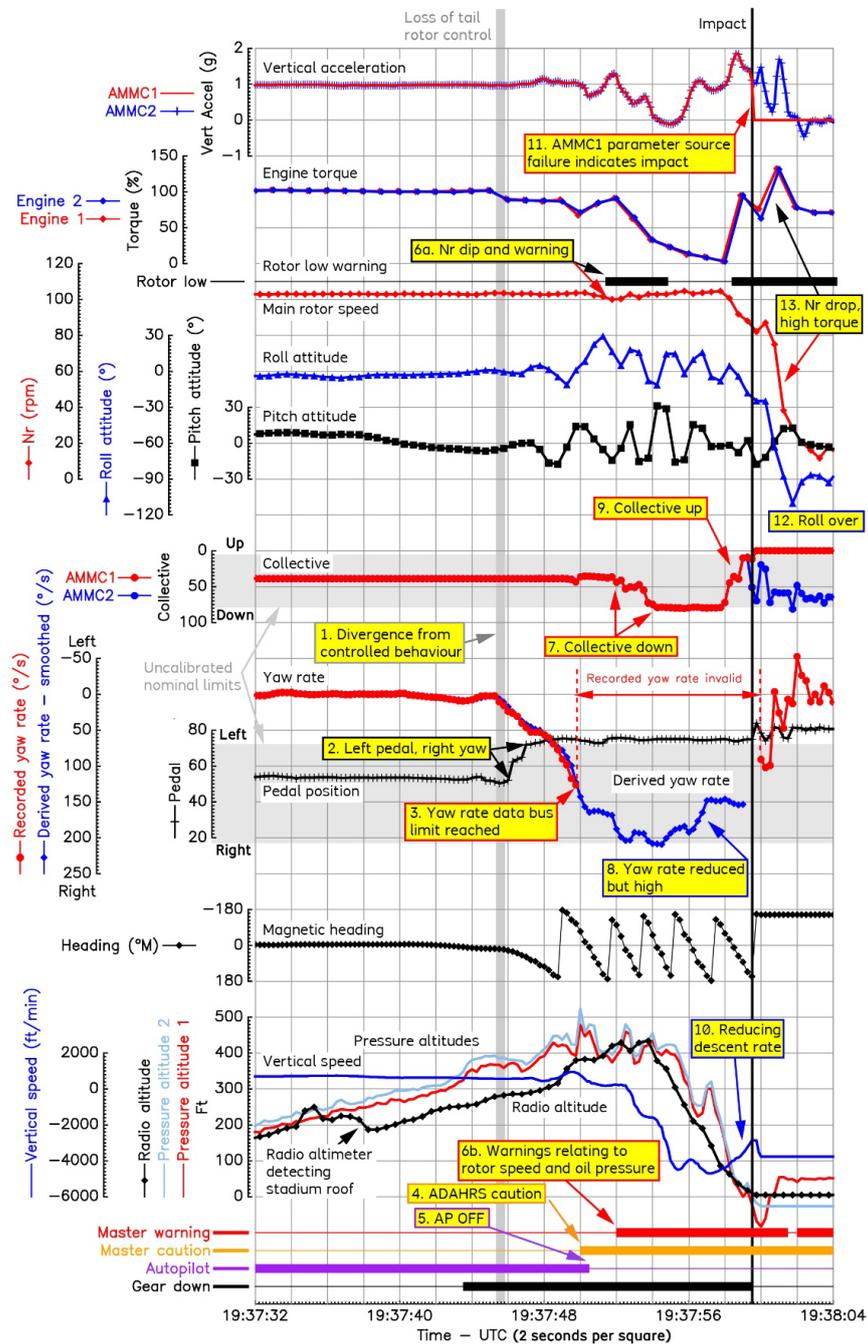
Figure 20

Pertinent extracts from the flight recorder

Passing approximately 300 ft, a heading change to the right was initiated and stopped followed by another heading change in the same direction (note 1 in Figure 20) which carried on accelerating despite opposite pedal being applied (note 2 in Figure 20).

After the yaw rate reached  $128^{\circ}/s$  (note 3 in Figure 20), the recorded yaw rate became invalid. ap ahrs 1 fail, ap ahrs 2 fail (note 4 in Figure 20) and 1-2 ap off (note 5 in Figure 20) cautions were recorded.

There was a small movement in the collective at the same time as the yaw rate became invalid, followed by a very slight increase. At this point the yaw rate was in excess of  $160^{\circ}/s$  and the rotor speed decayed to a recorded value of 99.75% after previously having been holding at approximately 103% (this equates to 348 rpm or nearly  $2,100^{\circ}/s$ ). A ROTOR LOW warning was triggered (notes 6a and 6b of Figure 20). The collective was partially lowered for approximately one second and then fully lowered (note 7 of Figure 20). The rotor speed recovered.

The radio altimeter height had peaked at about 430 ft agl. The yaw rate started to reduce and plateaued at about  $150^{\circ}/s$  (note 8 of Figure 20).

After the collective was lowered the helicopter started to descend. The descent rate increased and stabilised at approximately -4,000 ft/min until the collective was pulled up prior to impact (notes 9 and 10 of Figure 20). There was then an associated drop in rotor speed and engine output speed with increased engine torques.

However, loss of AMMC1 data is likely associated with the impact sequence, which occurred at approximately 1937:59 hrs (note 11, Figure 20).

After ground contact the helicopter rolled left (note 12, Figure 20) and pitched up, with a peak left roll of 110° and a nose-up attitude of 13° recorded two seconds after impact. It then rolled back to 83° of left roll and pitched to 6° nose-down in a similar time frame.

The quick roll over correlated with a recorded audio associated with the rotors striking the ground. The small reversion of pitch and roll ceased approximately as the sounds of the rotor strikes ceased. A sharp drop in rotor speed and increases in engine torque values were also recorded during this period (note 13, Figure 20).

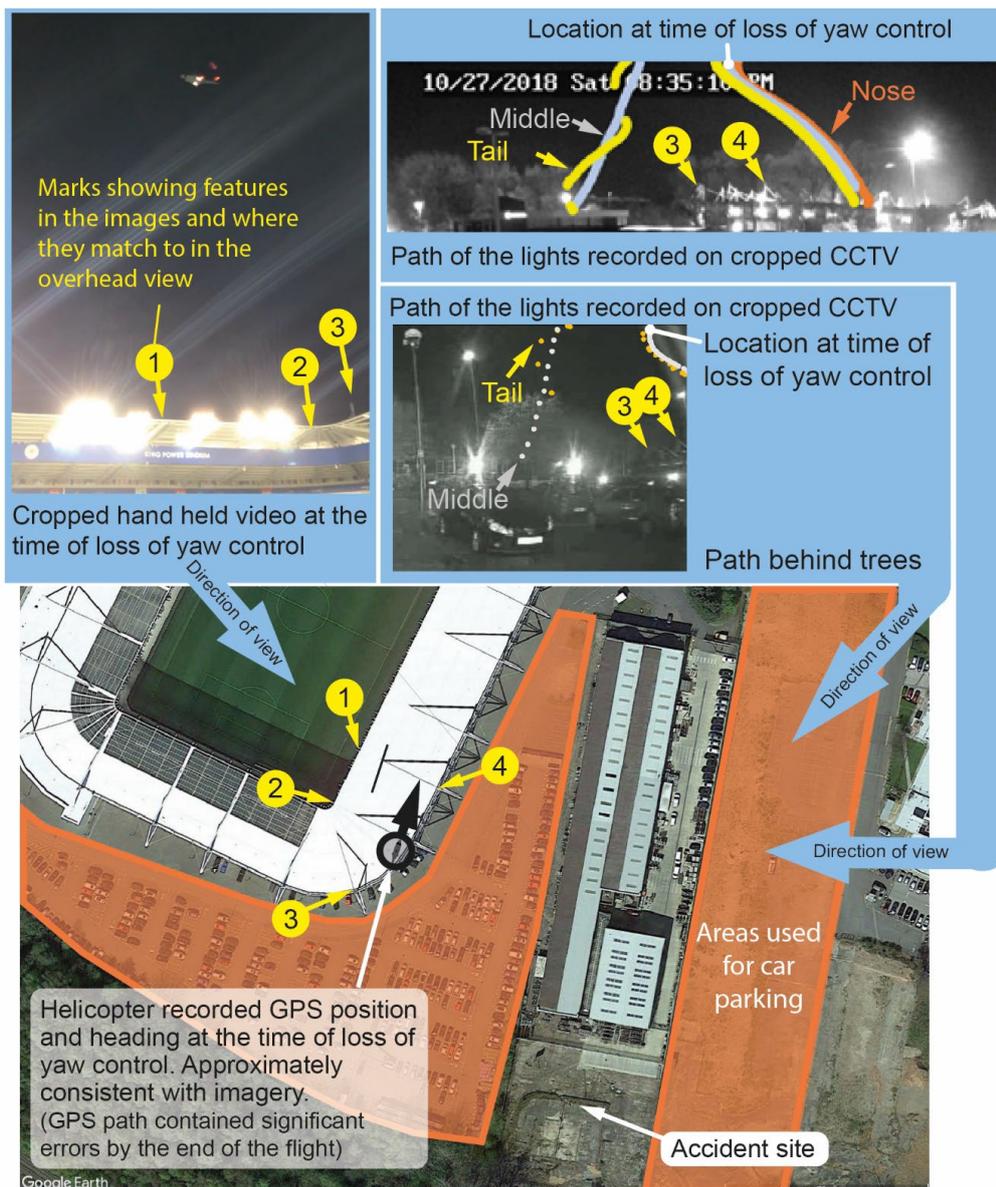
**Figure 21**

The recorded GPS position was highly inaccurate by the end of the flight. Analysis of the recorded imagery shows that at the onset of the loss of yaw control, the recorded GPS position was relatively accurate and the helicopter was above or close to being above the stadium roof as shown in Figure 21. The difference between the recorded radio height and barometric altitude also indicated that there was a structure underneath the helicopter when yaw control was lost.

Location at the point that yaw control was lost.  
 The original video and CCTV images are shown cropped  
 Map data © 2021 Google

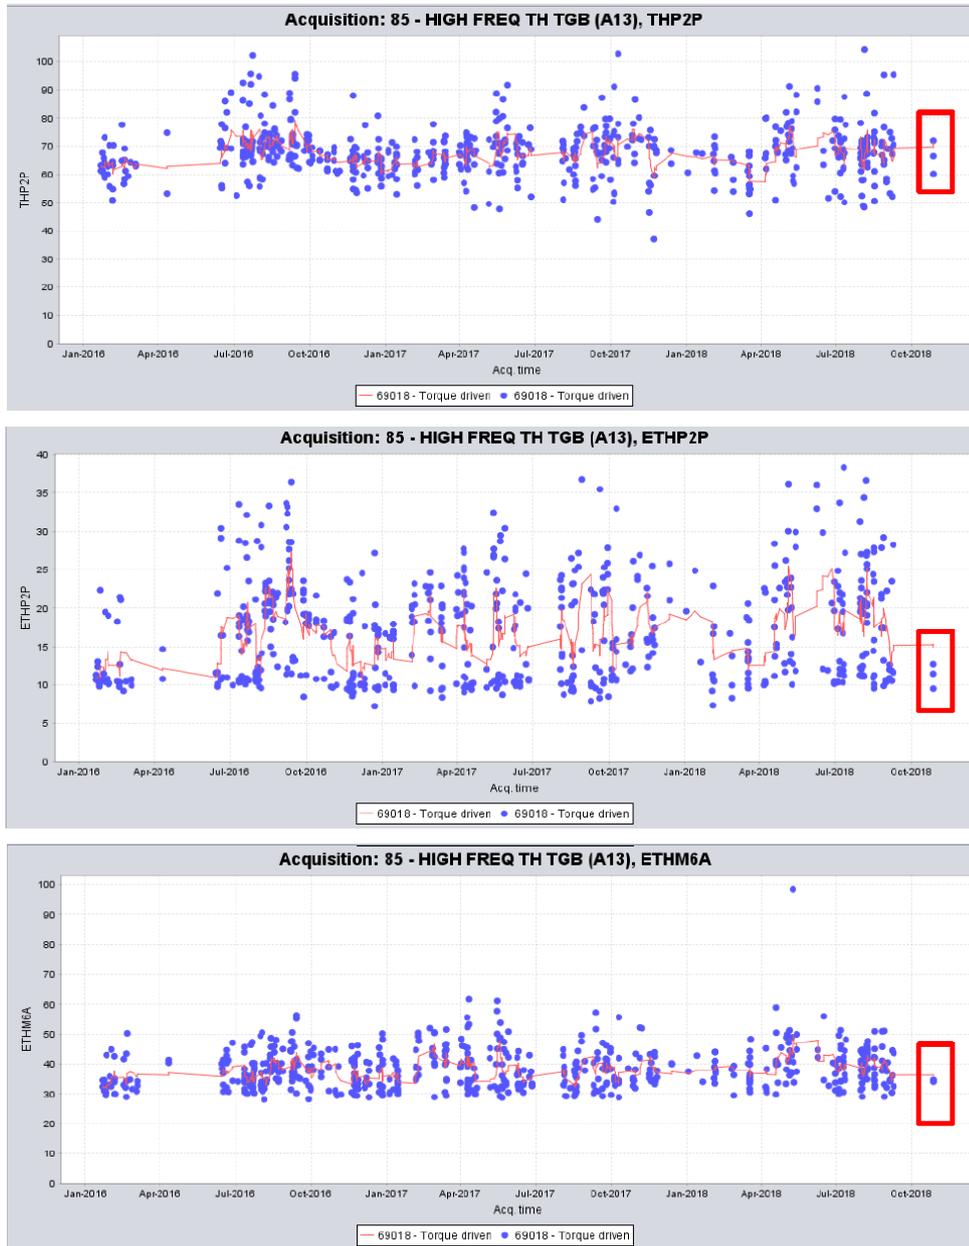
**Figure 24**

Example TGB Accelerometer A13 derived HI trends. The red box highlights the results from the accident flight

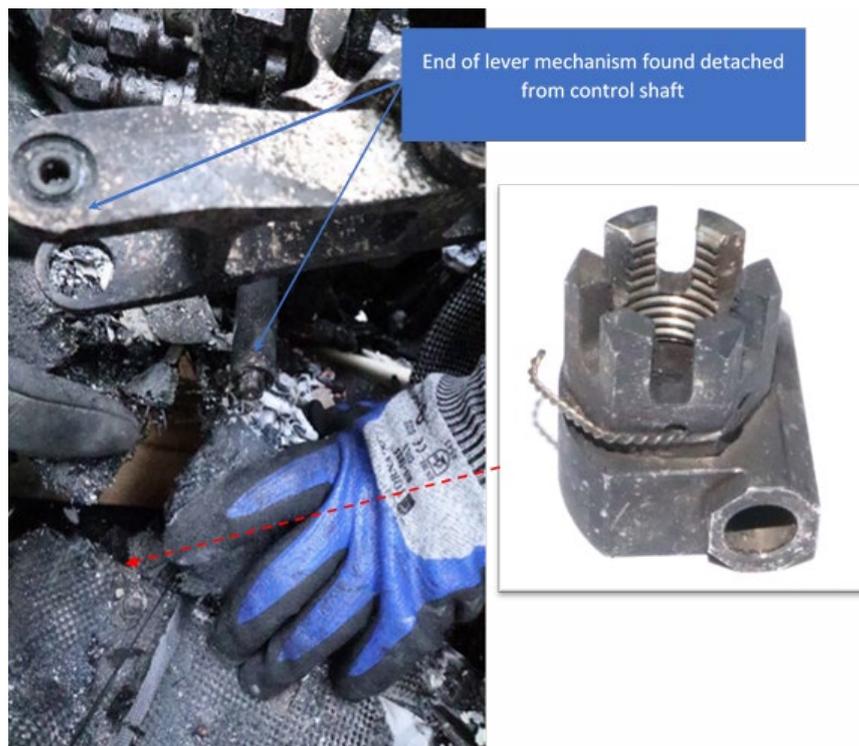
**Figure 25**

Initial evidence obtained from video footage of the accident, focussed attention on the tail rotor of the helicopter. The tail section of the helicopter where the tail rotor was located was less damaged by the fire than other sections of the helicopter. Onsite inspection of the tail rotor control mechanism identified that the servo actuator lever mechanism was no longer attached to the TRA control shaft. The castellated nut and pin carrier were found bonded to each other but detached from both the lever mechanism and the control shaft and lying in the remains of the vertical tail carbon fibre skin panel (Figure 25).

Disconnected lever mechanism, TRA control shaft and detached but fused nut and pin carrier

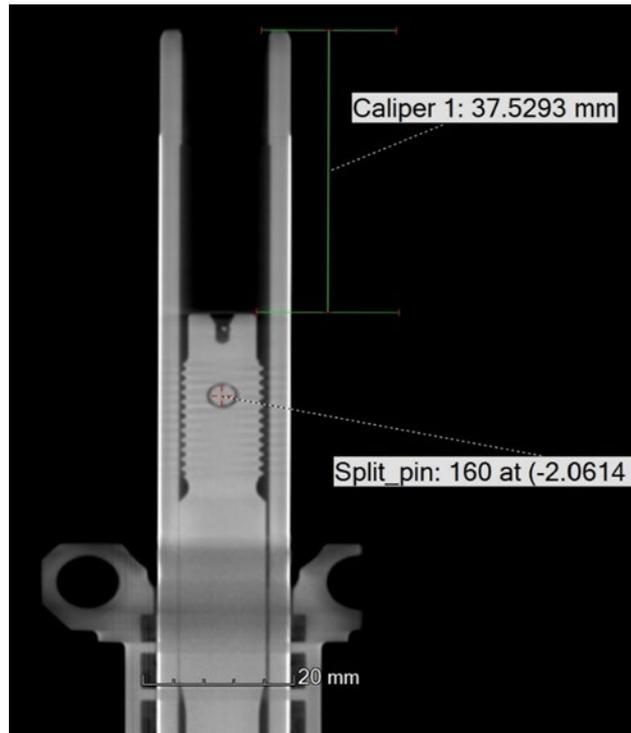
**Figure 27**

The shaft was imaged using the CT scanner, which confirmed the threaded portion of the control shaft was inside the outer shaft and contained the remains of the split pin. The top and bottom of the split pin had been sheared off in rotation (Figures 27 and 28).

CT scan of threaded section of control shaft and split pin

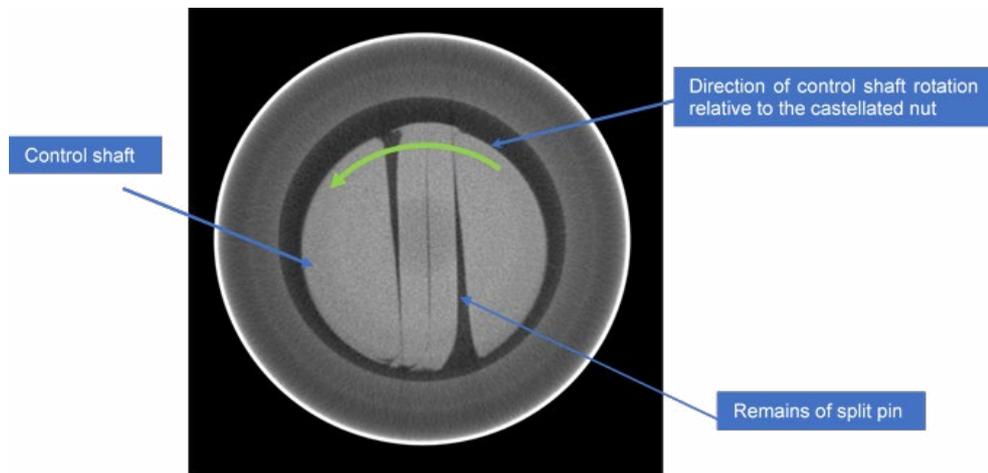
**Figure 28**

CT scan through tail rotor actuator control shaft (viewed from bearing end)

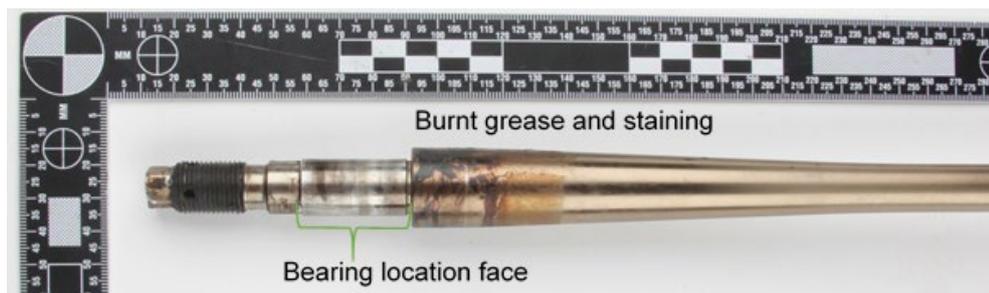
**Figure 29**

At the other end of the control shaft, the section adjacent to the duplex bearing face showed evidence of burnt-on grease and was discoloured along its length (Figure 29).

Duplex bearing location on tail rotor actuator control shaft after removal of the bearing

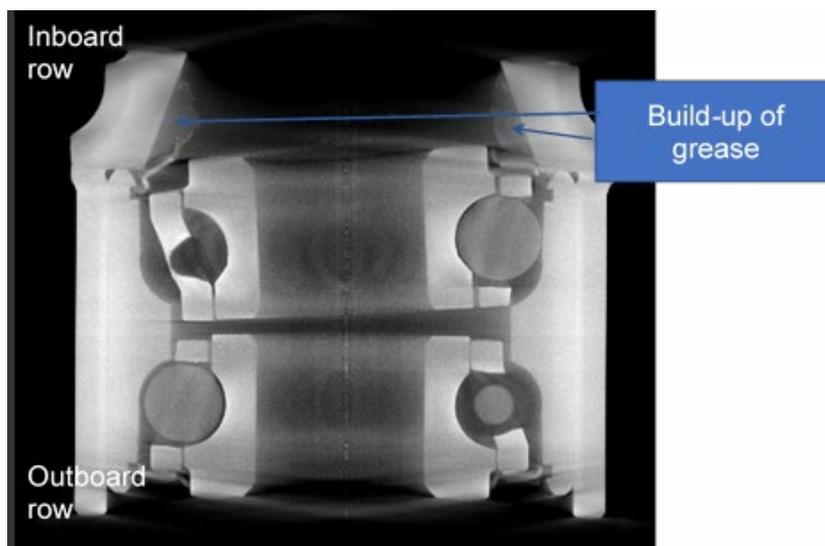
**Figure 30**

Following removal from the control shaft, the inner races of the bearing could only be rotated a few degrees in either direction by hand. There was also a small build-up of black grease inside the slider unit around the inboard face of the duplex bearing. The spider assembly was removed, and the slider/bearing assembly was CT scanned<sup>51</sup> (Figure 30).

CT scan of bearing/slider assembly

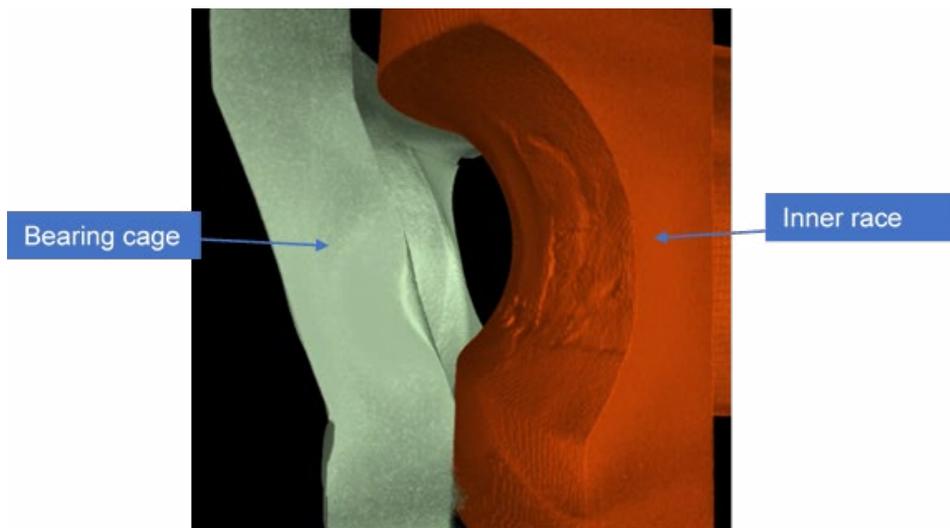
**Figure 31**

The scan of the bearing showed fractures to the bearing cages and significant damage to the surface of the inner bearing races, the damage being worse on the inboard inner bearing race (Figure 31) where there was evidence of sub-surface damage.

CT imagery of duplex bearing inboard inner ring surface damage

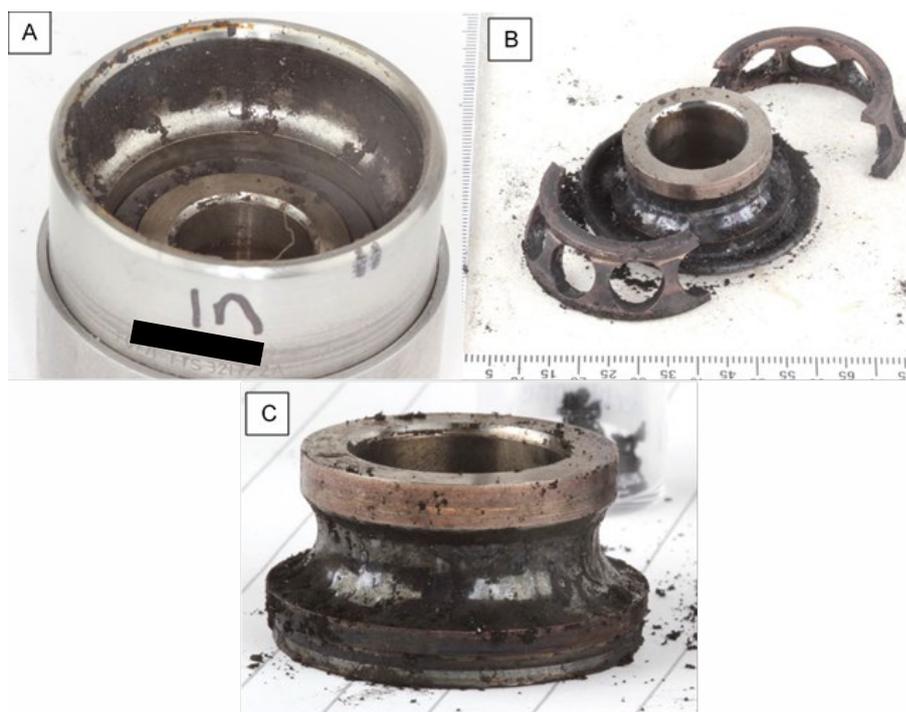
**Figure 33**

outer ring. The debris present on the CT scan was identified as a combination of black dust and metallic particles. No grease, in its original form, remained in the bearing but there was black dust in and around the bearing races and cage (Figure 33). The seal on the inboard side of the bearing exhibited wear marks on its inner surface from contact with the cage. Visual inspection of the surface of the bearing races confirmed the extent of the damage seen in the CT scans. The surface of each of the balls from both sides of the bearing was crazed and exhibited areas of matt white surface finish, but none of the balls were spalled.

(A) Inboard row, outer race (B) inboard row inner race and fractured cage  
(C) inboard row inner race

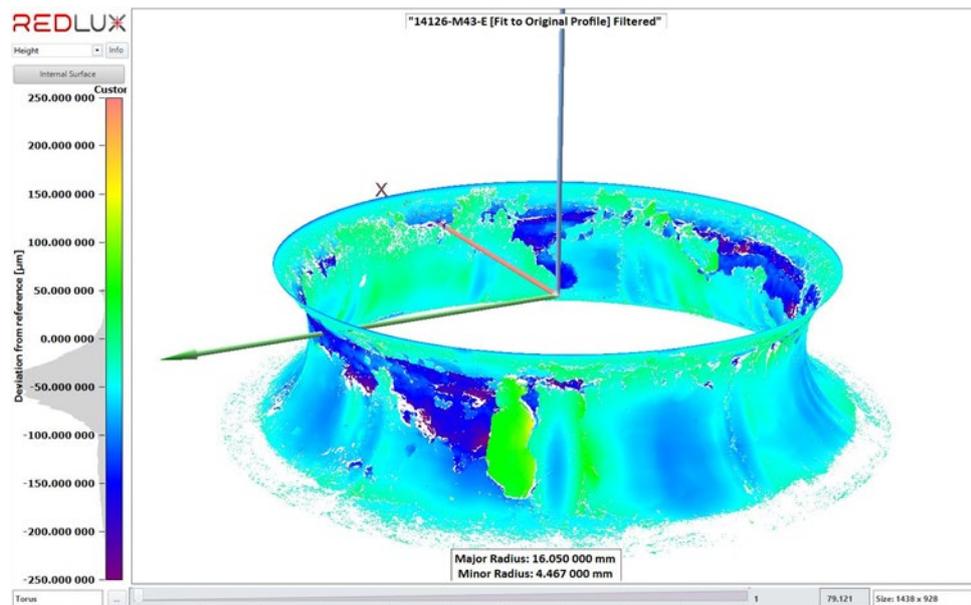
**Figure 34**

The duplex bearing was subjected to a sequence of detailed analysis techniques to document its condition. Initially the surface of the inner and outer races was scanned using a high resolution, non-contact, optical scanning technique to record the topography of the running surfaces (Figure 34). This was combined with higher resolution CT scans to identify the extent of the damage. The inner races were examined further using a Scanning Electron Microscope (SEM). This confirmed the presence of step-like features with striations, indicating that they were formed by a cyclic failure mechanism consistent with rolling contact fatigue.

Optical measurement of the rolling surface of the inner race showing heavy wear, with large pits (blue areas), but also areas raised higher than the original surface (green/yellow)

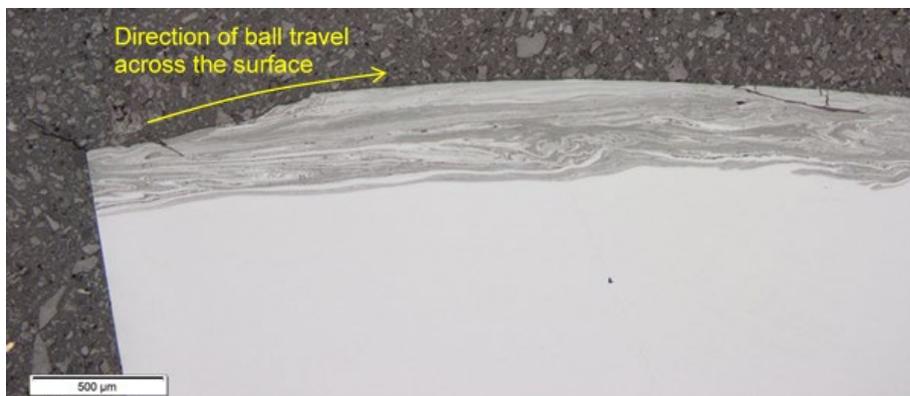
**Figure 37**

The sections were then polished and viewed under an optical microscope (Figure 37). On the inboard inner race this revealed that the surface in the centre of the race, down to a depth of approximately 0.5 mm, had a swirling, layered structure with extensive cracks in many locations (Figure 38). The surface of the polished sections were then etched using various reagents and again viewed under an optical microscope.

Optical microscopy view of circumferential slice from inboard inner race of bearing following polishing to show the layered surface

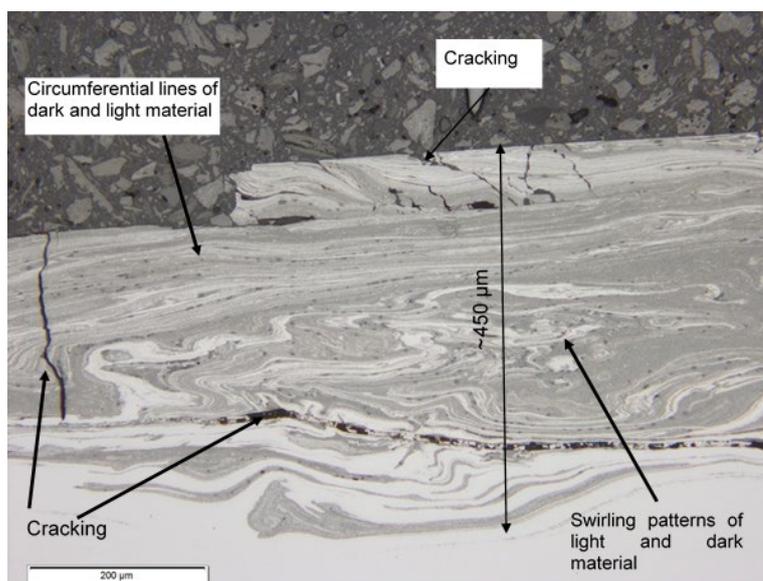
**Figure 38**

Magnified view of inboard inner race of bearing showing cracking of material

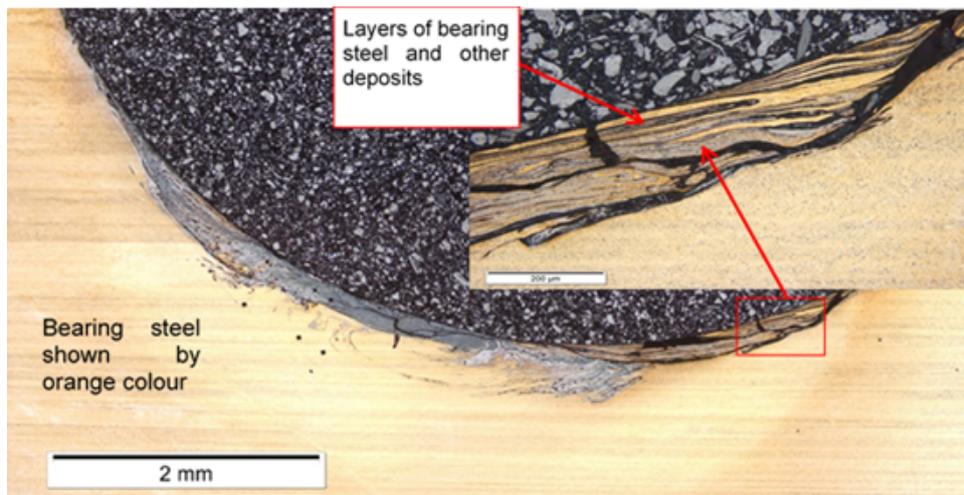
**Figure 39**

The outboard inner race showed evidence of a heat affected zone and a Dark Etched Region<sup>53</sup> (DER) below the surface. A combination of the reagents used and EDAX<sup>54</sup> analysis confirmed that the various layers on the inboard inner race were formed from different materials including carbon, steel and copper, which had been deposited and compressed (Figure 39).

Optical microscopy views of etched (Murakami’s reagent) radial slice from inboard, inner race showing mix of materials in the layer

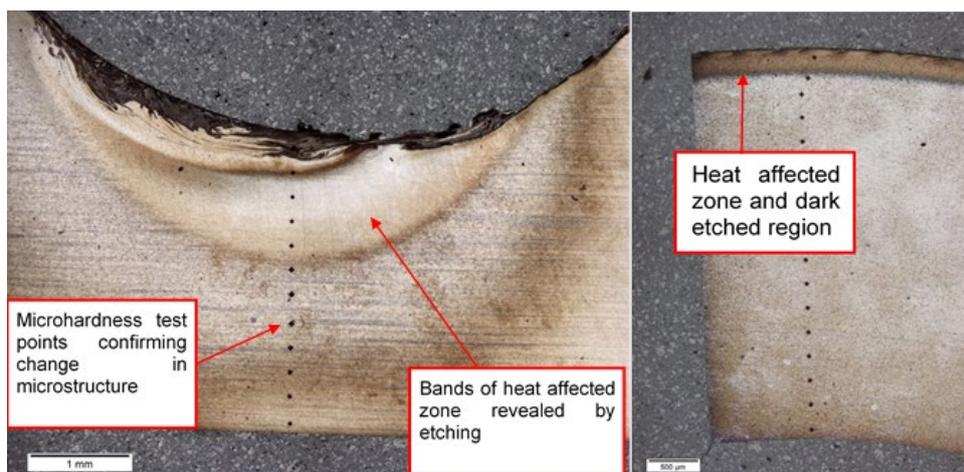
**Figure 40**

Below this layer of mixed material, was the original bearing steel material. However, use of etchant on the section surface identified a heat affected zone where the material microstructure had changed (Figure 40). Microhardness profiling was conducted both radially and circumferentially. The results confirmed that the steel had softened compared to a new bearing, but closest to the surface the material had rehardened. This suggested that the temperature at

the surface of the race had reached austenitising<sup>55</sup> temperatures of over 980°C, reducing to temperatures of 600°C at the lowest level of the heat affected zone which had only a tempering effect.

High magnification light microscopy views of etched (Vilella’s reagent) radial slice of inboard inner race (left) and circumferential slice of outboard inner race (right), showing heat affected zones, DER and microhardness testing points

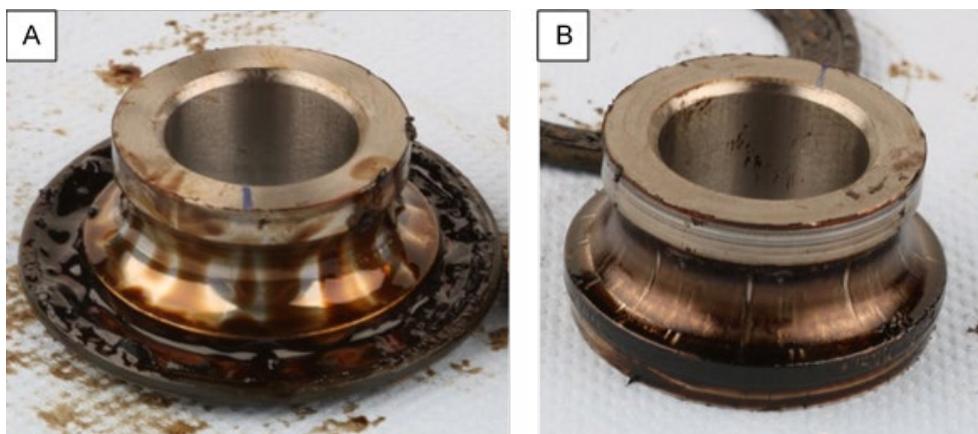
**Figure 45**

Once the bearing had been weighed and CT scanned, it was opened for detailed inspection. Visually there was evidence of degradation of the grease. The grease on the outboard inner race appeared brown but still moist, suggesting the presence of lubricating oil but no longer in the solid grease form. The inboard inner race was also brown but with a tacky rather than moist residue over the race surface (Figure 45). There was no evidence of any damage to the balls, but the cages showed evidence of wear in the ball 'pockets' and witness marks indicating a 'running line' around the circumference where the cage had been in contact with the inner race.

A) Outboard inner race of bearing showing evidence of moist lubricant residue. B) Inboard inner race showing tacky residue coating the race surface

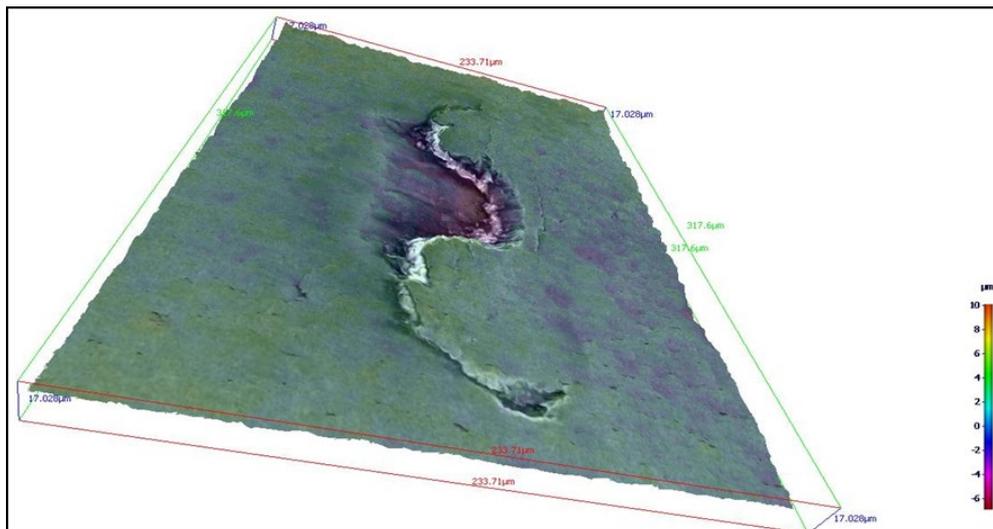
**Figure 48**

The inner races were inspected using an SEM, with the images then processed using MeX software to create height maps. The outboard inner race showed evidence of the original manufacturing grinding marks across the race surface, except for the running area band, where they had been worn smooth. The inboard inner race exhibited crack features, which displayed the same orientation and aspect ratio but varied in size (Figures 47 and 48).

MeX height map of crack feature 1 showing measurements and pitting

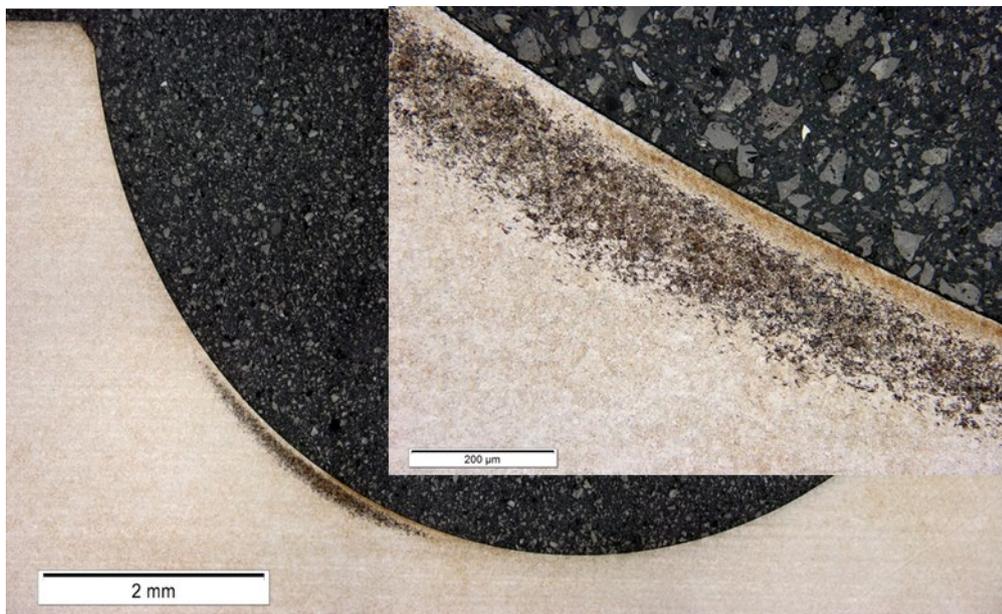
**Figure 50**

Etching of the sections from both the inboard and outboard inner rings confirmed a DER of microstructural change within a band from the surface to 0.2 mm down. (Figure 50). Nano hardness testing confirmed a reduction in hardness through this region. The area of microstructural change on the inboard race was deeper and more consistent than on the outboard race, but both showed

evidence of change consistent with the early stages of a surface origin, rolling contact fatigue mechanism.

Etched radial section from inboard inner race showing area of microstructural change (DER)

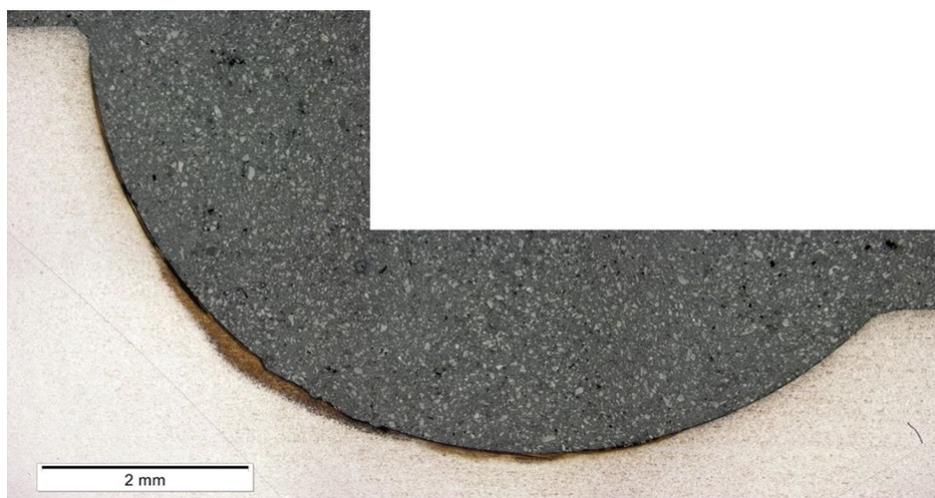
**Figure 53**

Macroscopic view of etched (Vilella) radial section from outboard inner race, showing change in microstructure (DER)

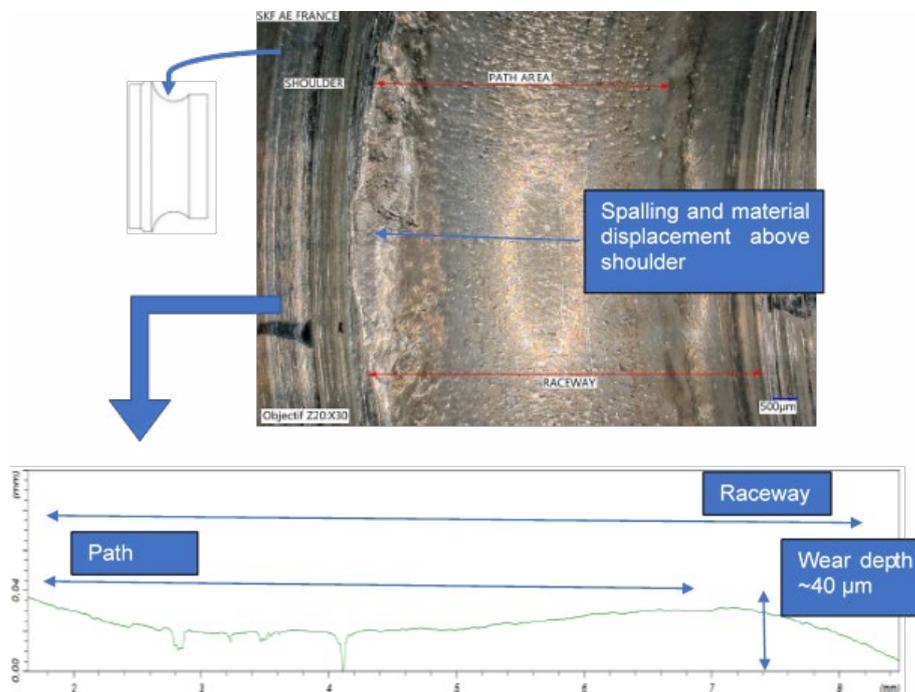
Figure 56

When the bearing was opened, it was found to have significant damage over the whole running surface of the bearing on the inboard row, inner and outer races (Figure 55). Material had been displaced from a wear path the same radius as the radius of the balls and pushed up above the shoulder of the race (Figure 56).

Inboard inner race showing wear path created by the balls and material displacement

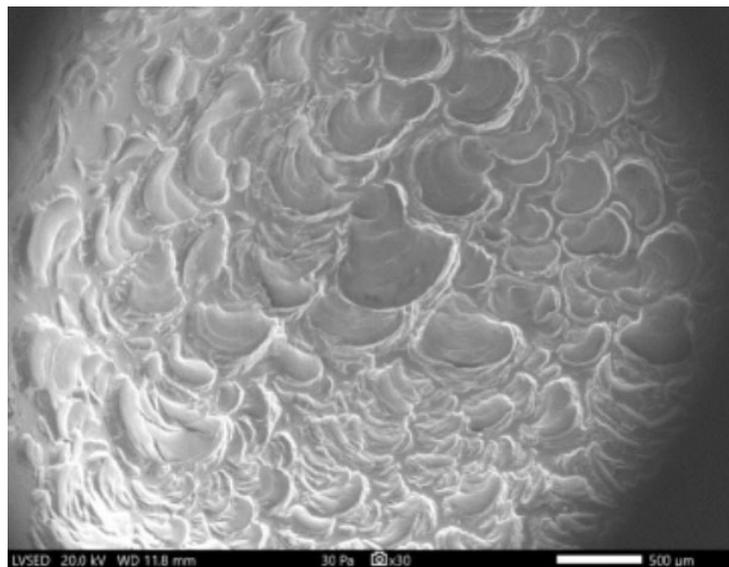
**Figure 57**

The inboard cage showed evidence of heavy wear predominantly to one of the cage pockets, where the wall was holed. One of the balls from the inboard row had heavy spalling, with wear scarring to the neighbouring ball as well, potentially caused by contact between the balls through the pocket wall.

The ball had spalled over 50% of its surface area. The bearing manufacturer's report stated that although the estimated initiation point of the spalling was identified, the cause could not be determined (Figure 57). The helicopter manufacturer's laboratory investigation report stated that a 3D particle was identified embedded in the spalled area of the ball. EDAX analysis of the particle suggested it was iron oxide, which the report identified was used as an additive during the sintering<sup>58</sup> and/or hipping<sup>59</sup> process. The bearing manufacturer refuted this, stating that iron oxide is not used in either of these processes and that the material was likely adhered debris rather than an inclusion. The helicopter manufacturer's report stated the particle was 'embedded' with ball material partially covering it. They considered it likely that this particle was originally below the surface of the ball material.

Magnified view of the spalling on the surface of the ball

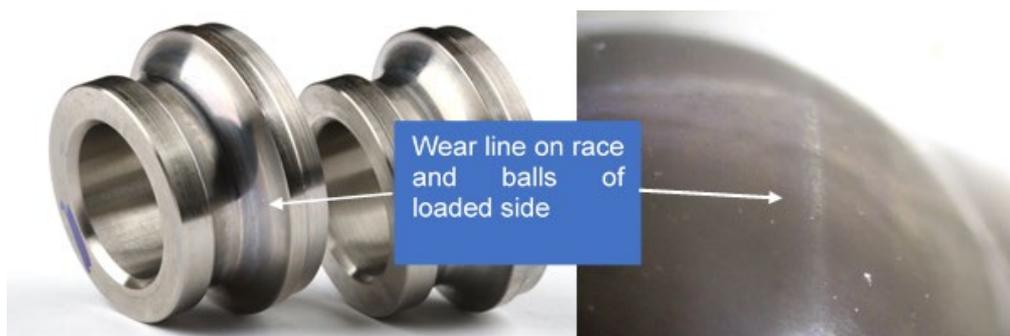
**Figure 66**

The races of the loaded side of the bearing showed evidence of a wear line created by the balls, but no evidence of fatigue damage. The balls also exhibited a 'run' line, which was off centre, but no spalling (Figure 66). The cages had witness marks in the pockets, which were more pronounced on the loaded side of the bearing, but no significant damage.

Wear on inner race and balls of the loaded side of the test bearing

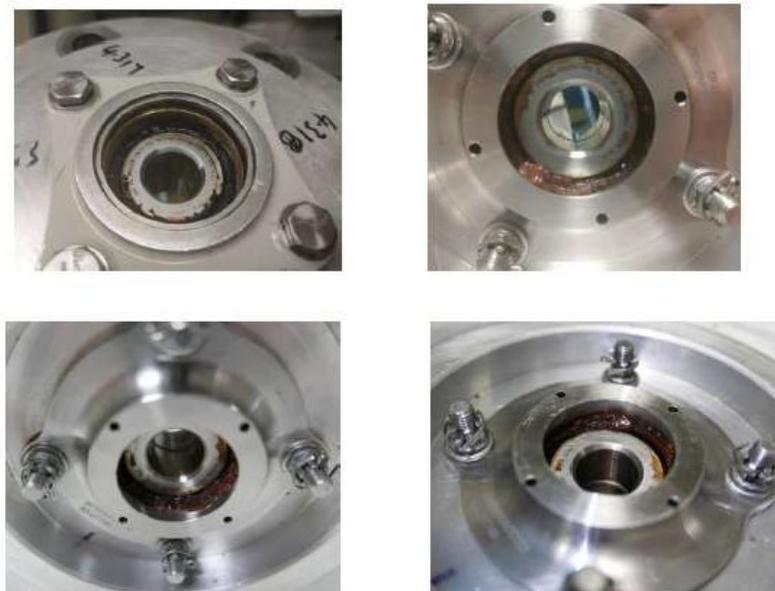
**Figure 71**

The inspection conducted at the first stop indicated that a 'collar' of grease extruded from the bearing had built up around the inboard bearing face where the seal had been removed (Figure 71). The volume of grease remained the same throughout the test.

Grease extruded from the bearing during the first 290 hours of testing.  
(original image courtesy of the manufacturer)

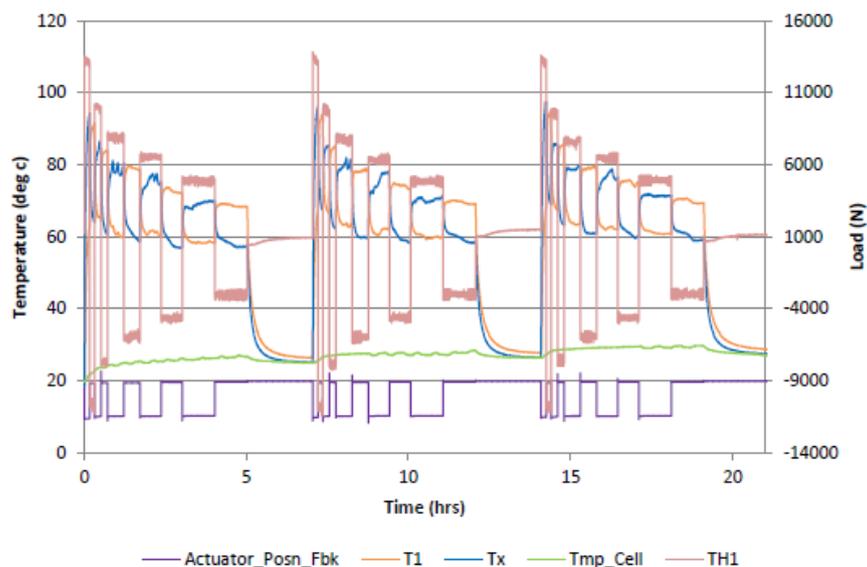
**Figure 72**

Graph showing temperature increase with load application during three blocks of the rig test (original image courtesy of the manufacturer)

Plotting the load and temperature sensor readings showed that the temperature on each side of the bearing increased proportionately to the load magnitude and direction applied. Figure 72 shows the two temperature sensors T1 and Tx and the load being applied TH1.

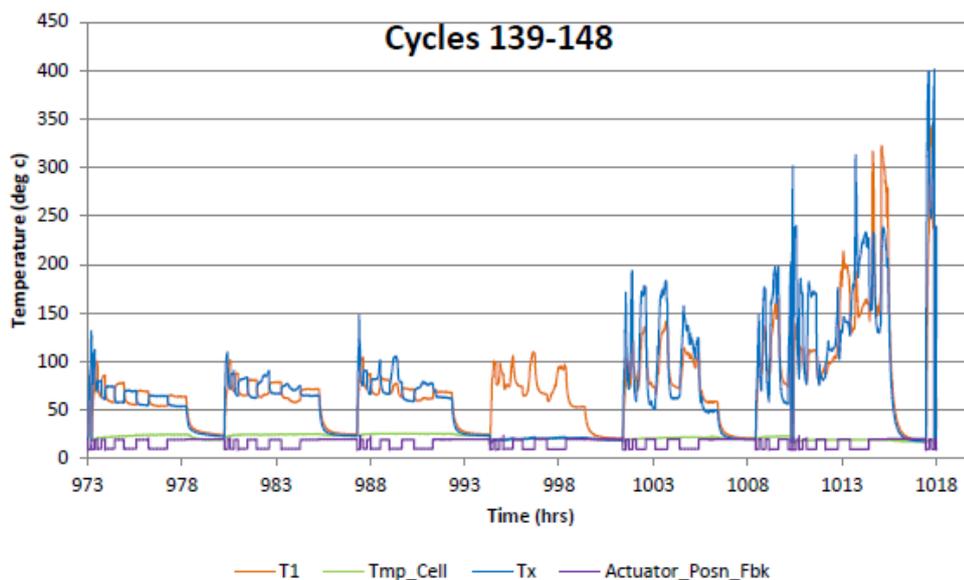
**Figure 73**

Towards the end of the test the temperature increase seen each time the load was applied began to increase significantly more than seen at the start of the test, until the torque alarm was triggered, and the test was stopped (Figure 73).

Graph showing rise in temperature increase with load application at the end of the test (original image courtesy of the manufacturer)

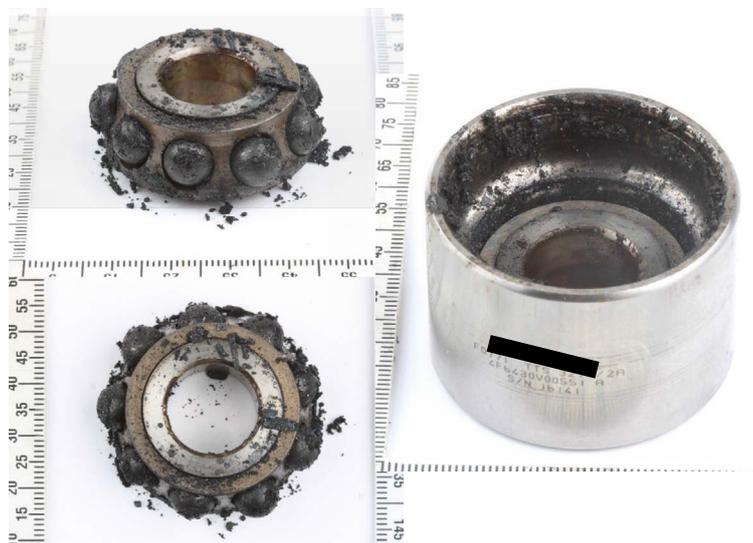
**Figure 75**

The inboard side of the bearing, which had operated with the seal removed, was disassembled and inspected. The grease had degraded to the extent that it was black, dry and powdery but it was still present (Figure 75).

Condition of the inboard side of the bearing which was operated with the seal removed

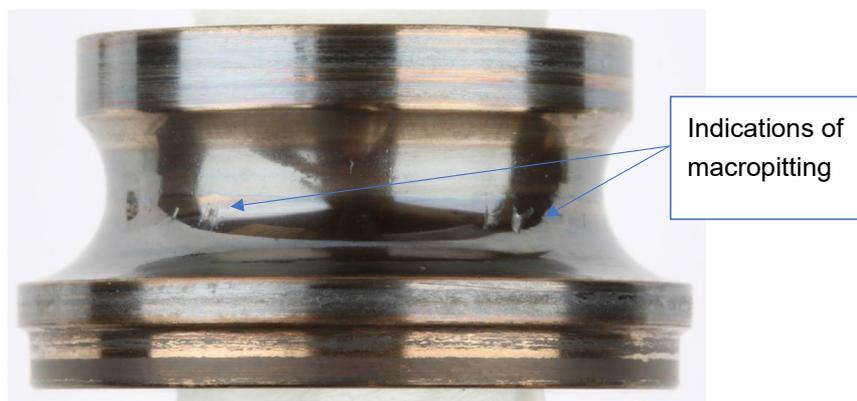
**Figure 76**

The inner race of the inboard side showed discrete areas of macropitting and high temperature induced permanent change in colour (Figure 76).

Inboard inner race showing discrete areas of macropitting and permanent colour change

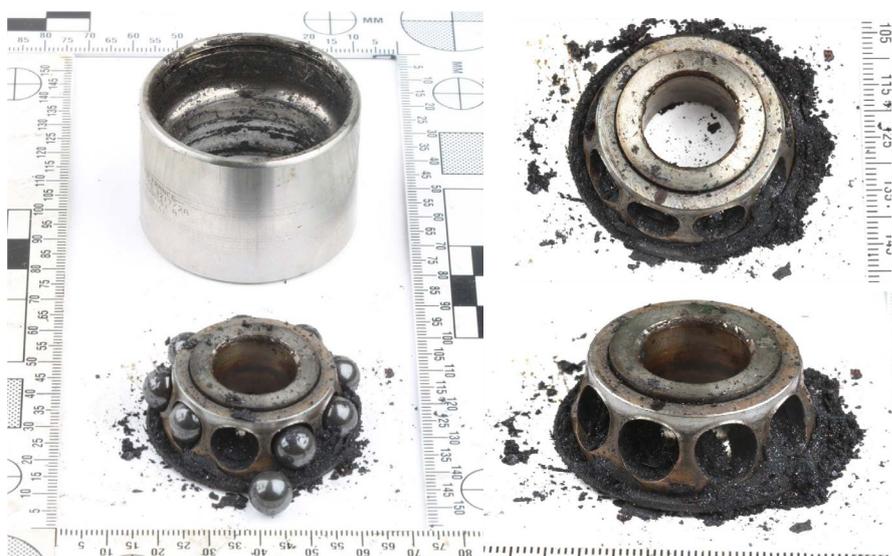
**Figure 77**

The grease on the outboard side was in a similar condition to that of the inboard side (Figure 77).

Condition of the outboard side of the bearing operated with the seal in place

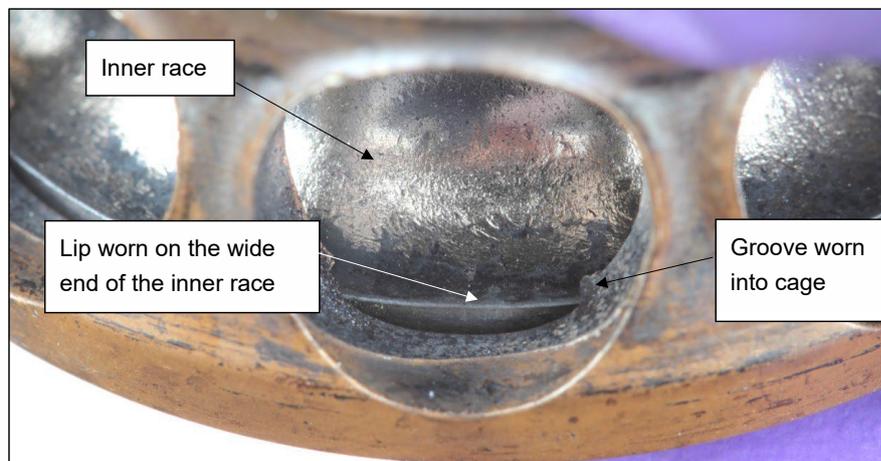
**Figure 78**

The cage could be rotated independently but not separated from the inner race due to the groove and lip worn into the cage and race (Figure 78).

Image showing the groove and lip worn into the cage and inner race of the outboard side of the bearing and the damage to the race running surface (post-cleaning)

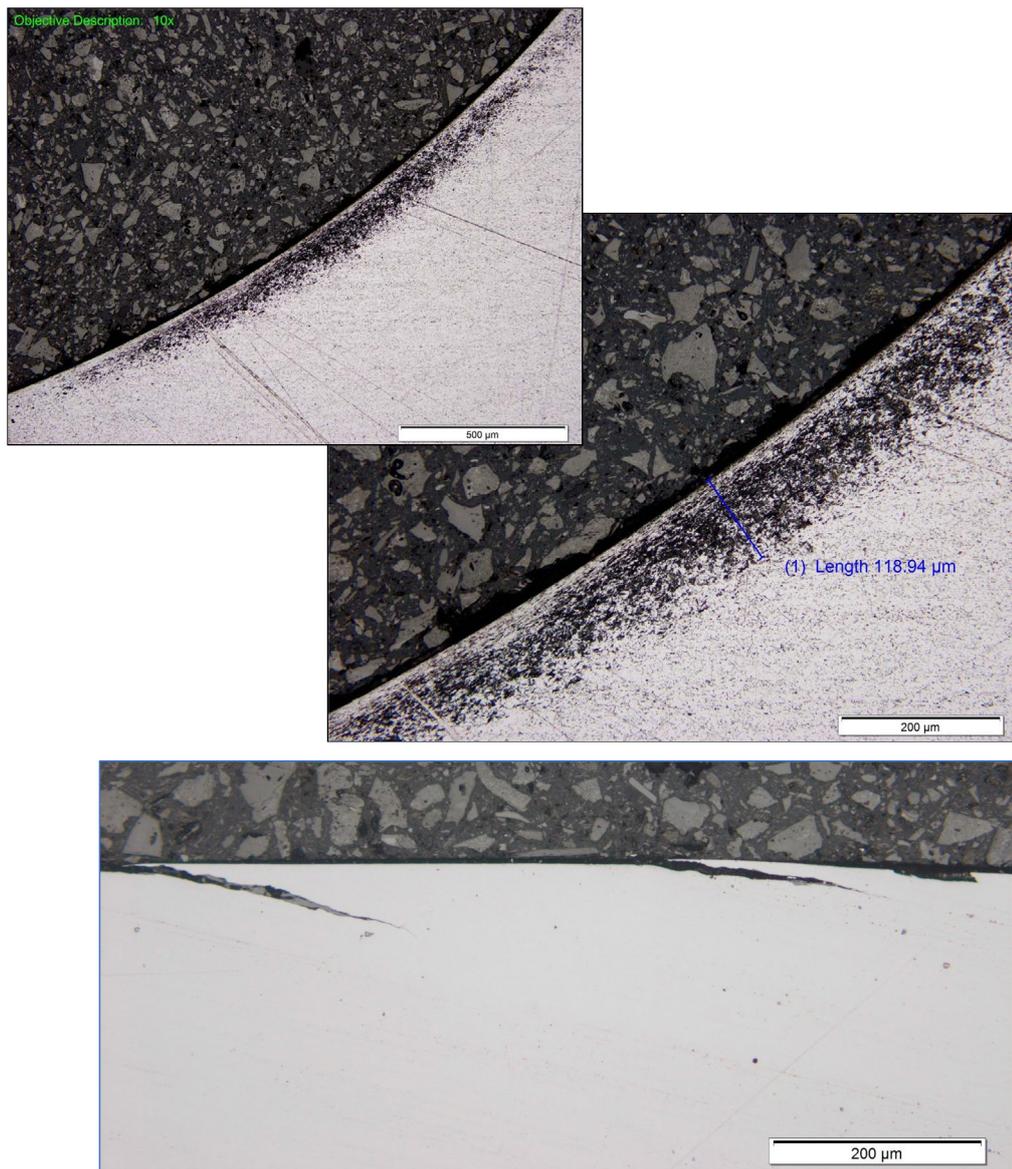
**Figure 79**

The inner races from both sides of the bearing were also sectioned and inspected using an SEM. The inboard side (no seal) showed discrete micro and macropitting consistent with surface initiated RCF. The cross sections were etched and polished to show a DER was present below the surface of the race (Figure 79), with compression and deformation of the microstructure immediately below the surface. Shallow angle surface initiated cracks were also present.

DER layer identified on the radial section and surface cracks shown on circumferential section of the inner race, inboard side
