# AIRCRAFT ACCIDENT REPORT 1/2023

Report on the accident to  
**Leonardo AW169, G-VSKP**  
at King Power Stadium, Leicester  
on 27 October 2018

Report on the accident to  
Leonardo AW169, registration G-VSKP  
at King Power Stadium, Leicester  
on 27 October 2018

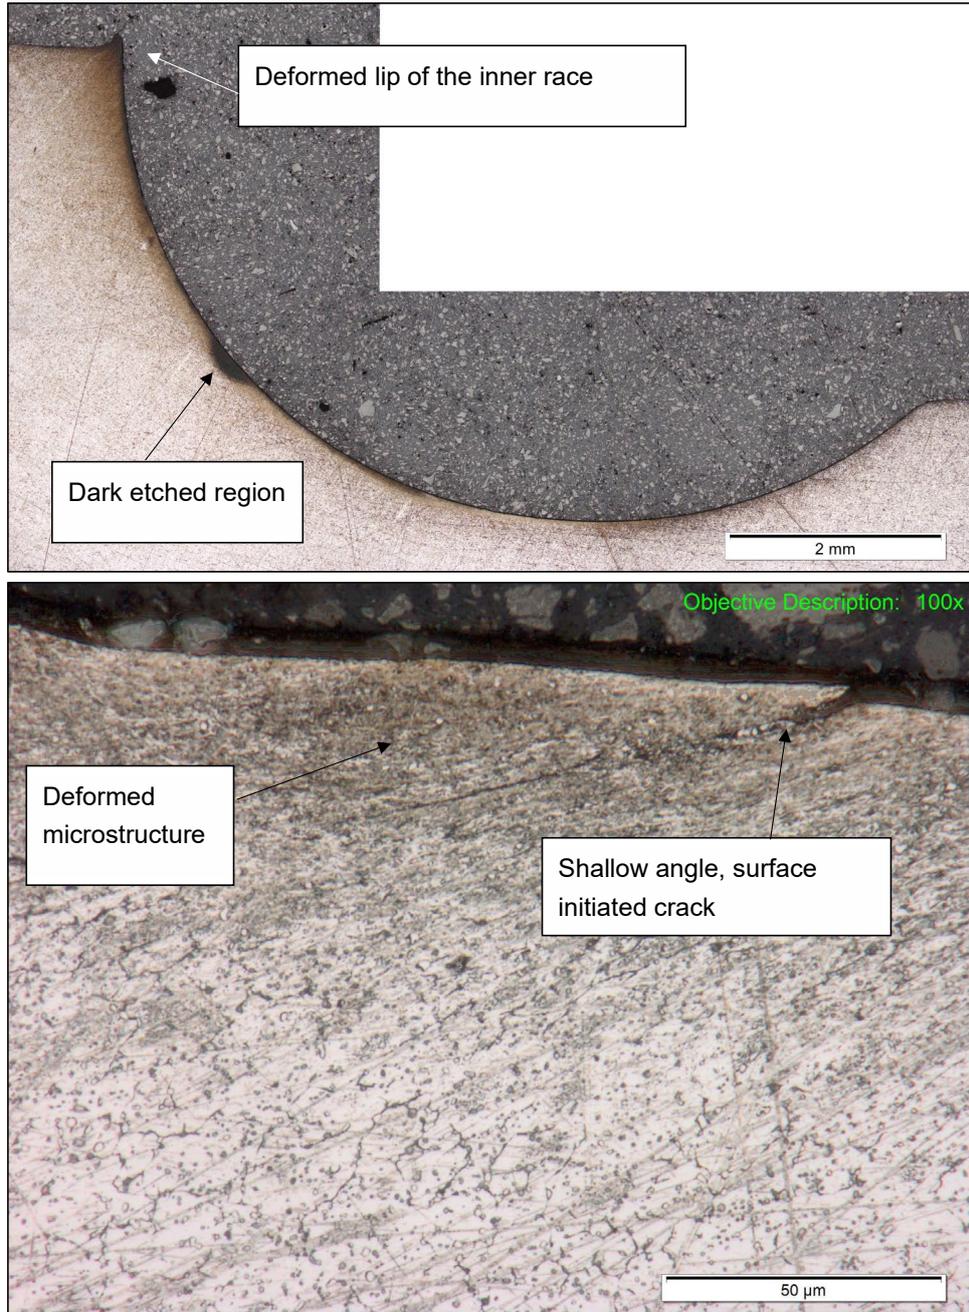
**Figure 79**

The inner races from both sides of the bearing were also sectioned and inspected using an SEM. The inboard side (no seal) showed discrete micro and macropitting consistent with surface initiated RCF. The cross sections were etched and polished to show a DER was present below the surface of the race (Figure 79), with compression and deformation of the microstructure immediately below the surface. Shallow angle surface initiated cracks were also present.

DER layer identified on the radial section and surface cracks shown on circumferential section of the inner race, inboard side

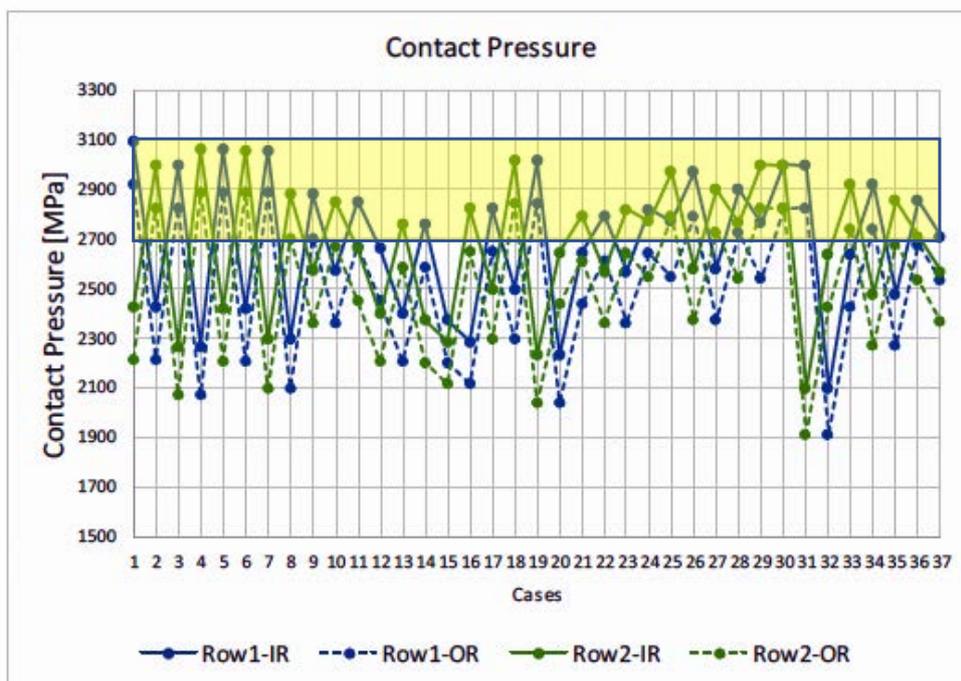
**Figure 81**  
Significant flight test points calculated contact pressures

Reassessment of the contact pressure using the current, more accurate, simulation software gave a revised contact pressure of 3,100 MPa and  $PV_{max}$  of 400 for this load case<sup>69</sup> (the top line of each yellow highlighted box), showing it to be comparable to the highest contact pressures identified in the flight test results, which were achieved with much lower axial loads around 7,000N to 8,000N as shown in Figure 81 and [Appendix E](#).

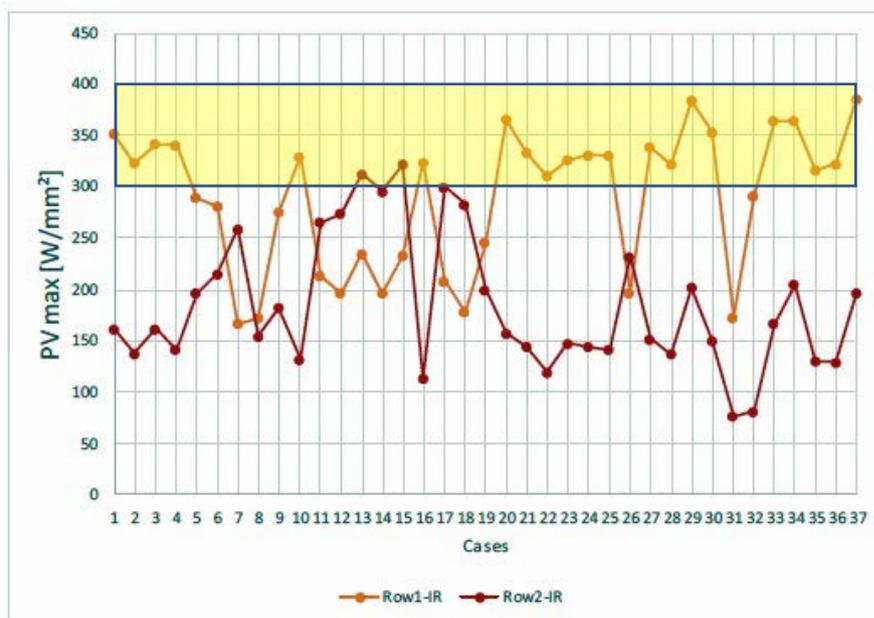
**Figure 82**

Significant flight test points calculated  $PV_{max}$

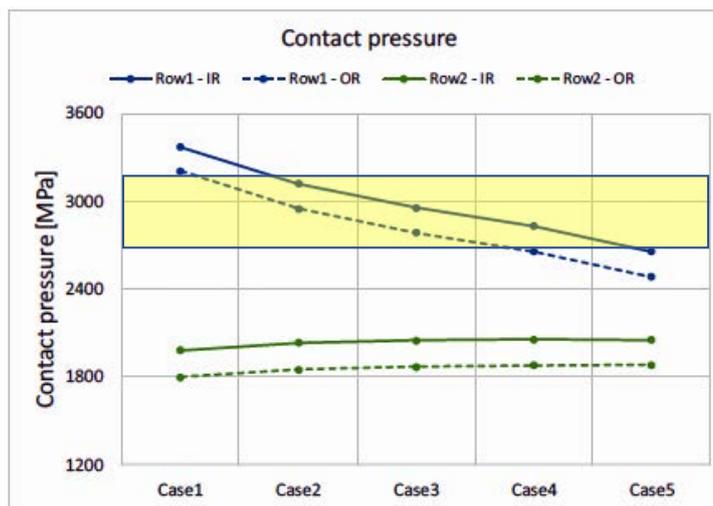
**Figure 83**

Rig test calculated contact pressures

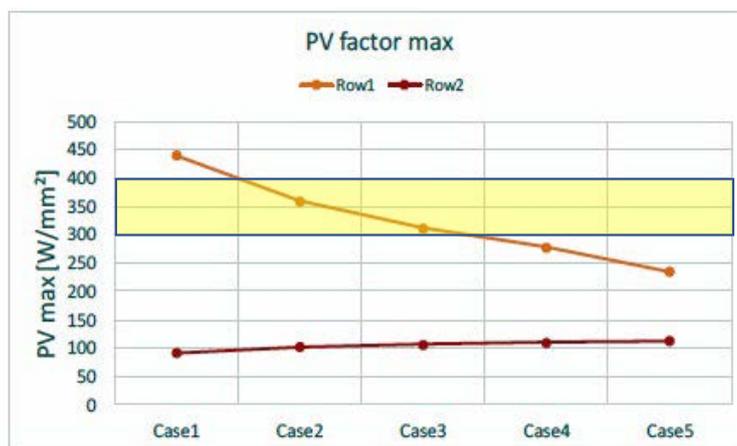
**Figure 84**

Rig test calculated PV<sub>max</sub>

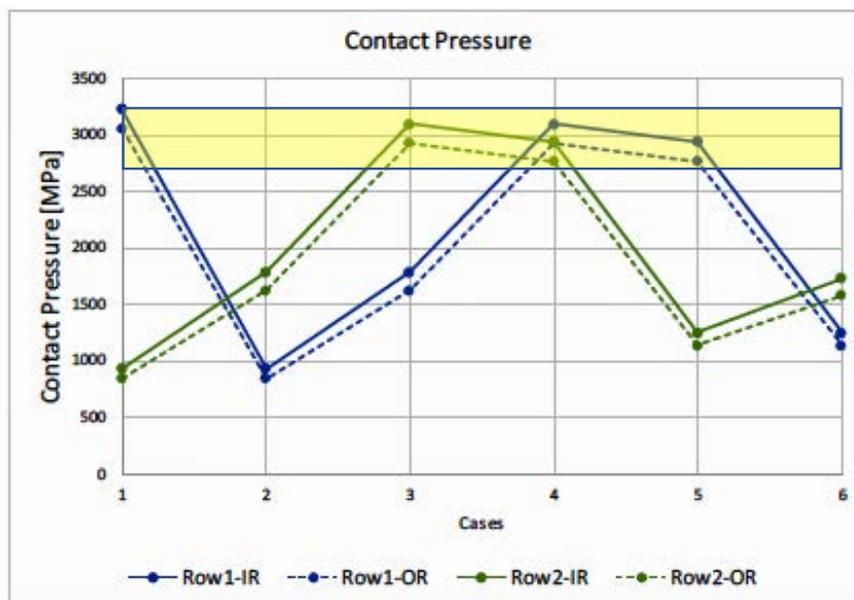
**Figure 85**

Rig test actual contact pressure (averaged data)

None of the contact pressures generated by the actual test load conditions were in excess of the contact pressures considered by the original development load spectrum, as calculated by the standard of bearing modelling software available at that time. However, the highest actual test point contact pressure was higher than the highest contact pressure in the development spectrum after it was reassessed with the latest standard of bearing modelling software now available.

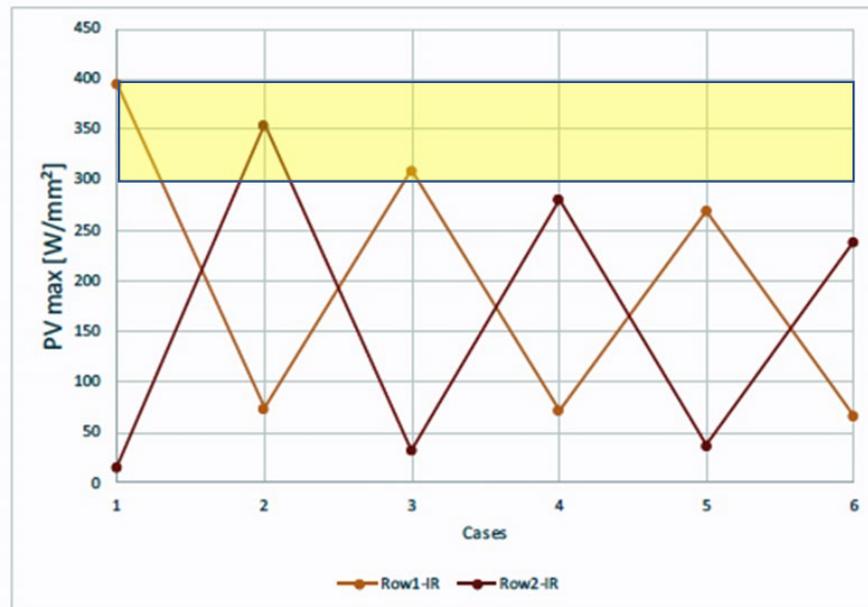
**Figure 86**

Rig test actual  $PV_{max}$  (averaged data)

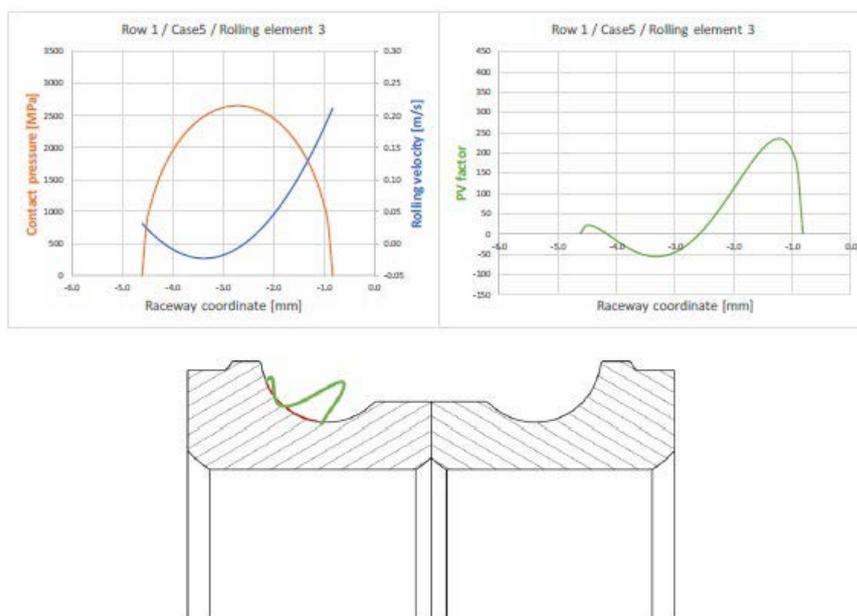
**Figure 87**

The graphs and illustration of the inner race profile in Figure 87 show how contact pressure and PV vary across the race profile and where the peak values occur ( $PV_{max}$ ). The location of these peak values correlates closely with where the first evidence of surface initiated rolling contact fatigue appeared on the inner races of bearing s/n 16141 used in the rig test, shown in Figures 76, 79 and 80<sup>71</sup>. And the inner races of bearing s/n 14134 which was removed from service, shown in Figures 46 and 50<sup>72</sup>.

PV distribution relative to the inner race curvature

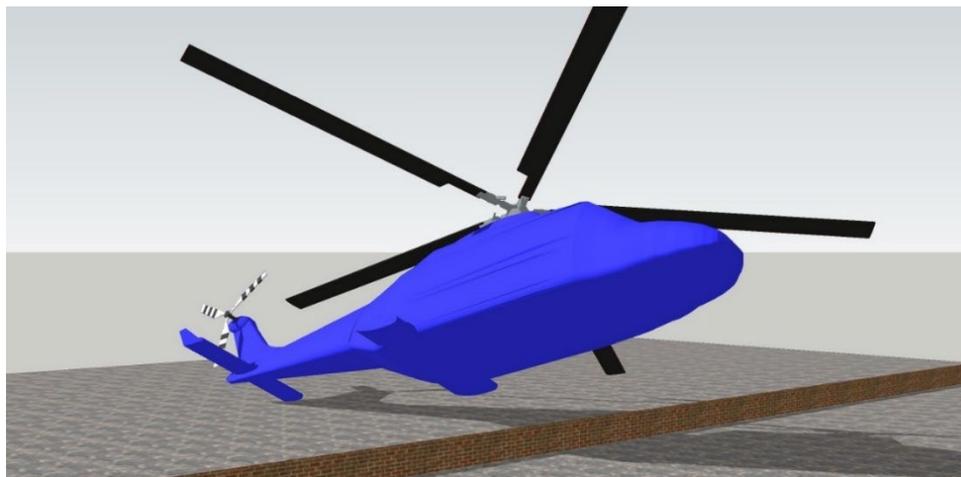
**Figure 88**

In reality the impact sequence was highly dynamic, but in order to estimate the deceleration loads, based on an analysis of recorded data, the assessment determined that the helicopter initially struck the ground with  $19.77^\circ$  of nose up pitch and  $29.88^\circ$  of left roll (Figure 88).

Illustration of initial impact attitude

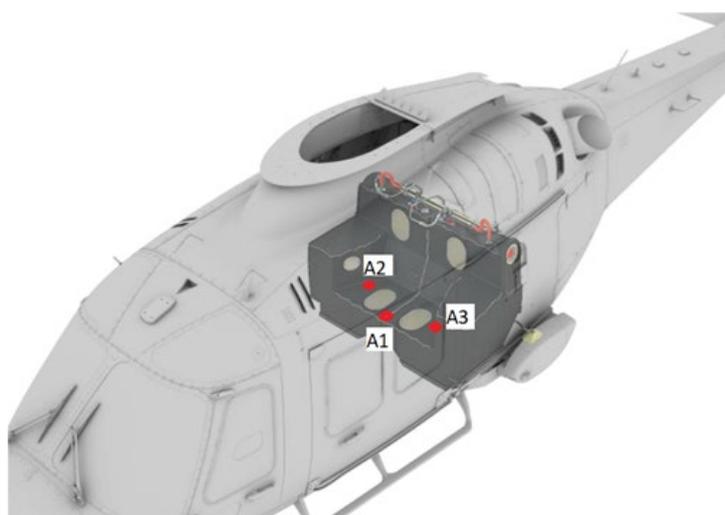
**Figure 89**

The deceleration loads were then calculated at three points, A1, A2 and A3 (Figure 89).

Impact load calculation positions  
(original image courtesy of the manufacturer)

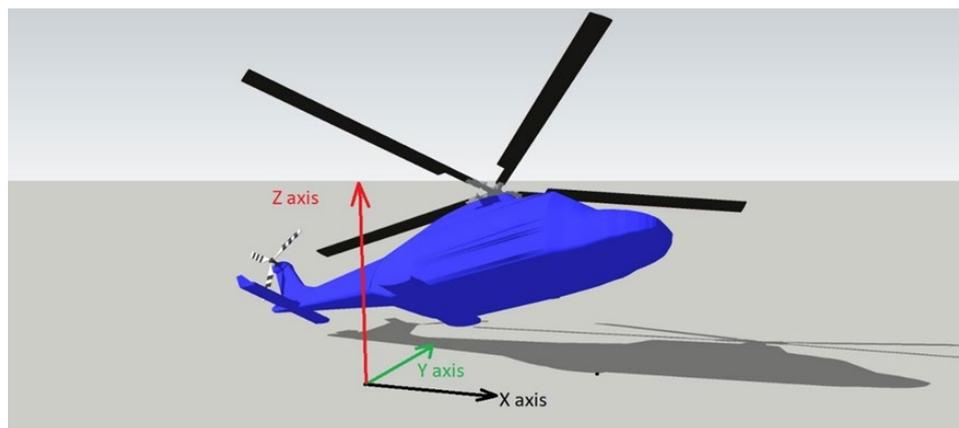
**Figure 90**

The maximum and minimum accelerations in the vertical (Z), lateral (Y) and horizontal (X) axes and the time they occurred after the initial impact were calculated (Figure 90 and Table 9). These indicated that G-VSKP had probably been subjected to loads which exceeded its design limits. The helicopter's attitude and the highly dynamic nature of the impact and subsequent loads meant that it was not possible to determine the absolute margin by which the design limits were exceeded.

Axis convention used for impact assessment calculation

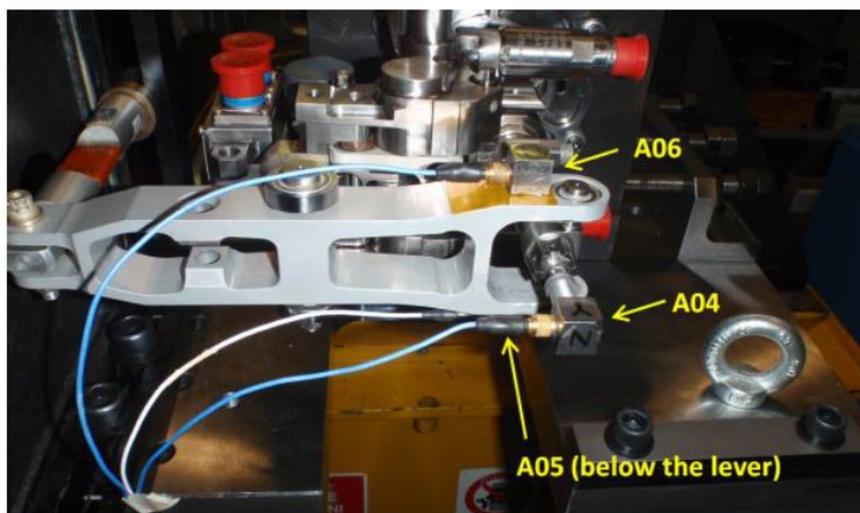
**Figure 93**

Figure 93 shows some of the accelerometer locations evaluated on a test rig. The rig was run with a normal bearing, a bearing with no grease and a damaged bearing. The signals acquired at sensors located at both ends of the rod were similar. Signals acquired on the lever, shown as A05 and A06 (Figure 93), retained a similar vibration pattern.

Sensor location testing.

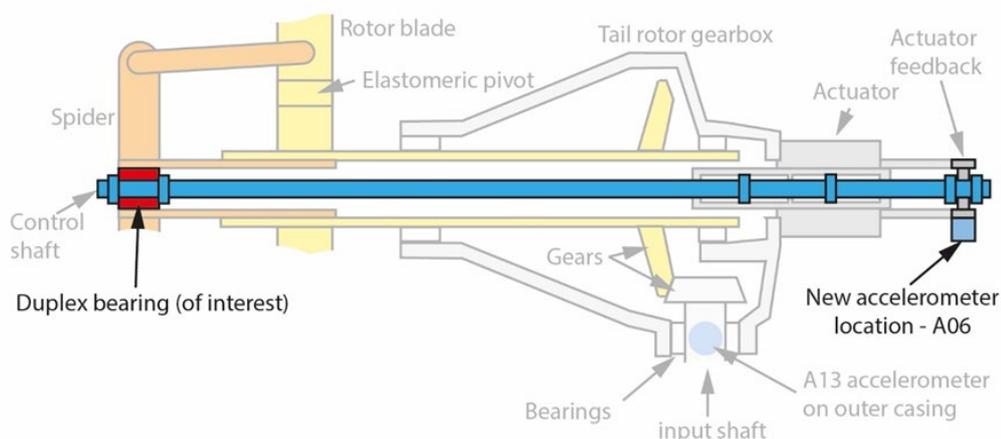
**Figure 94**

Simple schematic of the new accelerometer location relative to the duplex bearing of interest

The Health Indicator algorithms were applied to the gathered data. The most reactive to the degradation were linked to low frequency energy, though others also detected issues. It was decided that all their standard bearing Health Indicators would be used on the helicopter, coupled to a new sensor on the lever in the A06 location (Figure 94). Field experience would determine which are the most effective Health Indicators in practice.

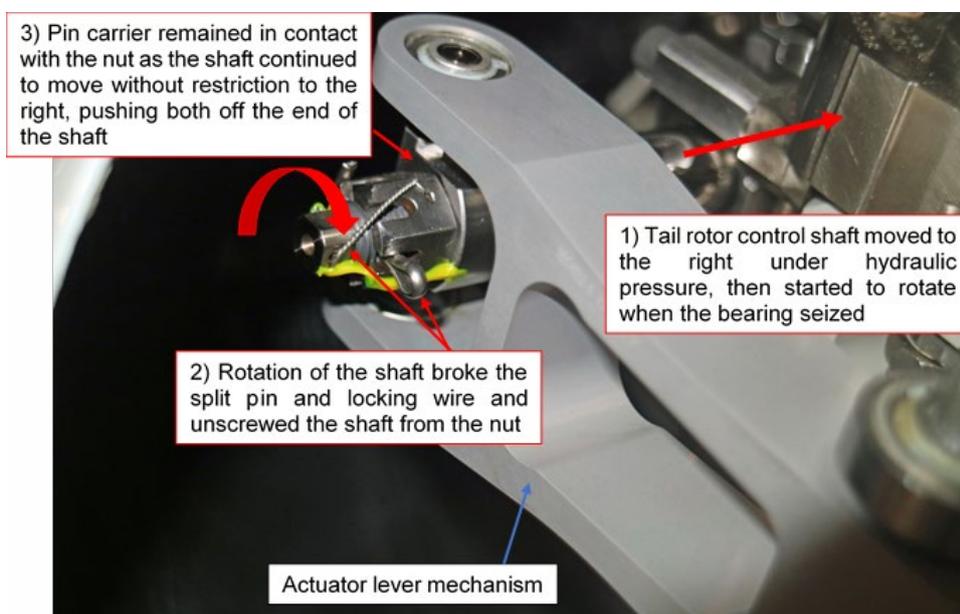
**Figure 96**

The locking nut at the actuator end of the control shaft clamped the pin carrier to the outer shaft of the hydraulic actuator, with the pin in the carrier providing the pivoting connection to the control system linked to the pilot's pedals. The now rotating inner shaft had enough torque to break the locking wire and shear the installed split pin on the nut. Continued axial movement of the control shaft under hydraulic pressure maintained the contact pressure between the nut and the pin carrier, allowing the threaded portion of the shaft to 'unscrew' completely from the nut<sup>2</sup>. In the process, friction heated the nut sufficiently for localized melting to occur, effectively welding it to the pin carrier. Both the nut and pin carrier were pushed off the end of the control shaft as it continued to move (Figure 96).

Sequence of disconnection of the TRA control shaft from the pilot's controls

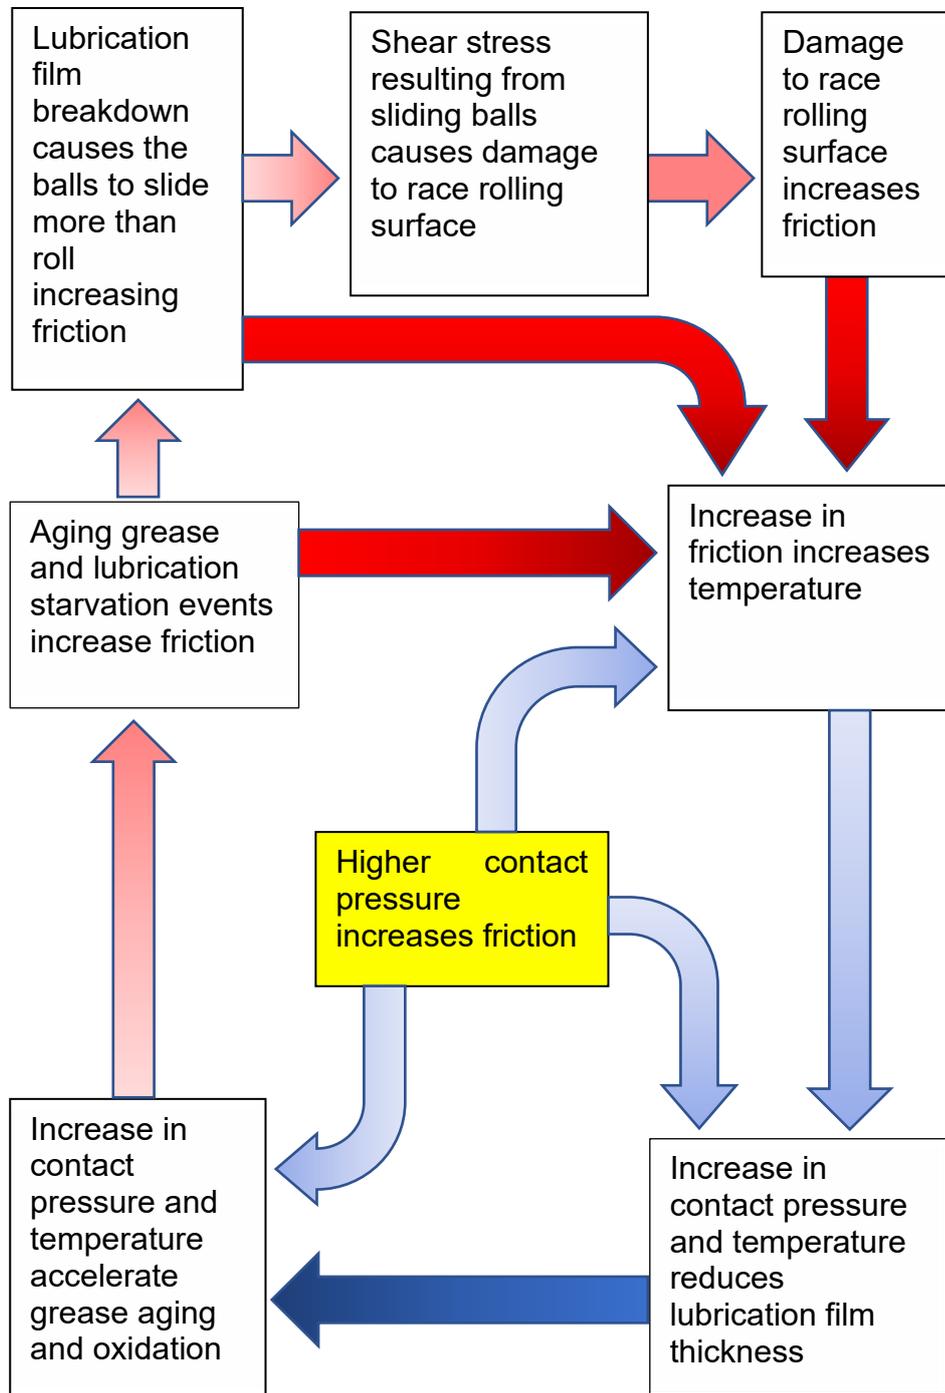
**Figure 97**

Loss of lubrication effectiveness either by momentary reductions in film thickness, which can result in lubrication starvation events, or by degradation of the grease, or by a combination of both, increases friction between the bearing race and the balls, leading to a further increase in temperature. This cycle also results in an increase in the amount that the balls slide which creates high shear stresses at the surface of the bearing race material, further increasing the temperature. Initially the increase in surface shear stress will manifest as subsurface microstructural change but this will progress under continued high stress to form distinctive surface initiated cracks and material loss, which also increases friction. This cyclic process eventually causes sufficient damage to the bearing race surface that it results in a self-perpetuating downward spiral of

reducing lubrication effectiveness, increasing friction, temperature and damage to the bearing until it seizes (Figure 97).

Cycle of increasing friction, grease deterioration and surface damage in bearings due to high contact pressure, resulting in premature failure

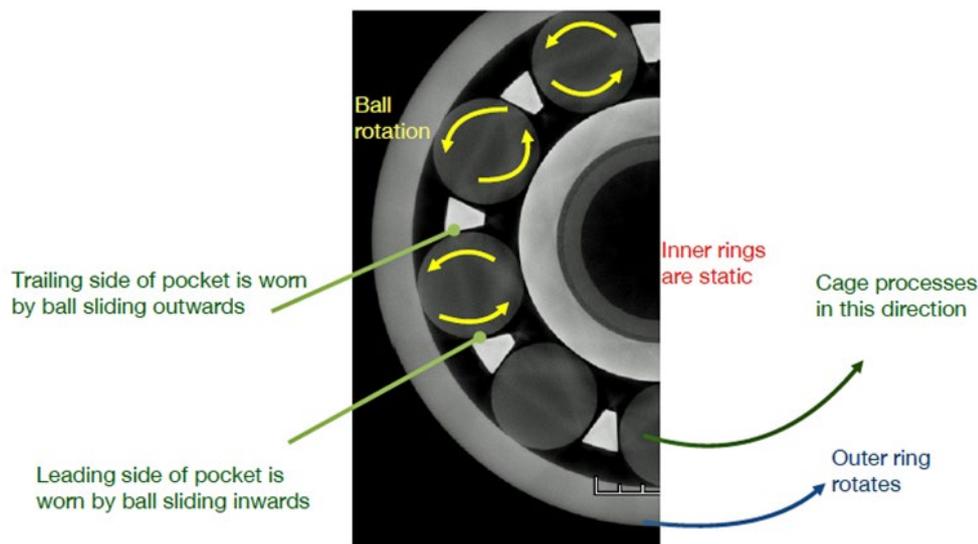
**Figure 98**

The damage and wear to the cages was also indicative of this failure mechanism and was consistent across the accident bearing, the bearings removed from service and the rig test bearing. Figure 98 shows how the balls and cage rotate within the bearing, resulting in wear to the cage.

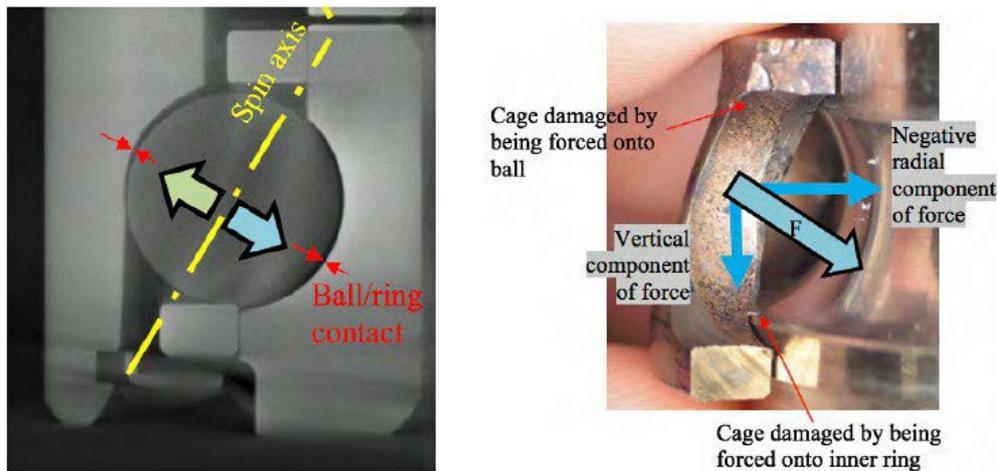
**Figure 99**

This force occurred whenever the cage rotational speed varied relative to the balls (Figure 99), but may also have been exacerbated by the bending moments acting on the bearing.

On the accident bearing the outboard cage, although fractured through three pockets at the narrow end, remained in one piece, whereas the inboard cage had broken completely into two sections. Where the fracture surfaces were not smeared, it was possible to identify fracture features consistent with fatigue. Momentary but repeated speed differences between the balls and the cage, driven by disruption to the procession of the balls, resulted in contact between the balls and the cage and generated tension across the pockets, creating the cyclic loading required to drive the fractures. Once the inboard cage broke into two sections it moved outwards against the outer race due to inertia, resulting in the wear mark on the outward side of the narrow end of the cage.

Ball spin axis and force generated by friction between the balls and the cage pocket
