Rail Accident Investigation Branch

Rail Accident Report

Signal passed at stop and near miss, Deansgate-Castlefield tram stop, Manchester 17 May 2019

Report 06/2020
August 2020

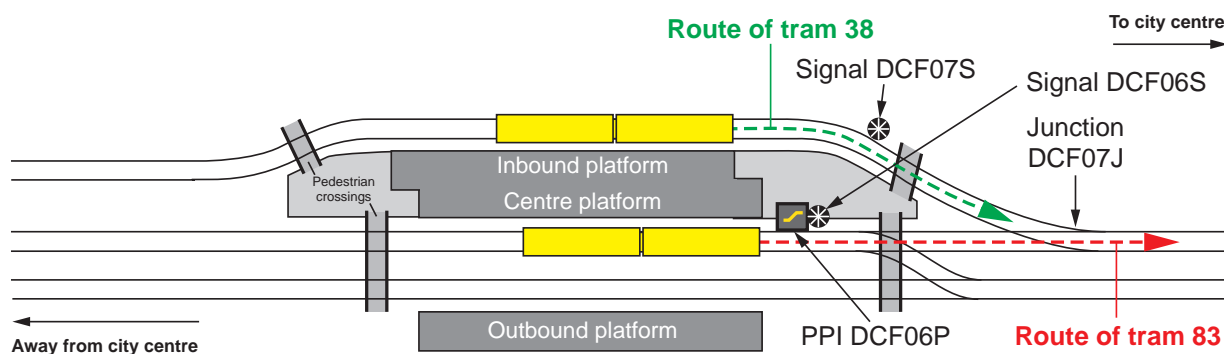
Figure 4: Layout of Deansgate-Castlefield tram stop (note some details have been removed for clarity)

- 6 The tram stop has three platforms, each of which can accommodate two trams. The inbound platform is used by trams travelling towards Manchester city centre from Cornbrook and the outbound platform by trams travelling away from the city. The centre platform was added in 2017 as part of the Deansgate-Castlefield remodelling programme. In normal service this platform is used by inbound trams, although it can be used by outbound trams during engineering work or degraded operations. The tram stop includes a pedestrian walkway at each end. This crosses the tram lines and allows pedestrian access to and from the platforms.

- 7 The lines from the inbound and centre platforms converge at junction DCF07J. This is made up of a set of trailing points¹ located approximately 35 metres from the end of the centre platform. Trams leaving the centre platform must also pass over a set of facing points at junction DCF06J. This junction allows trams to pass between the inbound and outbound lines outside normal service patterns.

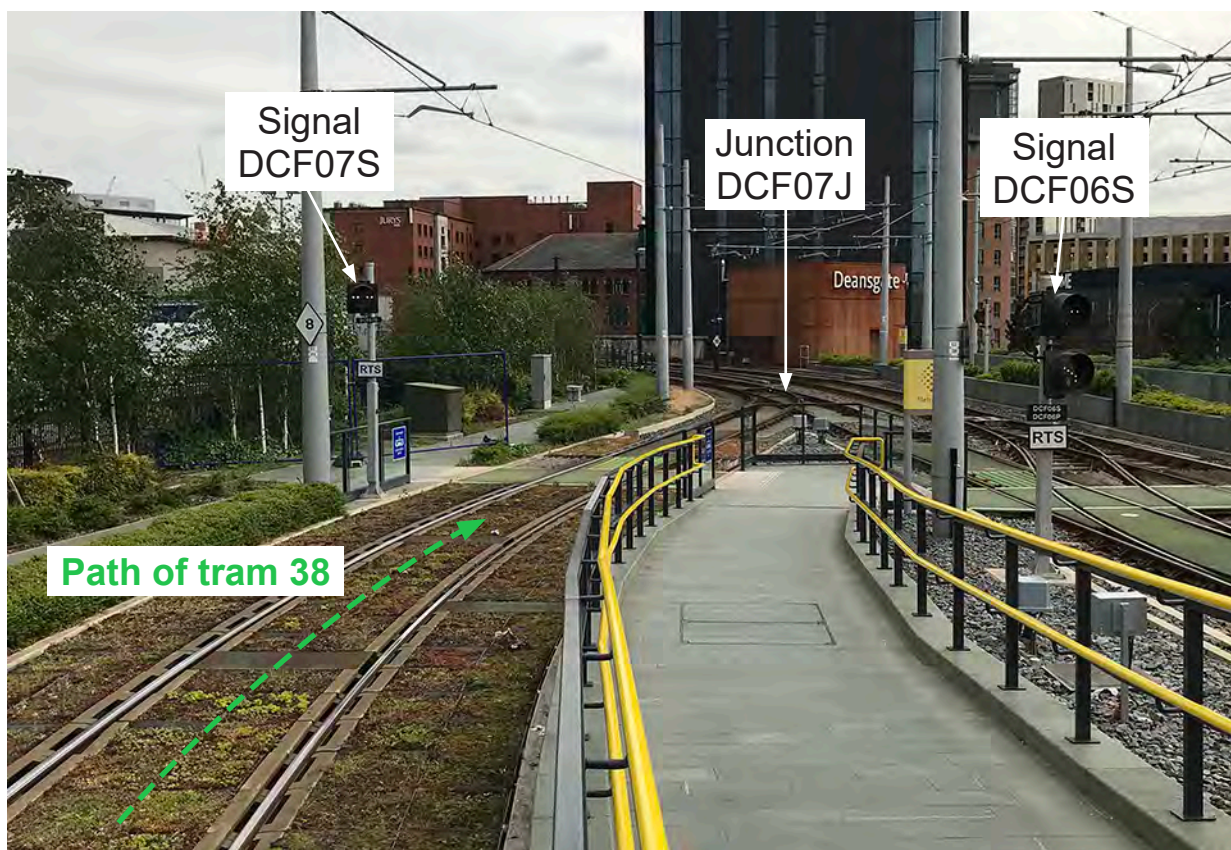
Figure 5: Signal DCF07S located beyond the inbound platform

- 11 TMS will normally route inbound trams approaching from Cornbrook into the inbound platform via a set of motorised points. A tram driver should not allow their tram to depart from the inbound platform until they receive a proceed aspect on DCF07S signal (figure 5). If the inbound platform is already occupied by two trams, TMS will route the next inbound tram into the centre platform instead. A tram should not depart from the centre platform until a proceed aspect is displayed on DCF06S signal and the PPI for junction DCF06J shows a left indication to indicate that it is set for trams to continue straight ahead on the inbound line (figure 6).

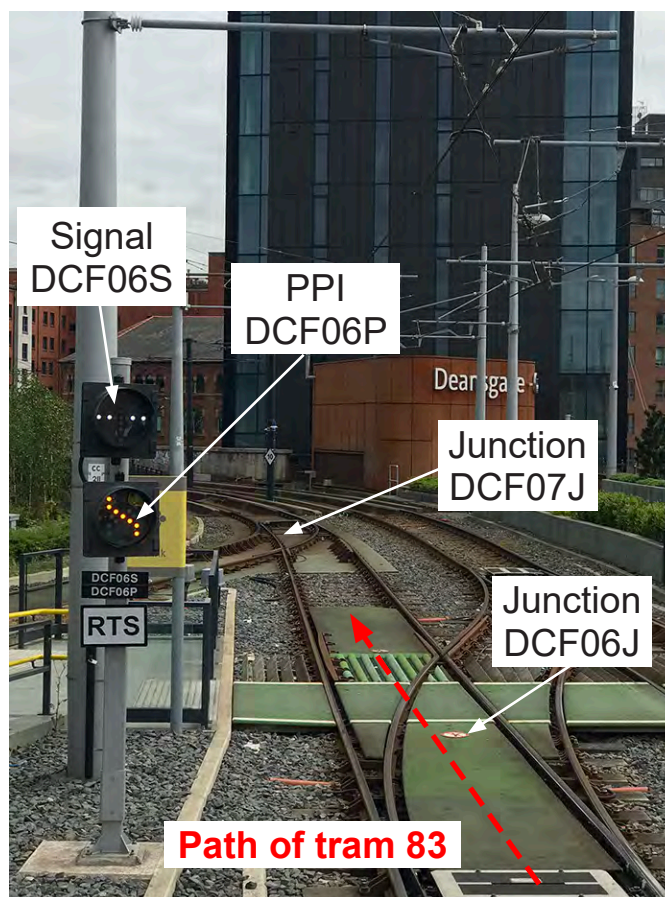
Figure 6: Signal DCF06S, PPI DCF06P and the junctions located beyond the centre platform

- 12 Signals DCF07S and DCF06S maintain a stop aspect unless the routes they control are granted by TMS. The process of granting a route is started by a driver making a request using the 'Tram Ready to Start' (TRTS) button in the tram's cab. The request is then transmitted to the TMS system via the track induction loops. Before TMS grants a route and clears the associated departure signal, a conflict manager function ensures that no conditions exist which could make granting the route potentially dangerous.

- 13 This conflict management process means that DCF07S and DCF06S should not show a proceed signal at the same time. Once a route has been granted by TMS, junction DCF07J will be reserved in the system until the departing tram has confirmed it is clear by passing a track induction loop located beyond the junction.
