Rail Accident Investigation Branch

Rail Accident Report

Fatal collision between a tram and a pedestrian at Cleveleys, Lancashire 24 November 2021

Report 14/2022
November 2022

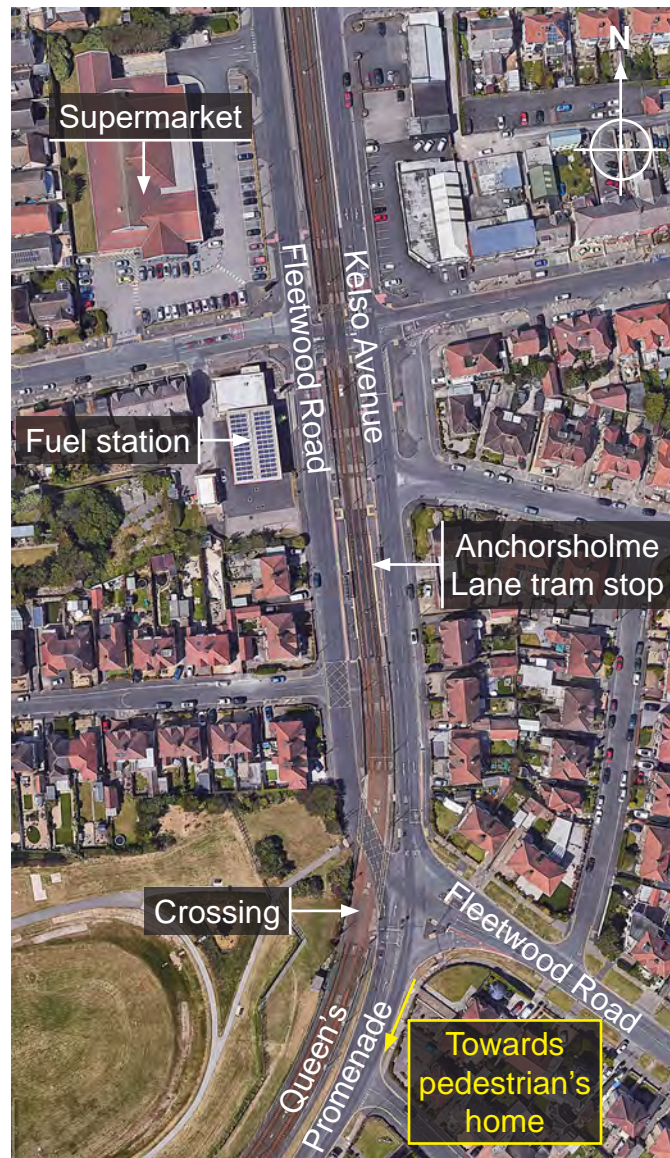
- 5 The crossing which the pedestrian was using is on the south side of the traffic-light controlled road junction where Fleetwood Road, Queen's Promenade and Kelso Avenue meet. The tramway passes through the junction on an approximately north-to-south alignment (figure 2).
- 6 The tramway at the location comprises two tracks, one for each direction of travel, with the southbound track on the east side (furthest from the sea). To the north of the junction, road traffic runs on two separate carriageways either side of the tramway with northbound road traffic using Fleetwood Road and southbound, Kelso Avenue. The southern end of the southbound platform of Anchorsholme Lane tram stop is approximately 70 metres north of the centre of the road junction.

Figure 2: Google Earth image of site showing geographical relationship of important features.

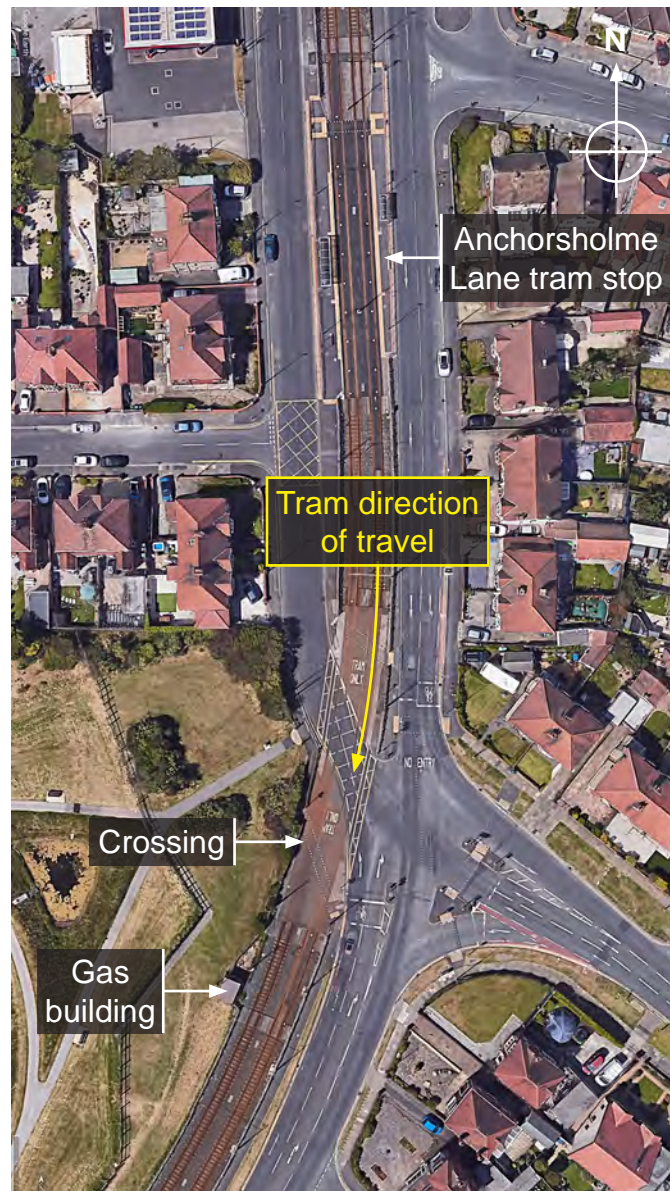
Figure 5: Google Earth image showing detailed view of site showing geographical relationship of important features.

- 38 On the western edge of the tramway, approximately 30 metres south of the crossing, is a small building (figure 5) associated with the provision of mains gas to the area. The proximity of this 'gas building' to the tramway on the inside of the curve means that it restricts the view of the western end of the crossing from the south. Because the eastern end of the crossing is towards the outside of the curve and further south, the gas building does not affect the view at the eastern end of the crossing (see paragraph 88). It has no effect on visibility of the crossing from trams approaching from the north as was the case in this accident.

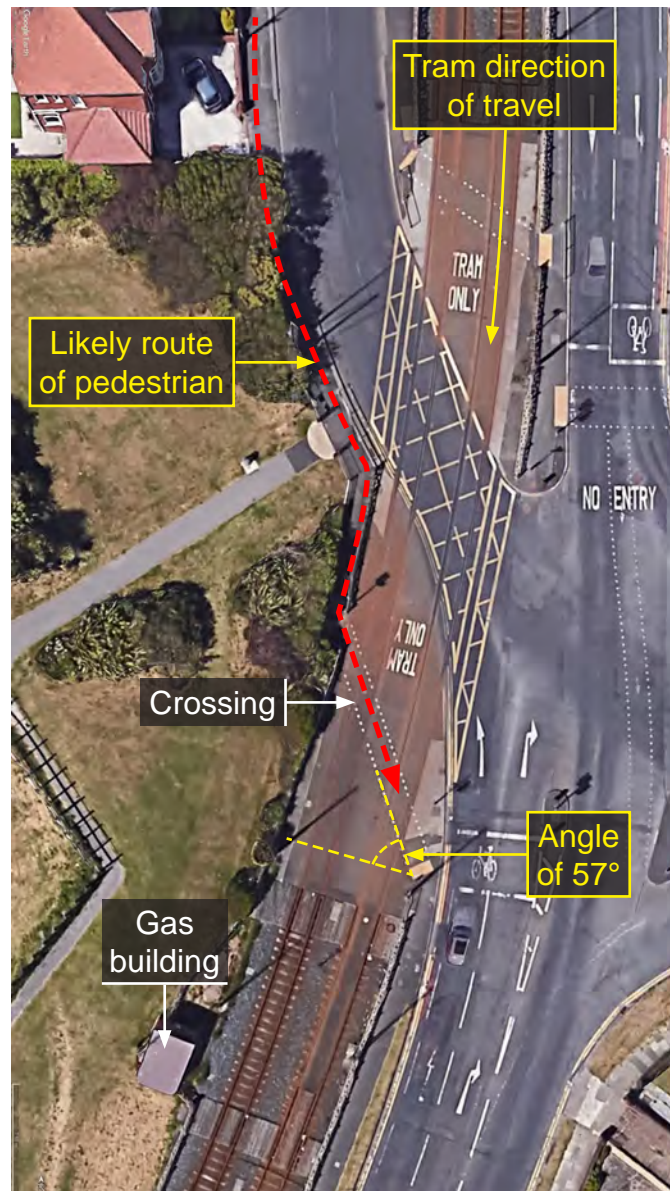
Figure 6: Google Earth image showing the likely route taken by the pedestrian.

82 Users of the crossing walking from west to east (such as the pedestrian involved in the accident) who stay within the defined limits of the crossing will cross at an angle of 57 degrees to the perpendicular route across the tramway (figures 5 and 6). This means that, when on the crossing, they are more naturally orientated towards northbound trams than if the crossing was perpendicular to the tramway. This also means that southbound trams are both behind and to the left of crossing users and will appear in their peripheral vision later in contrast to someone crossing perpendicular to the track. As they advance further across the tramway, crossing users would, in practice, also need to turn their head or body further to see southbound trams. This may have deterred the pedestrian from looking back to his left as he was crossing.

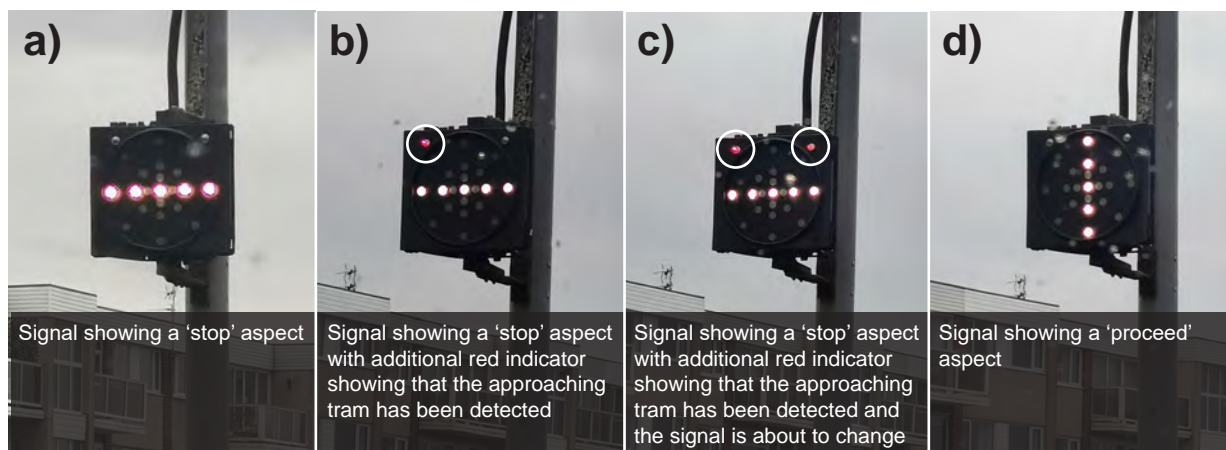
- 41 Tram signal heads contain two discreet additional lamps (figure 7) that give tram drivers information about the status of the traffic light system. A single lamp in the top left corner of the signal head tells tram drivers that the transponder has correctly detected their tram and is working to change the tram signal to show a 'proceed' aspect. A second lamp in the top right corner tells drivers that the tram signal is about to change to a proceed aspect. On seeing the first lamp, drivers will normally drive their trams slowly up to the junction because, although they must be in position to stop at the signal, they are aware that the system is working to change the aspect to allow them to proceed.

Figure 7: Tram signal showing a 'proceed' aspect and the indications given to tram drivers that the approach of their tram has been registered by the signalling system.
