Rail Accident Investigation Branch

Rail Accident Report

**Near miss at Farnborough North footpath level crossing
19 May 2022**

Report 04/2023
April 2023

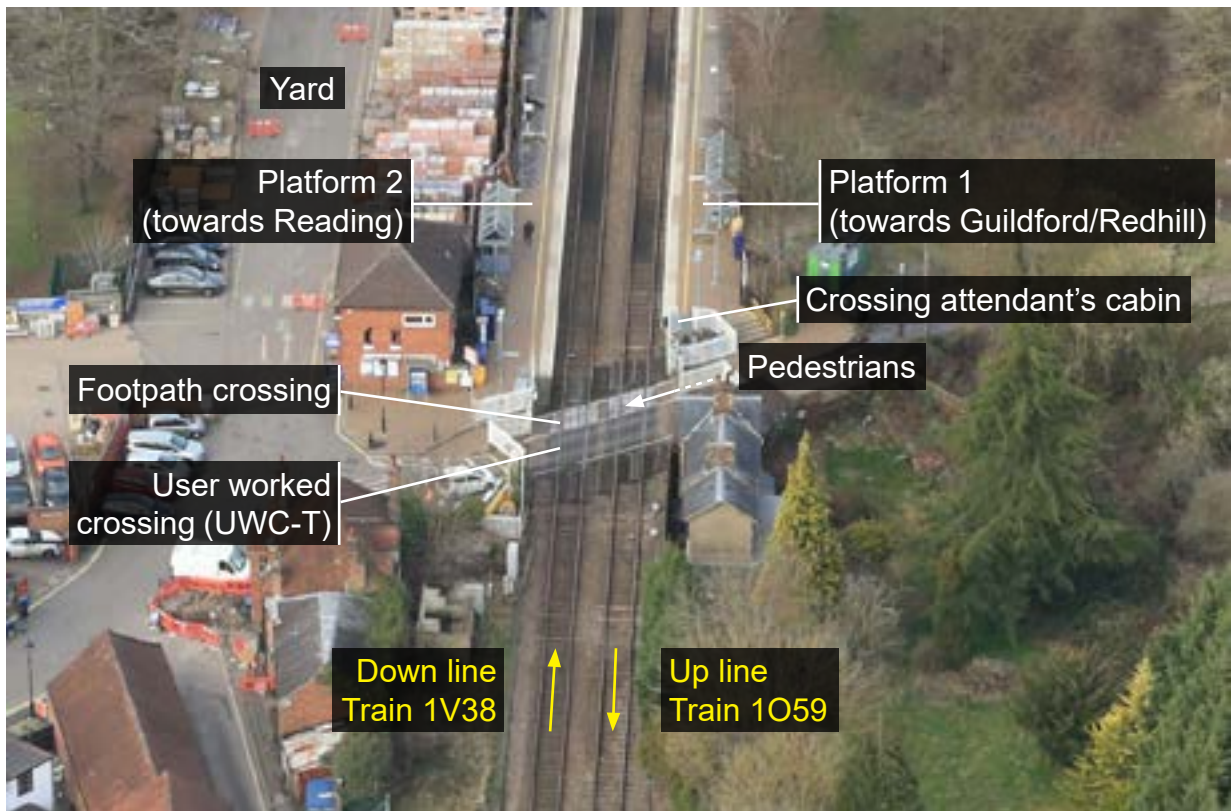
Figure 2: Aerial view of Farnborough North station looking north in 2019 (courtesy of Network Rail).

- 9 Farnborough North footpath crossing is located at the south end of the station at 53 miles 11 chains.¹ The footpath crossing is immediately adjacent to a user worked crossing with telephone (UWC-T) used by vehicles (figure 2). The footpath crossing provides platform to platform access within the station and is also a public right of way linking Frimley Green and Farnborough. The right of way crosses railways at Farnborough North and at Hatches footpath crossing near Frimley Green (figure 3).

- 83 The location of the attendant's cabin was inside a fenced compound for security, but this also meant they had no direct access to the crossing gate if they needed to directly intervene as became necessary on 19 May 2022 (figure 2 and figure 12).

- 93 In January 2016, Network Rail made a pre-application submission to the local planning authority, Rushmoor Borough Council. Pre-application submissions are not in the public domain but allow a scheme proposer to start a dialogue with the planning authority. The submission included a drawing of a footbridge with steps and ramps. The bridge was to be located directly above the existing level crossing with ramps running north of the crossing behind the station platforms. Each ramp would have a total length of just over 100 metres to limit the maximum gradient to 1 in 16, and with landings every six metres. On the west side of the station, the scheme would require additional land to be purchased from a building materials supplier which is currently used as a yard (figure 2).
