SB3/2023

Serious passenger injury on board a sea safari rigid inflatable boat

MAIB SAFETY BULLETIN 3/2023

The Marine Accident Investigation Branch is carrying out an investigation into a serious passenger injury on board a sea safari rigid inflatable boat.

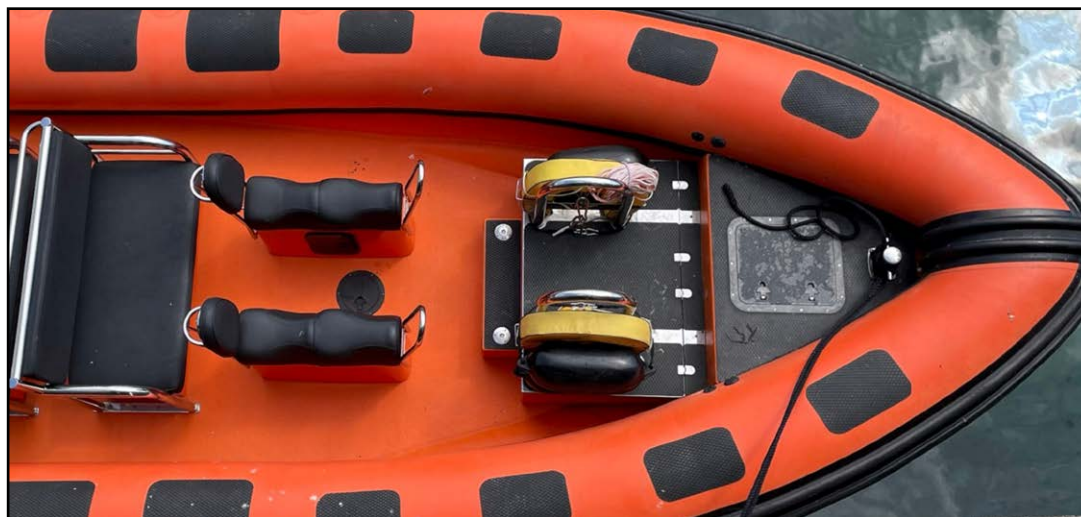
On 7 June 2023, a passenger on a rigid inflatable boat (RIB) sea safari suffered a spinal injury that left them paralysed from the waist downwards. Twelve passengers had boarded the RIB and, once it was clear of the jetty, the two crew gave them a safety briefing and instruction on the wearing of lifejackets. The RIB then proceeded out to sea and was increasing speed in choppy sea conditions when it encountered a steep-sided wave. The boat fell off the wave and slammed violently into the trough, dislodging a passenger from a forward jockey seat (**Figure 1**). The passenger immediately lost feeling in their legs.

When the boat hit the trough, the resulting force applied to the passenger's spine was of sufficient magnitude to fracture a vertebra. With a normal BMD level and no pre-existing conditions to increase their susceptibility to this type of injury, the factors contributing to the fracture related to the activity being undertaken. These included:

- the speed and movement of the RIB in the sea conditions
- the forward location of the seat that the passenger was using
- the passenger's seated posture and their ability to react and compensate for the RIB's motions
- the passenger's awareness of the hazards associated with the RIB's movement.

There is a significantly higher risk of spinal fractures to people seated in the front area of RIBs, regardless of speed.
