Rail Accident Investigation Branch

Rail Accident Investigation: Interim Report

**Loss of speed restrictions on the Cambrian line
20 October 2017**

Report IR1/2018
October 2018

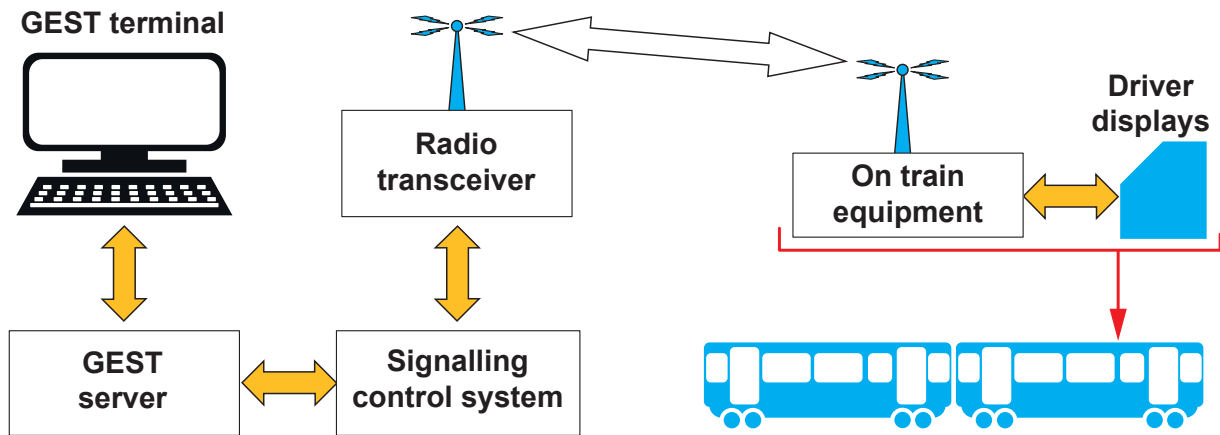
Figure 4: Simplified arrangement of GEST and signalling control system interface

- 25 To apply a temporary speed restriction on the Cambrian ERTMS system, the signallers use a computer system called the 'poste de GEstion des Signalisations Temporaires' (GEST) terminal. This terminal acts as an interface between the signalling control system and the signalling staff (figure 4). The GEST terminal is also used by the signalling staff to perform other tasks associated with the operation of the ERTMS signalling system, such as those required to return the signalling system to service after a rollover.

- 30 Following the initial rollover shortly after 23:00 hrs on 19 October 2017, the automated process to upload temporary speed restrictions from the database in the GEST system failed. Such failures should have been revealed to the signallers by the signalling control system and trains should have been prevented from resuming service. However, on this occasion the failure to upload the temporary speed restriction database was not recognised by the signalling system.
