Rail Accident Investigation Branch

Rail Accident Report

**Train driver struck by a train near West
Worthing Middle Siding, West Sussex,
1 February 2022**

Report 02/2023
February 2023

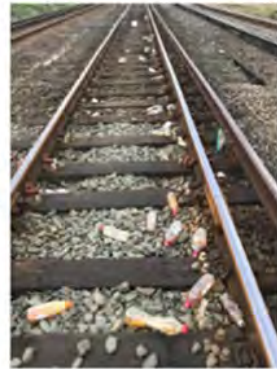
If you have a medical condition that requires you to have immediate access to a toilet please speak to your Manager

Network Rail are considering the installation of a camera, I don't believe this action is necessary..... do you?
