AAIB Bulletin

10/2023

Published 12 October 2023.

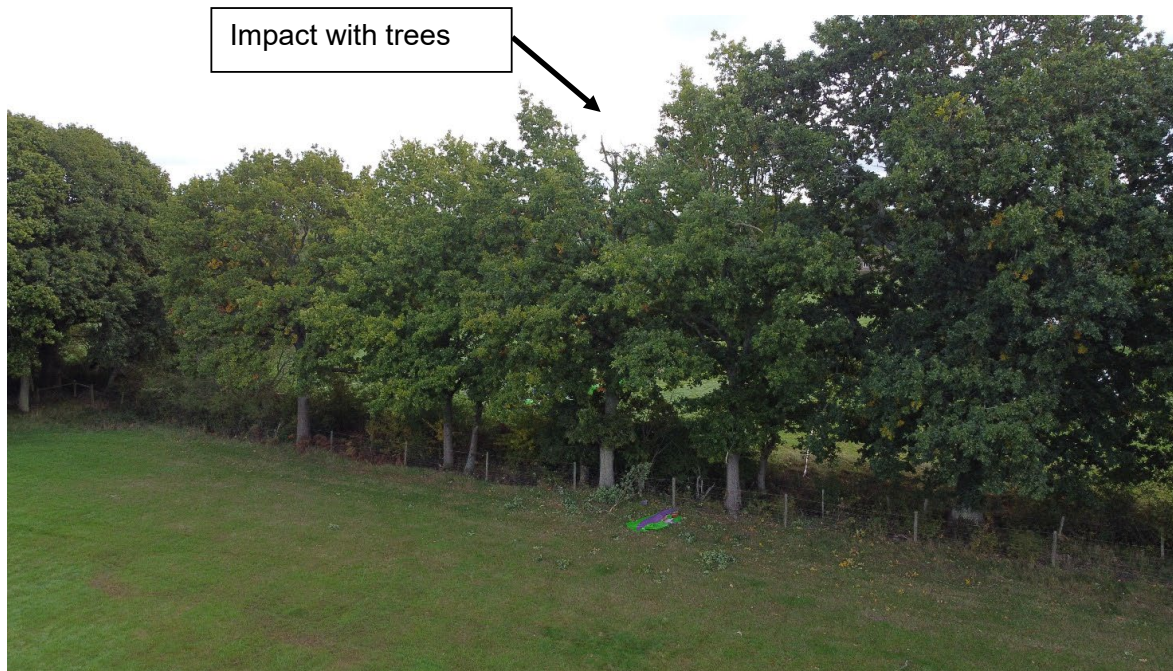
Figure 3

Tree line viewed from direction of aircraft travel

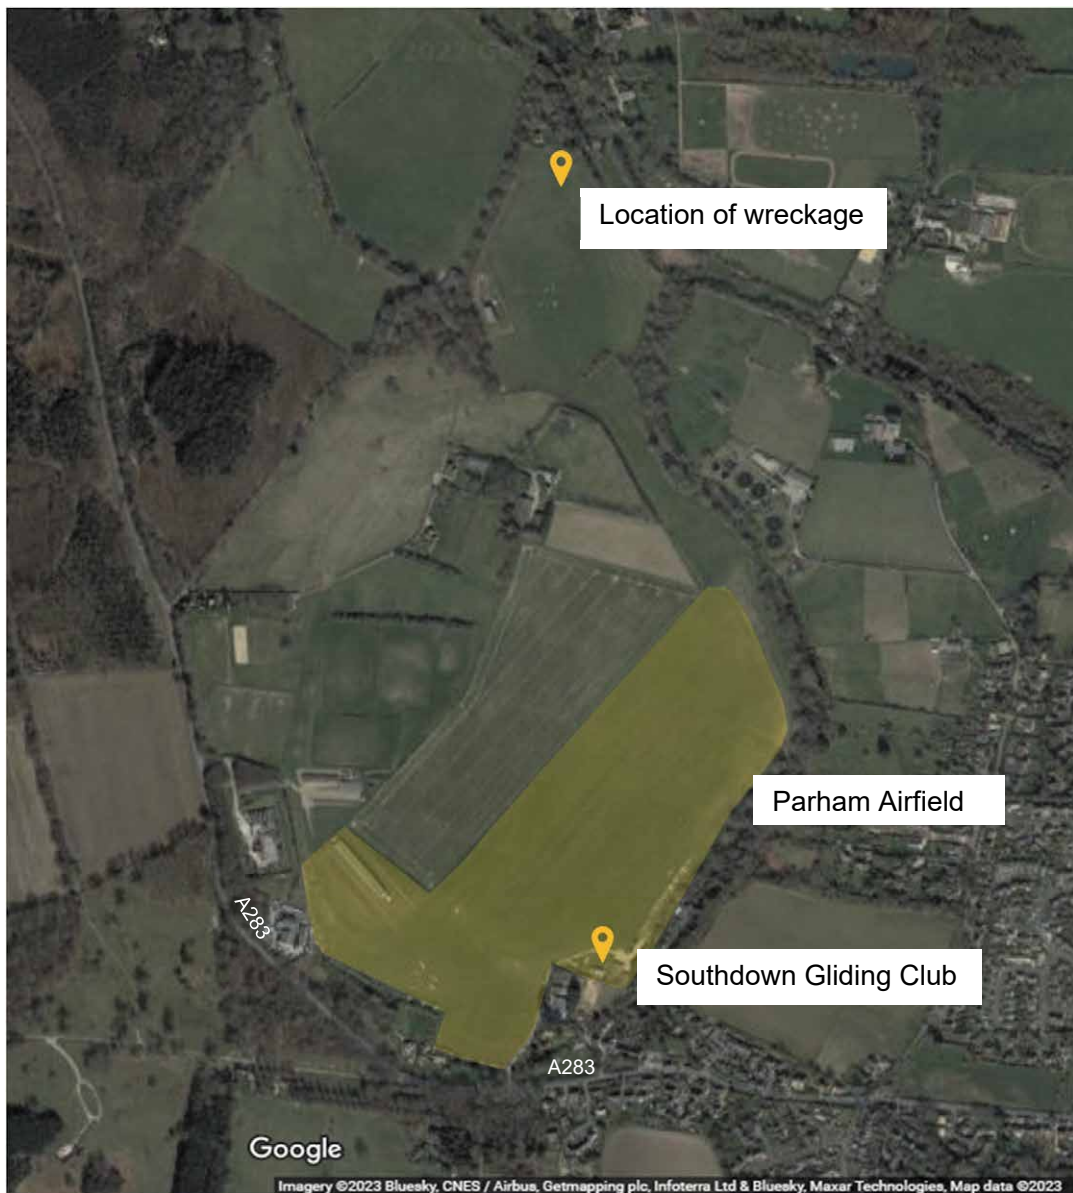
Figure 4
Location of accident site

The aircraft wreckage was found in a field north of Parham Airfield (Figure 4).

The ground marks and damage to the aircraft structure indicated that the aircraft struck the ground with the right wing slightly low and in a steep nose-down attitude. Ground marks and scratches found on the lower surface of the left wing showed that after the right wing and nose had struck the ground, the aircraft rotated to the right, dragging the left wing along the ground as the aircraft's momentum carried it forwards. The aircraft came to rest pointing towards the initial impact point with the tail boom structure disrupted in two places and bent towards the right wing (Figure 5). The nose and cockpit structure were fragmented, leaving only the severely damaged flight controls, some twisted cockpit structure and the

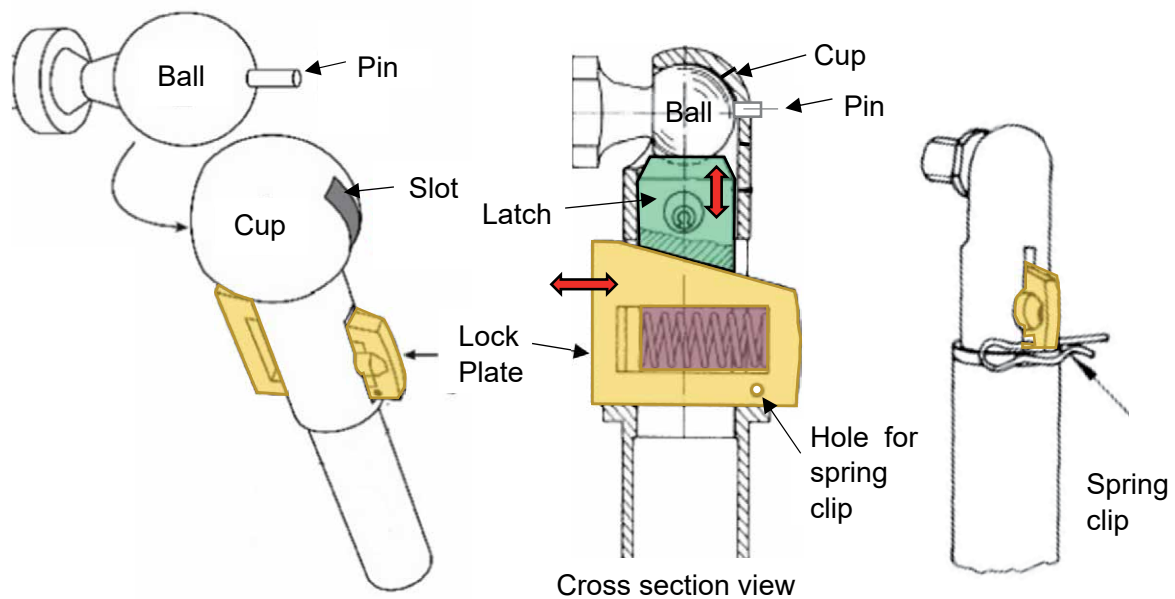
Figure 7

The elevator has a ball fitting attached to its lower surface which is inserted into the L'Hotellier cup connector to connect the control pushrod to the control surface (Figure 7).

Pressing the spring-loaded lock plate in allows the latch in the cup to move into the barrel of the connector to make room for the ball to fit into the cup. Once the ball is inserted and the lock plate released, the latch clamps onto the ball holding it in place. To ensure the

latch remains seated against the ball, an 'R' shaped spring clip is inserted into the lock plate to prevent it from dislodging and allowing the latch on the cup to release the ball. The pin on the ball protrudes through the slot in the L'Hotellier cup when properly connected. There are six other manually connected L'Hotellier connections on the ASW 20 for the ailerons, flaps and airbrakes. These L'Hotellier connections are secured with a safety device known as a Wedekind sleeve, and do not use a spring clip, thus the elevator connection was the only control connection on G-CFRW which required the use of a spring clip. The presence of a spring clip is checked as part of the annual maintenance check.

Diagrams showing details of the L'Hotellier cup and ball connection

Unlike many other glider types, the elevator connection on the ASW 20/20 L is visible when the elevator control surface is lifted. This enables a secondary post-rigging visual inspection which, if performed, could identify a disconnected or partially connected L'Hotellier connection or a mis-installed or absent spring clip. The pin on the elevator ball protrudes through the slot in the L'Hotellier cup when properly connected (Figure 7). This, together with the position of the lock plate provides visual and tactile cues to verify correct engagement of the L'Hotellier connection. Pulling the control rod or trying to depress the lock plate can provide further indications of correct connection.

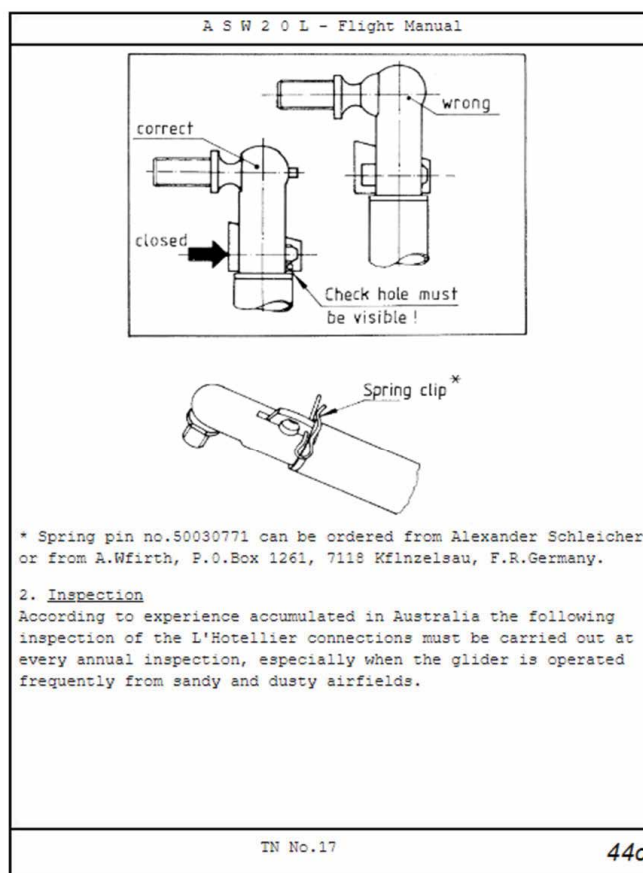
Figure 9

No fin sticker was found on G-CFRW or two other exemplar ASW 20 gliders. The manufacturer was not able to provide any information about the fin sticker. Diagrams of the correct and incorrect connection of the L'Hotellier quick-release connectors and location of the spring clip are shown in Figure 9.

Page 44c of G-CFRW's FOM

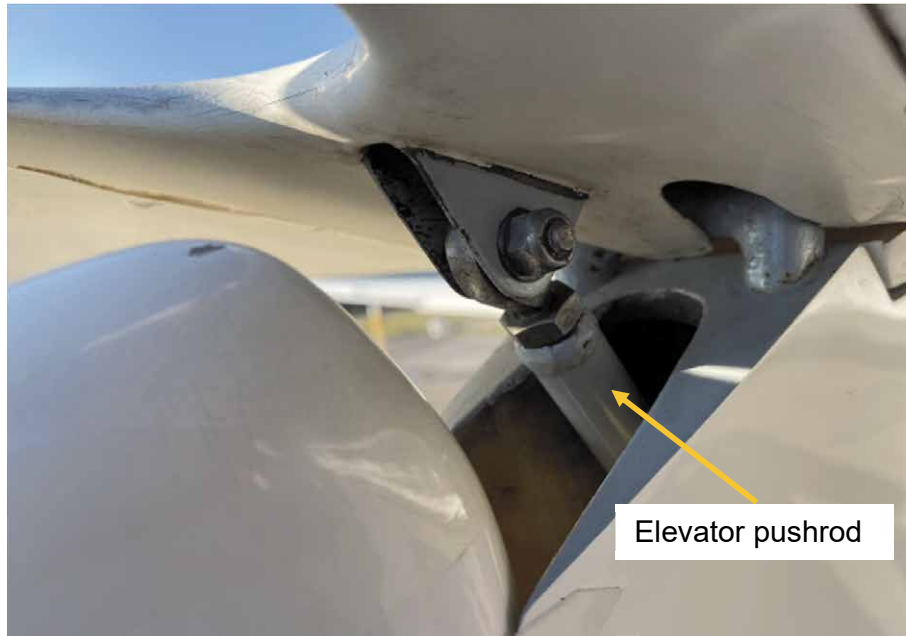
Figure 12

To actuate the elevator hinge, an 'elevator pushrod' replaces the L'Hotellier cup connection and is fixed to the elevator control surface by a bracket (Figure 12). The modification may be considered expensive and potentially cost prohibitive by owners when compared to the cost of purchasing the glider. Whilst this optional modification was available, it had not been adopted on the accident aircraft.

Elevator pushrod connection to the elevator control surface
