Defence
Safety Authority

Service inquiry

Loss of F-35B Lightning
ZM152 (BK-18) of 617
Squadron RAF, embarked on
HMS QUEEN ELIZABETH

17 November 2021

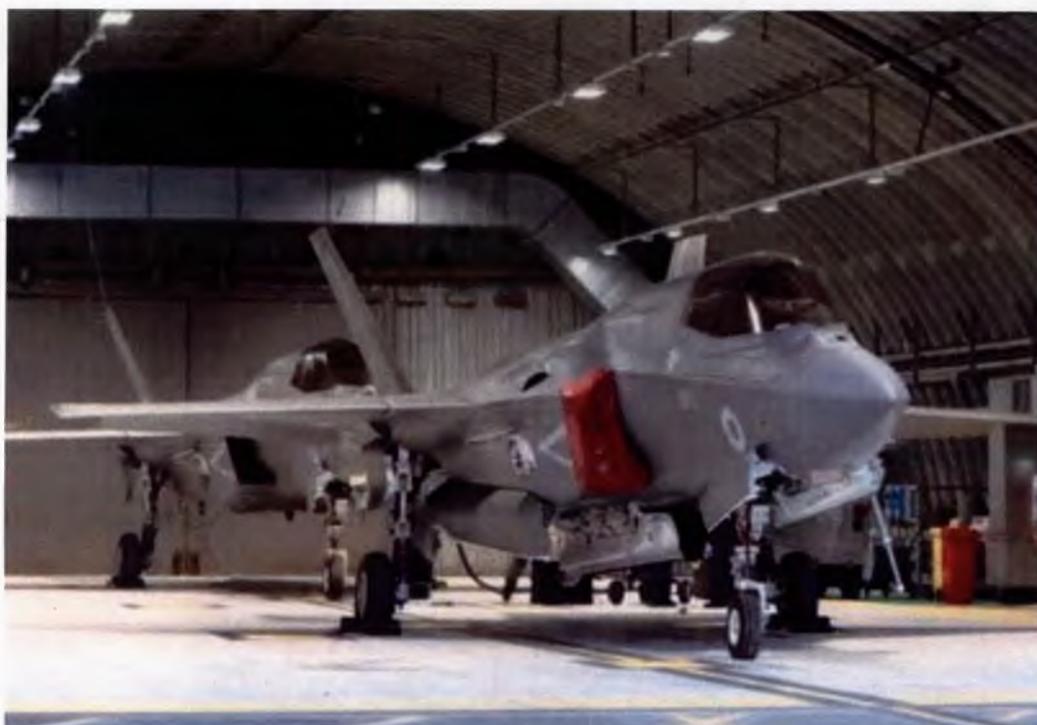
1.3.27. At the time of the accident, three different designs of intake blank had been used. The first design was a wrap-around cover (Figure 1.3.7) allocated Lockheed Martin design numbers A00016 (left) and A00017 (right). Lockheed Martin observed that these were difficult to fit and caused damage to the external skin of the aircraft, as well as materially breaking down and presenting a FOD risk.

Figure 1.3.7 – Wrap around intake cover fitted to 617 Sqn aircraft at RAF Marham.

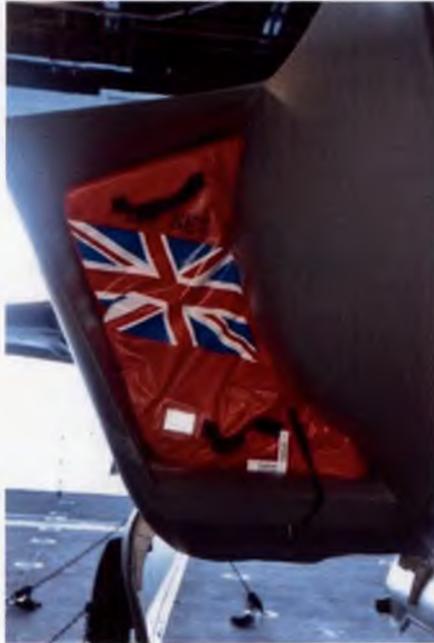
1.3.30. The text 'REMOVE BEFORE FLIGHT' was printed on the intake blanks by the manufacturer but the characters were found to peel off and present a FOD hazard. Early on Op FORTIS, 617 Sqn engineers removed the lettering from the intake blanks and raised awareness of the FOD issue by raising a Defence Air Safety Occurrence Report (DASOR).⁹

Figure 1.3.9 – Plug-type intake blank of the approved design, as used on Op FORTIS.

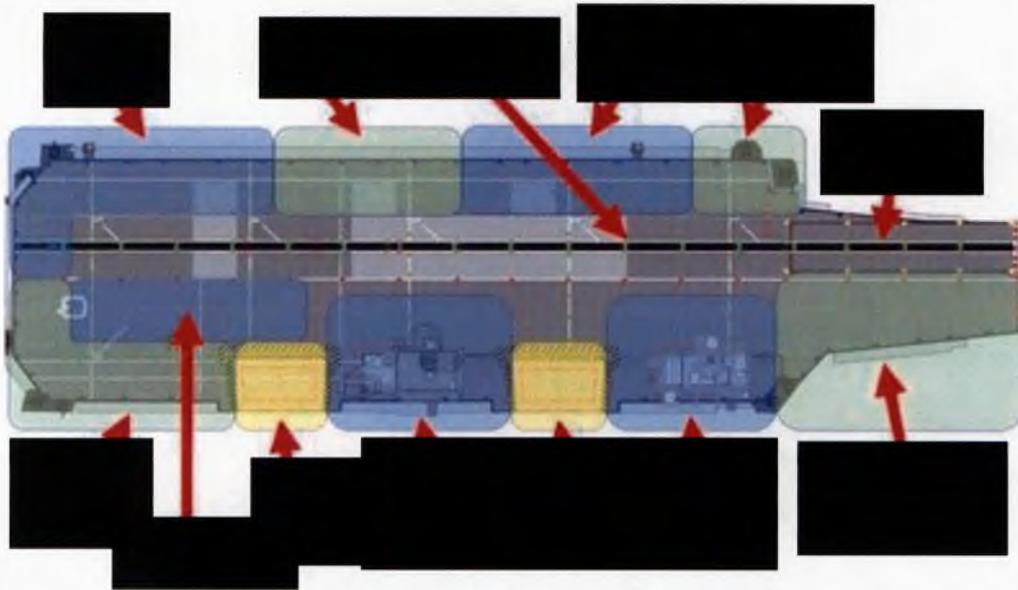
Figure 1.4.5 – Flight deck parking area identification.

1.4.32. The tail of BK-20 overhung the edge of the forward lift, which would have prevented exhaust blank removal, so it had to be left until a tow team could pull the aircraft forward. Subsequently the exhaust blank blew out and was lost in the sea over the starboard side of the ship before the tow team could be mustered.

1.4.36. Recommendation. The Lightning Chief Air Engineer should ensure a robust and auditable Red Gear control procedure is in place in order to verify the location of Red Gear at all times.

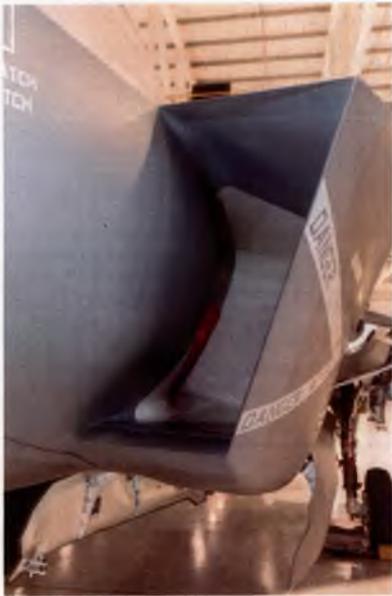
Figure 1.4.8 – Intake blank positioned in the intake.

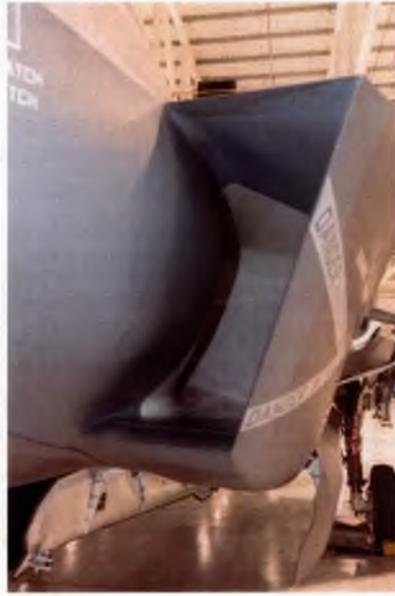
Figure 1.4.9 – Intake blank positioned in the intake, but not externally visible.

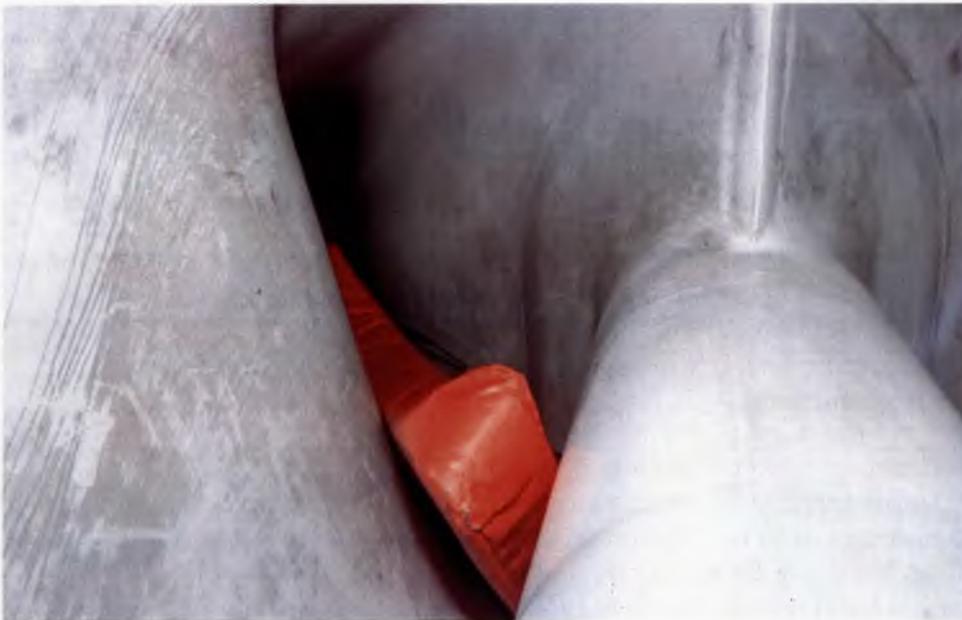
Figure 1.4.10 – Blank located in common duct, but no longer visible to external view.

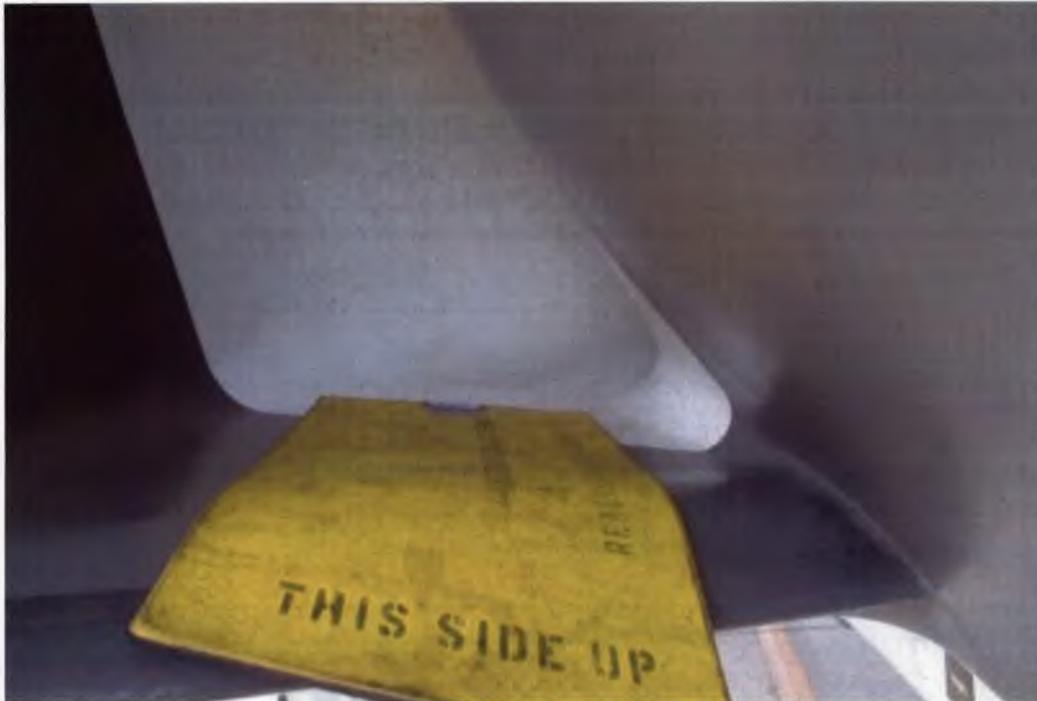
yellow maintenance mat when conducting work in the intakes and there were incidents of these being left in the aircraft (Figure 1.4.25). These mats were not in use on the UK Lightning Force.

Figure 1.4.25 – Yellow maintenance mat used by US forces.

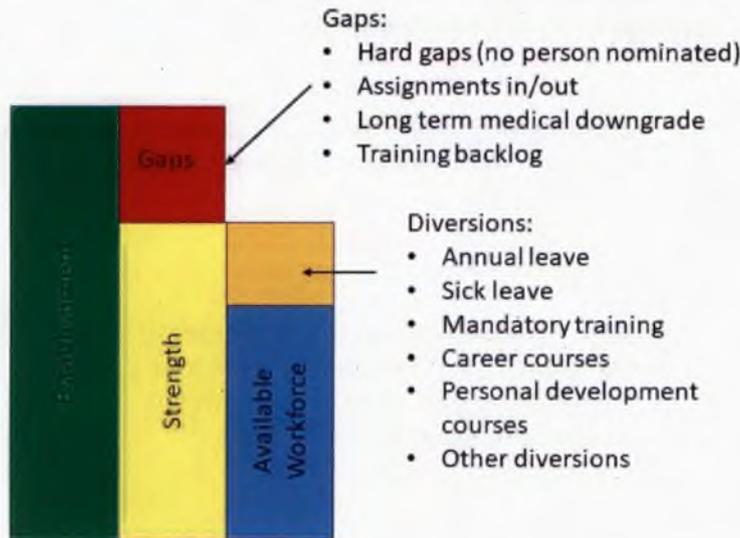
Figure 1.4.31 – Generic workforce limiters.

1.4.151. Since its inception the UK F-35 workforce was under resourced. This resulted in an inability to generate sufficient aircraft to deliver the required operational capability. The establishment was below that required, resulting in insufficient availability of workforce. To put this in perspective, on Op FORTIS 617 Sqn deployed 113 personnel for their [REDACTED] aircraft, [REDACTED] deployed 255 personnel to support [REDACTED] aircraft. Whilst some of these were support staff, they still had around 50-60 more engineers than 617 Sqn for only [REDACTED] more aircraft. Even to deploy 113 personnel on Op FORTIS, 617 Sqn had to borrow personnel from 207 Sqn.
