AAIB Bulletin

11/2023

Published 10 November

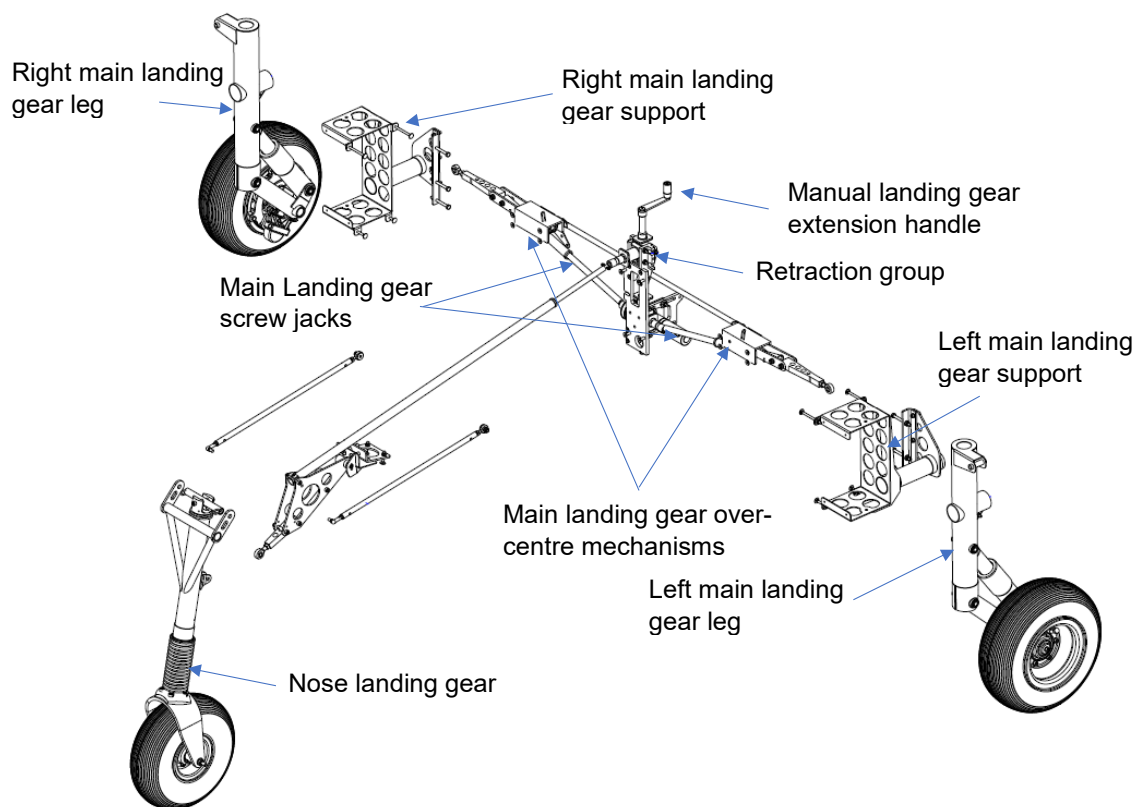
Figure 1

The Alpi Pioneer 300 is a small two-seat, low-wing aircraft, of mainly wooden construction. The aircraft is fitted with electrically operated retractable tricycle landing gear (Figure 1).

Alpi Pioneer 300 landing gear configuration
