B. J. UNWIN FORESTRY CONSULTANCY Ltd.

Site: **Land west of Robin Hood Road, Elsenham, Essex,
CM22 6EB.**

Subject: **BS5837 Tree Constraints, Tree Impacts and draft Tree Protection
Method Statement for OUTLINE Residential Development.**

Surveyor: Owen Hutchison.
Report:: Owen Hutchison. (professional-CV in Appendix VI).
Dates: Inspection 2018, updated 25th May 2023. Report: Stage 1: 14th June **Stage 2: 1st Sept & 9th Oct 2023.**

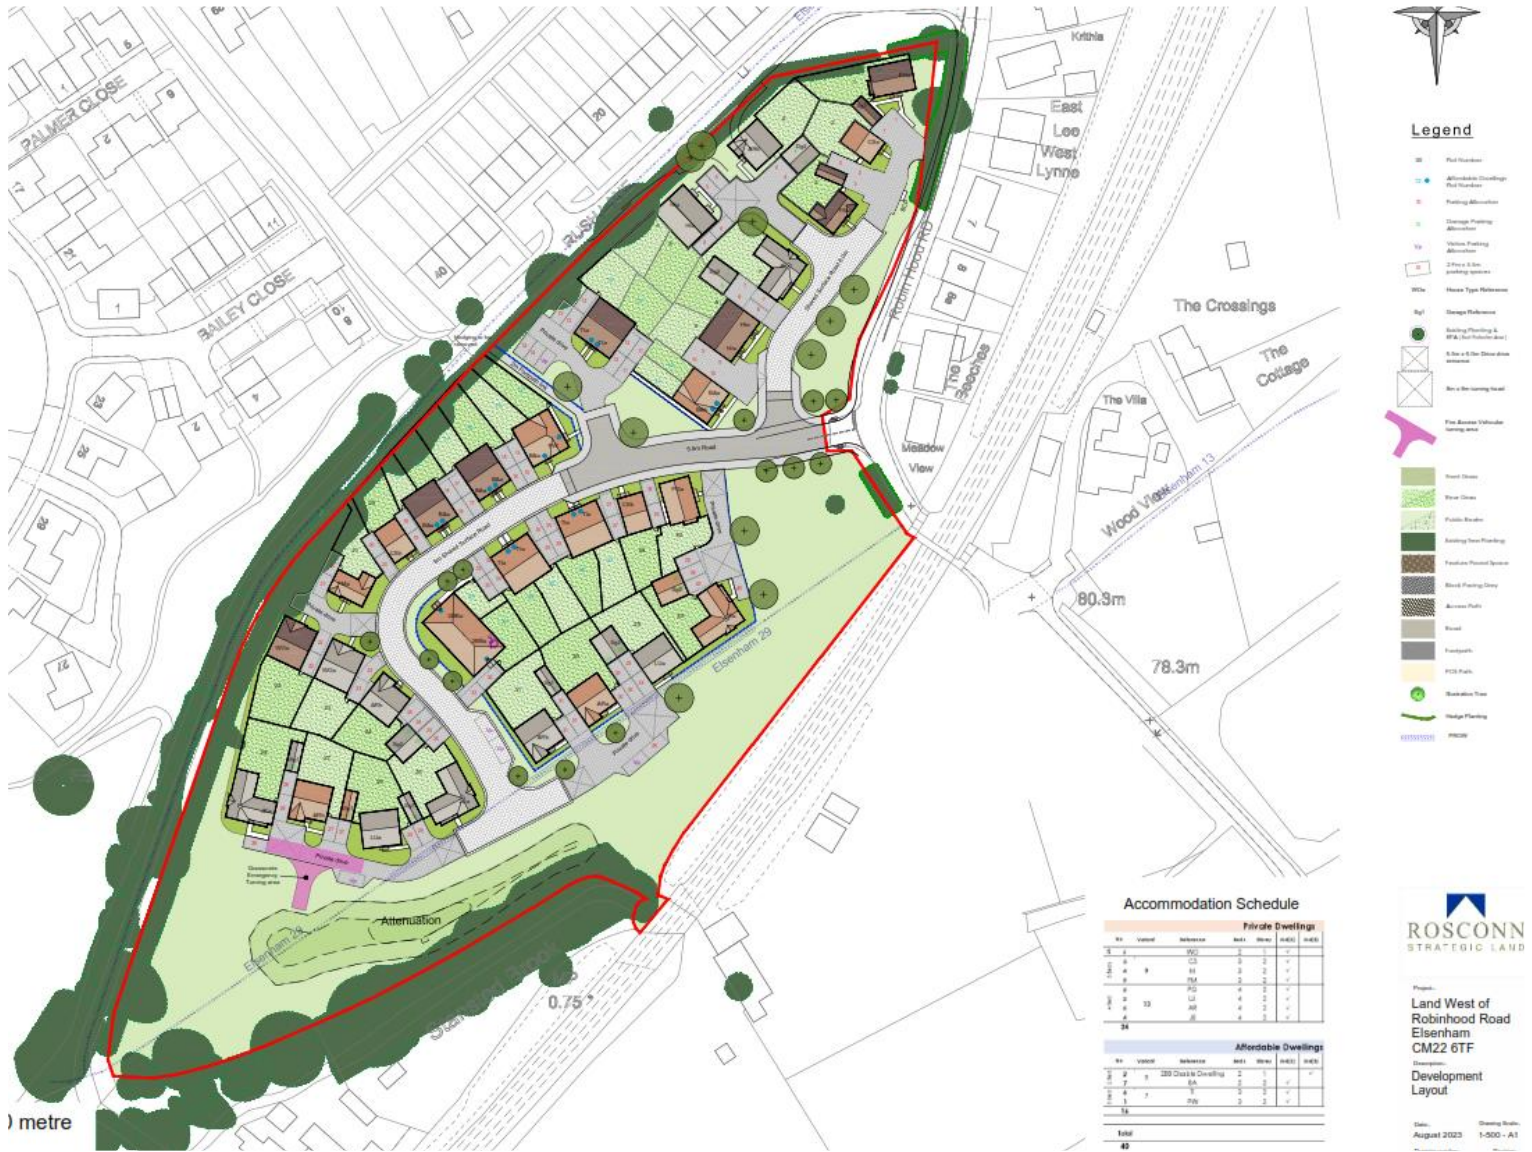
5.1.1 The proposal, JCN Design Development Layout BW289a-PL-02 Rev C of August 2023, extract below, shows the development.

5.1.2 Forty dwellings are created within the site.

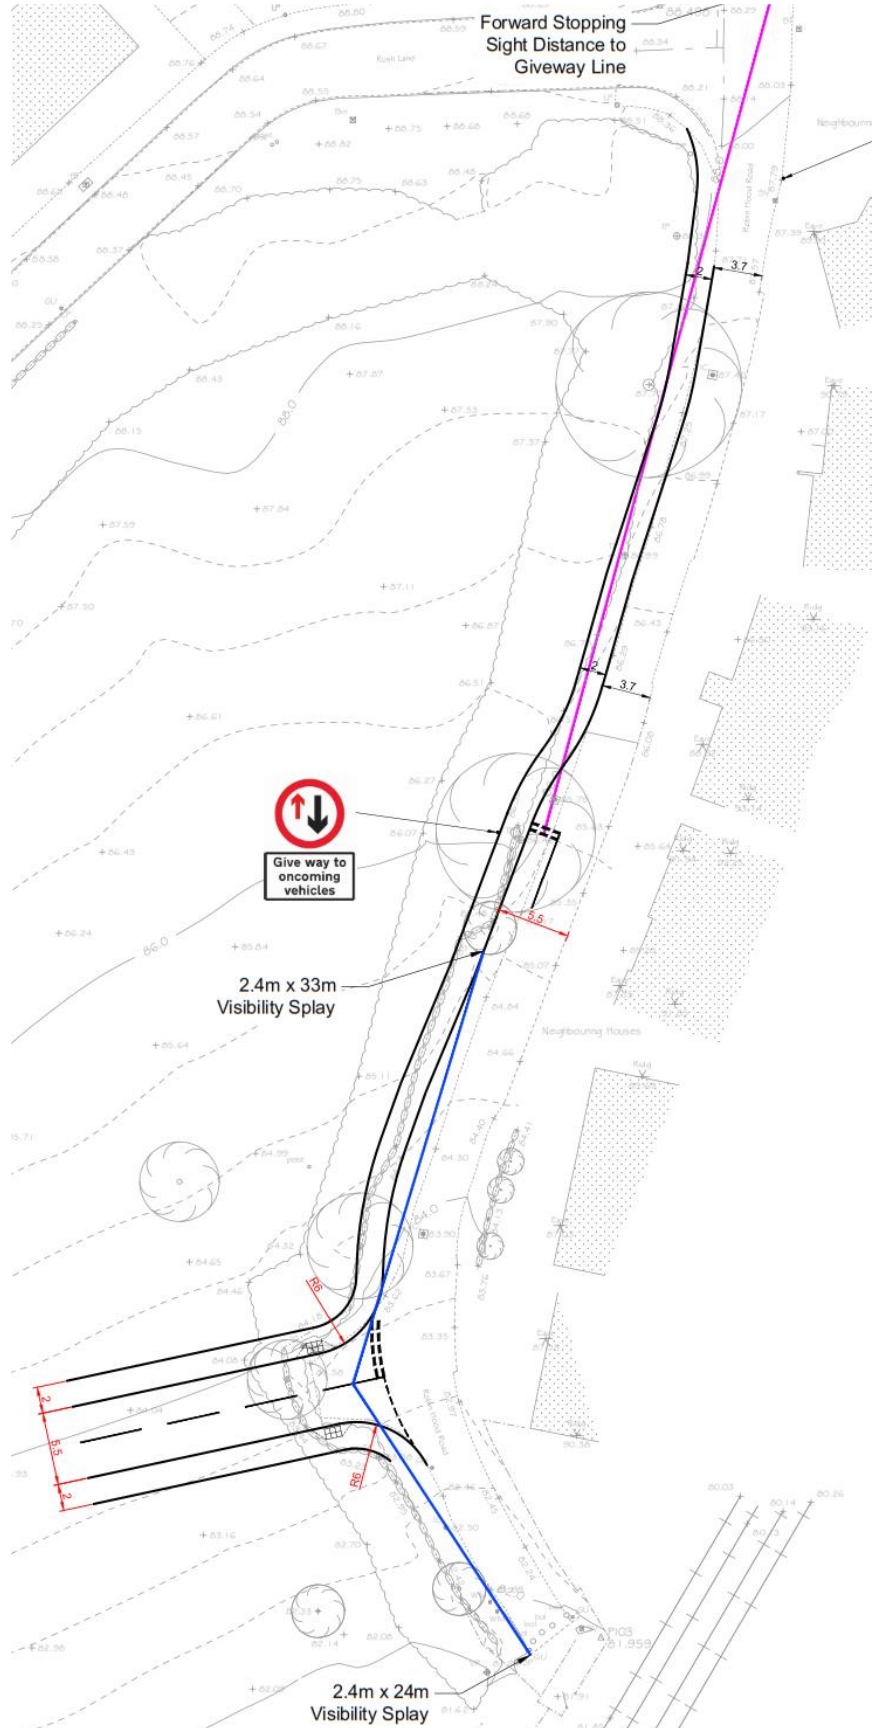
- 5.1.3 A footpath halfway along the north-western boundary links the site to Rush Lane.
- 5.1.4 The existing access off Robin Hood Road is improved, with a footway along the western side of the road. Indicative footway shown on Savoy Consulting DWG-05 Rev C, extract below:

- The proposal to accommodate a new 2m footway on the road edge requires pruning the Robin Hood Road hedge H56 back to stems in its northern 45m, and removal of about 60m of hedge further south along Robin Hood Road.
- About 4m of Rush Lane's H56 need removing to make a new footpath access.
- H56 needs pruning back for construction access behind plot 1 house.
- Some small trees (alders and hawthorns) may be removed to allow new drain outfall and headwall in G87 on the southern edge.
- Some of G87 may be replaced by attenuation pond on the southern edge of the site.
