Rail Accident Investigation Branch

Rail Accident Report

Collision between passenger trains at Salisbury Tunnel Junction, Wiltshire 31 October 2021

Report 12/2023
October 2023

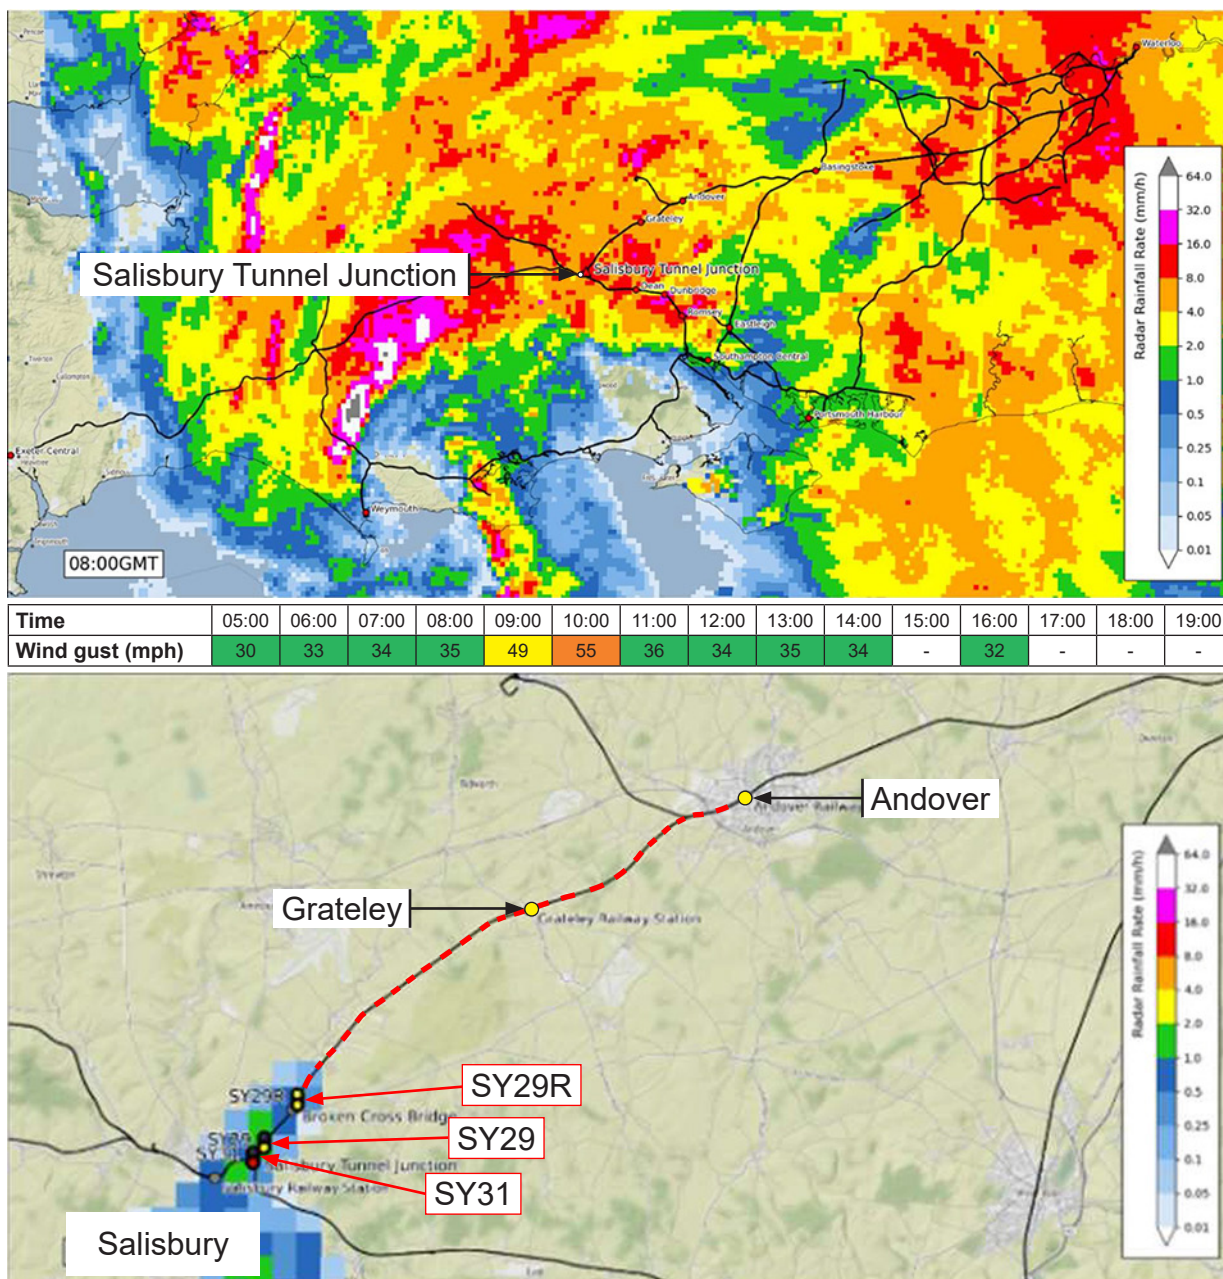
- 46 After the weather front had passed, the area remained windy for the rest of the day with peak wind gusts of approximately 23 to 37 mph (37 to 60 km/h). Between 18:35 and 18:40 hrs, radar imagery showed a band of drizzle passing over the Up and Down Main lines in the area of Salisbury Tunnel Junction, just before the passage of train 1L53 (figure 6).

Figure 6: Met Office radar image (top) showing weather front for 31 October 2021 with wind gust speeds (middle) and macro radar image (bottom) showing the weather front passing over the Salisbury area and railway line (moving south-eastwards) between 18:35 and 18:40 hrs, in relation to the location of signals SY29R to SY31 (© Crown copyright 2023, the Met Office).

- 62 Evidence from the train's OTDR data shows that the driver initially selected brake step 1, followed almost immediately by brake step 2. When the driver applied the brakes, he stated that he immediately felt and observed that something was wrong. The driver stated that the feeling 'under his seat' indicated that the train's wheels were sliding.

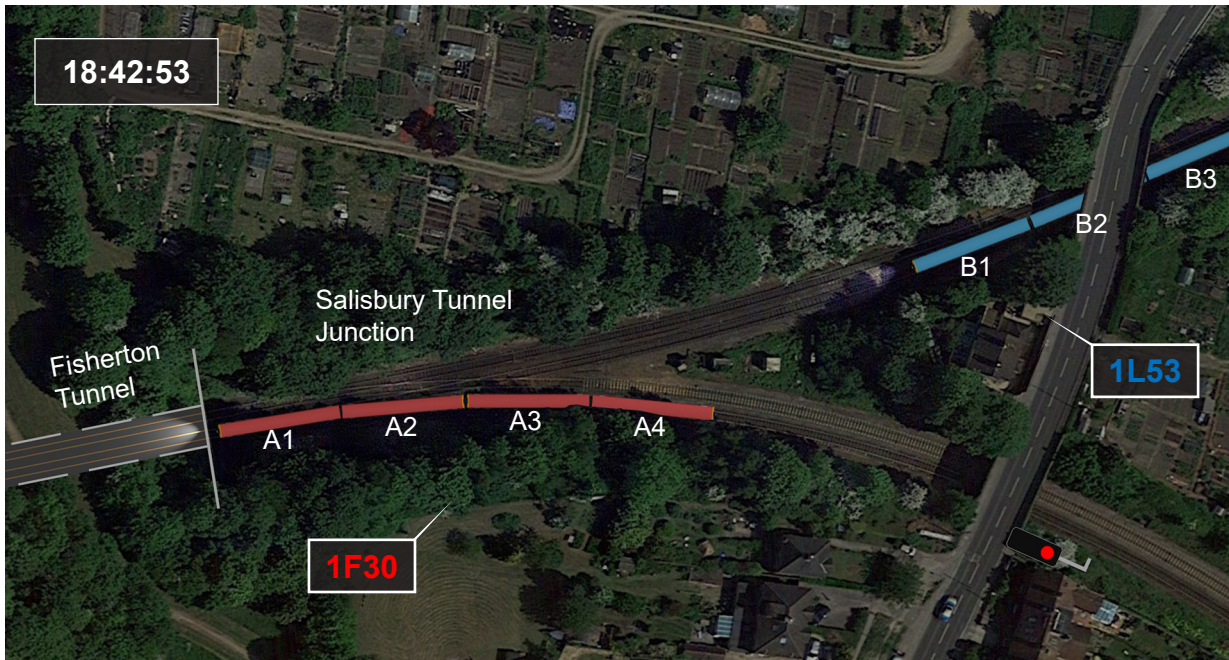
- 68 The driver of 1L53 saw train 1F30 appear from the left and move into the path of his train. Believing there was little he could now do to prevent a collision, he got out of his seat with the intention of exiting the cab into the saloon. However, in doing so, he tripped over his bag, and fell onto the floor just before the collision occurred (figure 9).

Figure 9. Diagram showing train 1L53 (carriages marked as B1 to B3) and train 1F30 (carriages marked as A1 to A4) immediately before the collision.

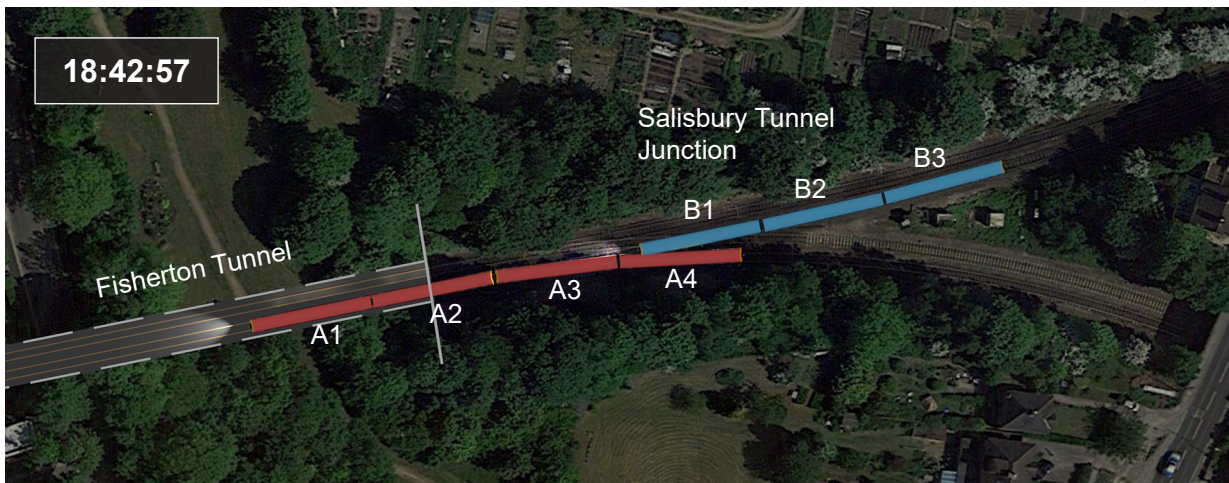
- 69 As train 1F30 was entering Fisherton Tunnel, train 1L53 collided with its right-hand side, near the front of the fourth carriage (figure 10). Evidence from the OTDR on train 1L53 suggests that the collision occurred at 18:42:57 hrs, with train 1L53 travelling at a speed of approximately 52 mph (84 km/h). The OTDR on train 1F30 recorded its speed as being around 20 mph (32 km/h) at the time of the collision.

Figure 10: Diagram showing train 1L53 colliding with train 1F30.

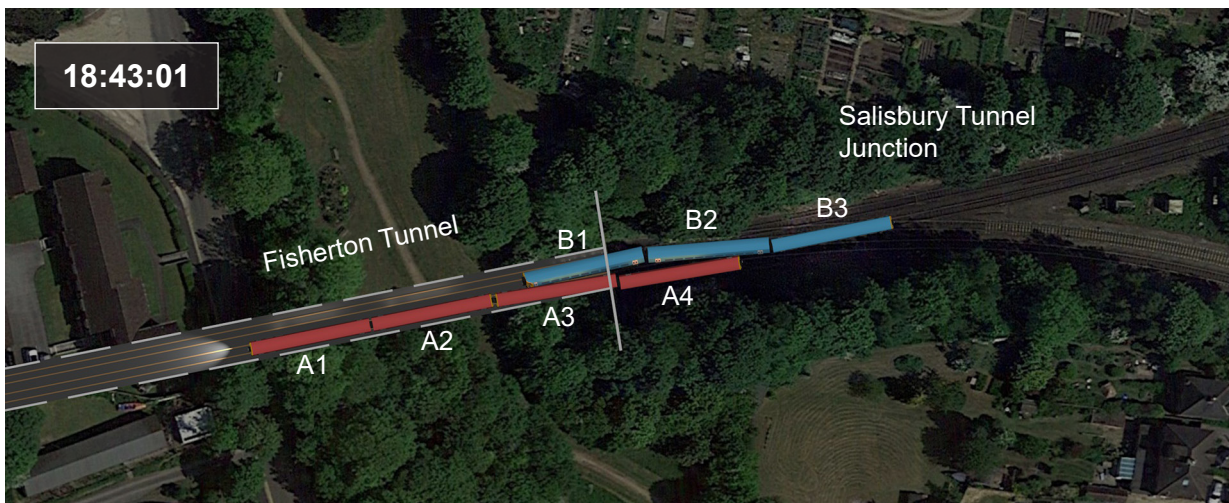
- 70 The 32 mph (51 km/h) speed differential between the two trains meant that train 1L53 travelled forwards in heavy contact along the right-hand side of the fourth carriage of train 1F30. It then continued along the right-hand side of the third carriage, with the leading left-hand edge of the cab of train 1L53 embedding itself in the front end of this carriage (figure 11).

Figure 11: Diagram showing trains 1L53 and 1F30 derailed into Fisherton Tunnel.

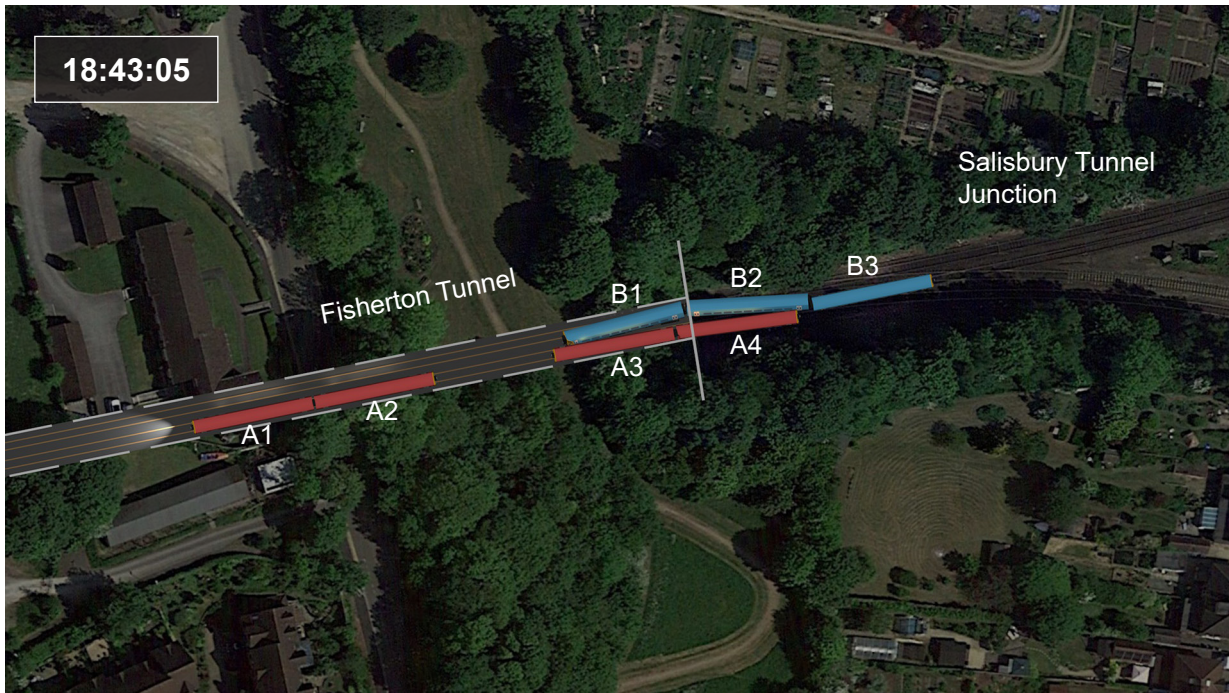
- 72 Both trains travelled into Fisherton Tunnel, with the tunnel walls acting to keep the carriages upright. The rear two carriages of train 1F30 and all carriages of train 1L53 derailed, with the cab of train 1L53 being severely damaged. The front carriage of train 1L53 came to rest adjacent to the leading end cab of the third carriage of train 1F30 (figures 13 and 14).

Figure 13: Diagram showing carriages A2 and A3 separated within Fisherton Tunnel.

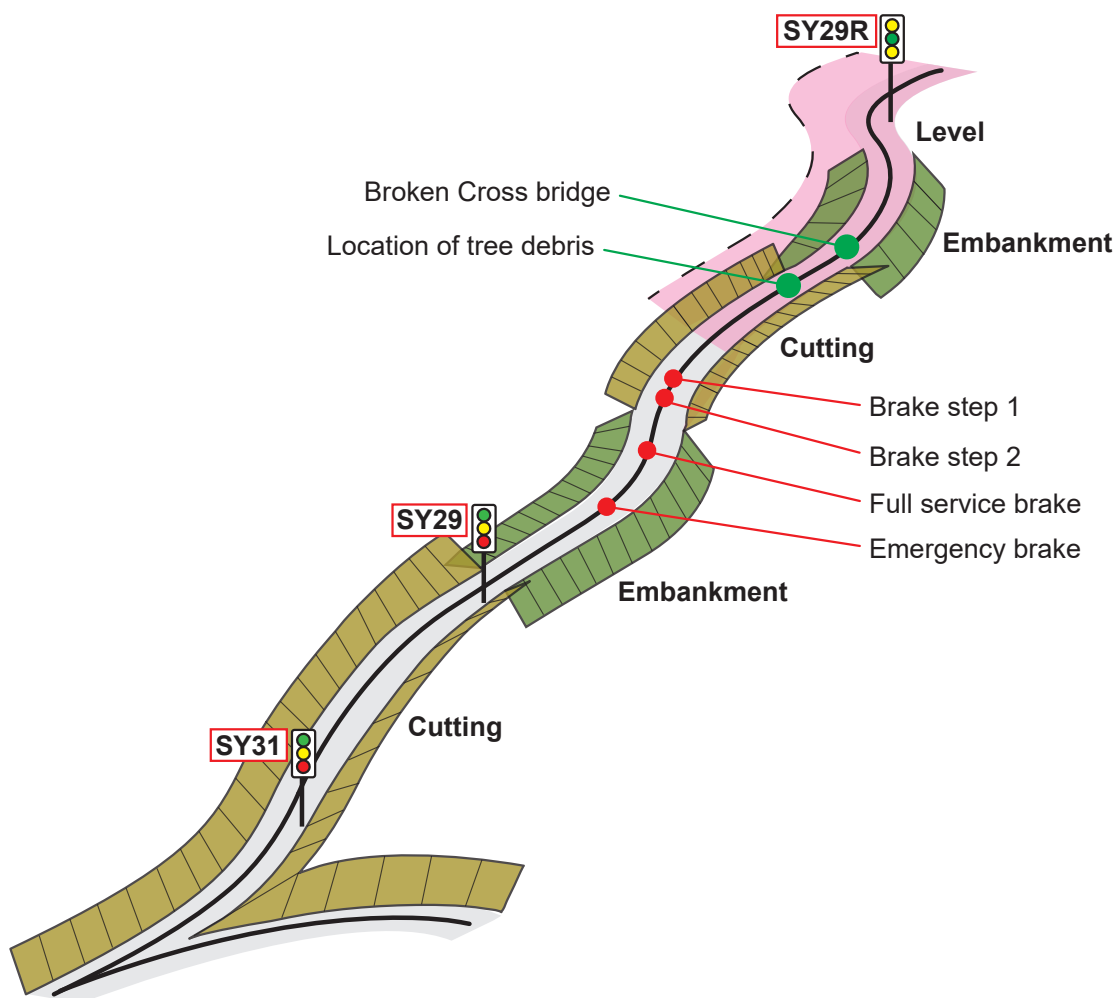
Figure 16: Topography data showing the embankment/cutting profiles, including the previously classified high risk of low adhesion site (pink shaded area - see paragraph 143), the location of Broken Cross bridge, tree/associated debris (green dots), the braking points of train 1L53 (red dots) and signals.

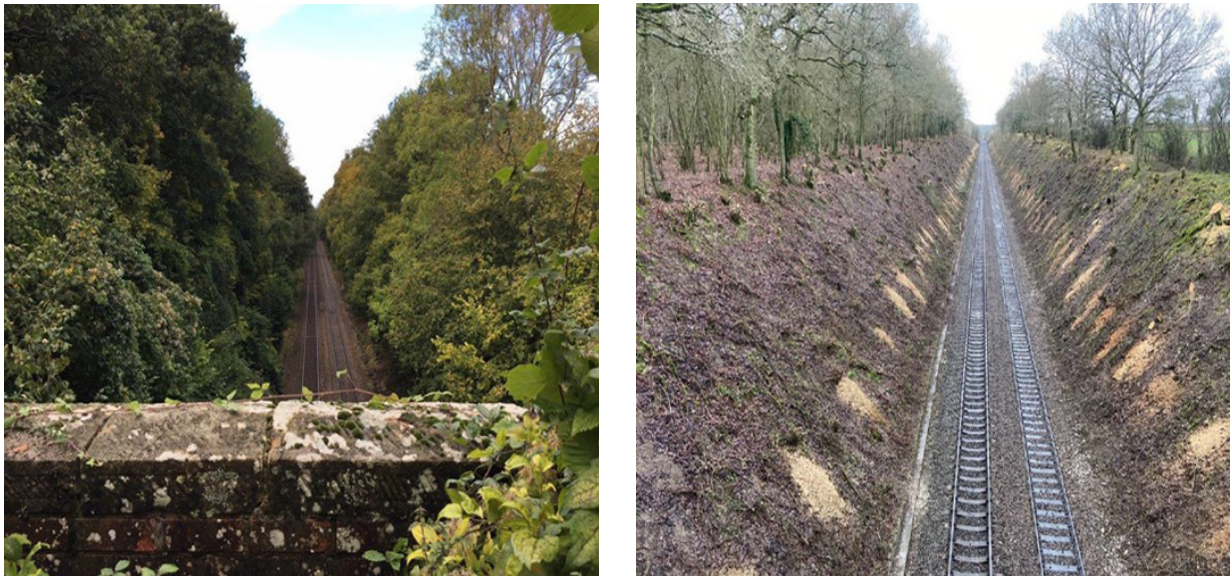
142 Network Rail's Wessex route was unable to provide any data from leaf fall inspections before 31 October 2018. However, witness evidence suggests that from 2016 a section of track between Overton (55 miles 42 chains) and Whitchurch (59 miles 8 chains), just over 20 miles from the accident site, had been classified as a 'supersite', that is, one suffering from excessive leaf fall resulting in railhead contamination causing frequent WSTCF. Figure 28 shows the effects of vegetation work undertaken during 2019/20. There is no evidence to suggest that the track in the vicinity of the accident had been classified as a 'supersite'. In the absence of any historical documentation, RAIB was unable to confirm the technical basis for categorising a site as a low adhesion 'supersite', but it is possible that this was what later became known as an HRLA site.

Figure 28: The main lines between Overton and Whitchurch looking towards Salisbury showing the condition of the vegetation before (taken in summer) and after (taken in winter) vegetation work was completed in 2019/20.

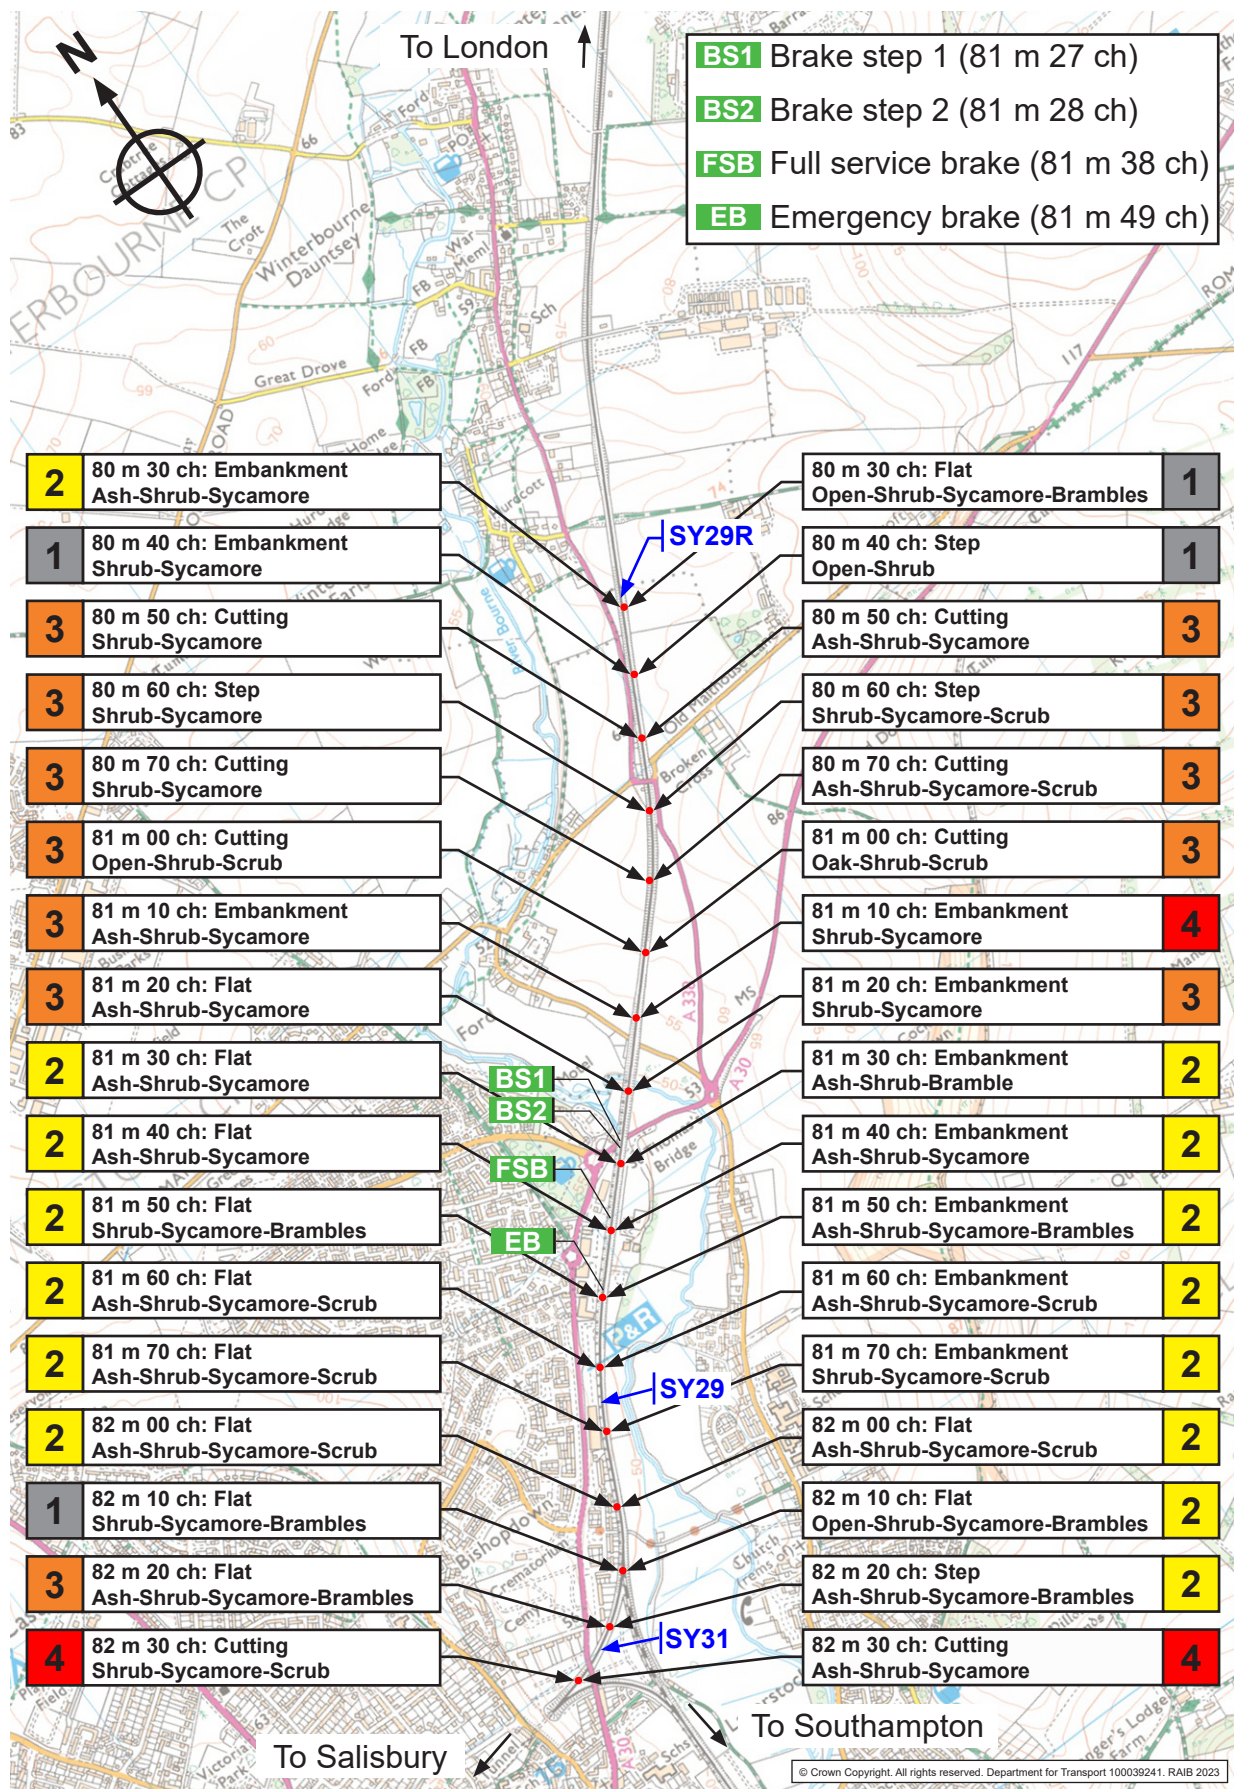
- 146 In June 2021, arboriculture specialist contractors undertook a further leaf fall inspection of the Down Main line. The results from this assessment showed the presence of several level 4 sites between 80 miles 30 chains and 82 miles 30 chains but no level 5 sites (figure 29). The risk scores resulting from this inspection for the sites that had previously been identified on the Down Main line in 2018 and 2019 as level 4 or level 5 were scored at lower levels. Of particular note was the section around 80 miles 30 chains. This was reassessed as a level 1 site having previously been scored as a level 5 site. This scoring meant that none of the line was categorised as being an HRLA site and, as such, no actions to reduce the trees or vegetation were required. However, RAIB found that this section was not removed from the table of HRLA sites, likely because the SDS risk assessment process (paragraph 139) is undertaken on an annual basis and requires consideration of other operational experience as well as the leaf fall risk assessment.

- 147 No action to manage the vegetation had been taken between 2018 and 2021 and video footage shows that vegetation continued to grow on the main lines approaching Salisbury Tunnel Junction between 2019 and 2021. A comparison between the 2021 scores and those from earlier inspections therefore brings into question the robustness of the process. It is also unclear whether classification of sites with an assessment score of between 21 and 26 as *'high risk during peak leaf fall period and wet conditions'* in NR/L2/OTK/5201/F3076 may have affected the contractors' scoring. As explained in paragraph 139, operational standard NR/L2/OPS/095 did not require any action to be taken for such sites, but the contractors were unlikely to have been aware of this. Figure 32 shows the change in the management of vegetation at Salisbury Tunnel Junction over the previous decades.

Figure 29: Network Rail (Wessex) data in diagrammatic format showing mileage, topography, tree species and leaf fall risk assessment data scores (June 2021).

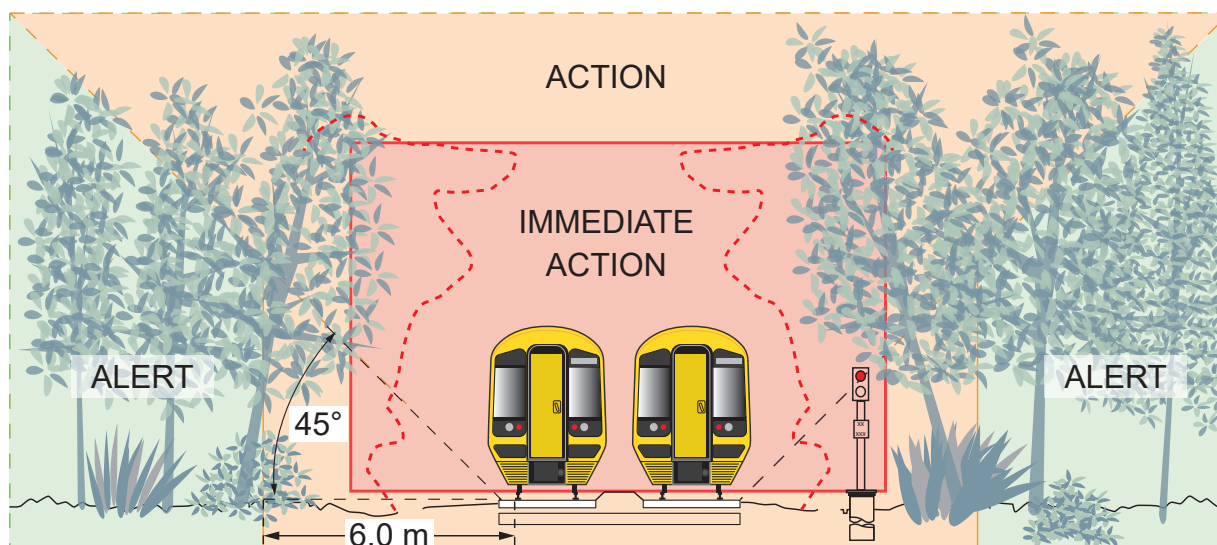
Figure 31: RAIB diagram showing the action zones from Network Rail standard NR/L2/OTK/5201, train profiles similar to class 159 trains, and tree growth as found on certain sections of the main lines between signals SY29R and SY31 (red dotted line).

148 Furthermore, an examination of the section of line from signal SY29R to beyond signal SY31 after the accident (paragraph 130) showed there were areas of medium to heavy railhead contamination which would have resulted in low levels of wheel/rail adhesion, even on sections that had low scores in the 2021 risk assessment. The amount and condition of the vegetation and trees were also seen to be non-compliant with the wider requirements of NR/L2/OTK/5201 (figure 31).

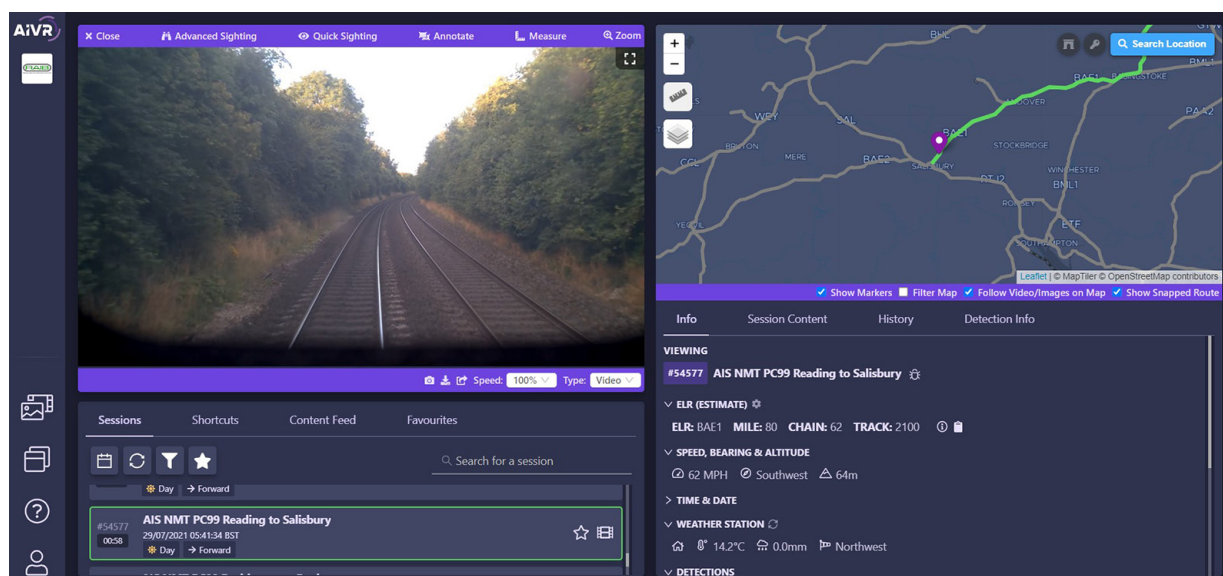
- 152 The last vegetation inspection undertaken by the MDU before the accident was carried out remotely between 13 and 14 June 2021 by the section manager reviewing footage that had been taken the previous week from high-definition trainborne cameras (figure 33).²¹ No WAIFs were raised from this inspection since the section manager was aware that existing work orders were already in Ellipse from the previous inspection in 2019. The tree and vegetation work to reduce the risk was further deferred to April 2022 (paragraph 150).

Figure 33: Automated Intelligent Video Review software for cab/remote assessments of vegetation (image courtesy of Network Rail and One Big Circle).

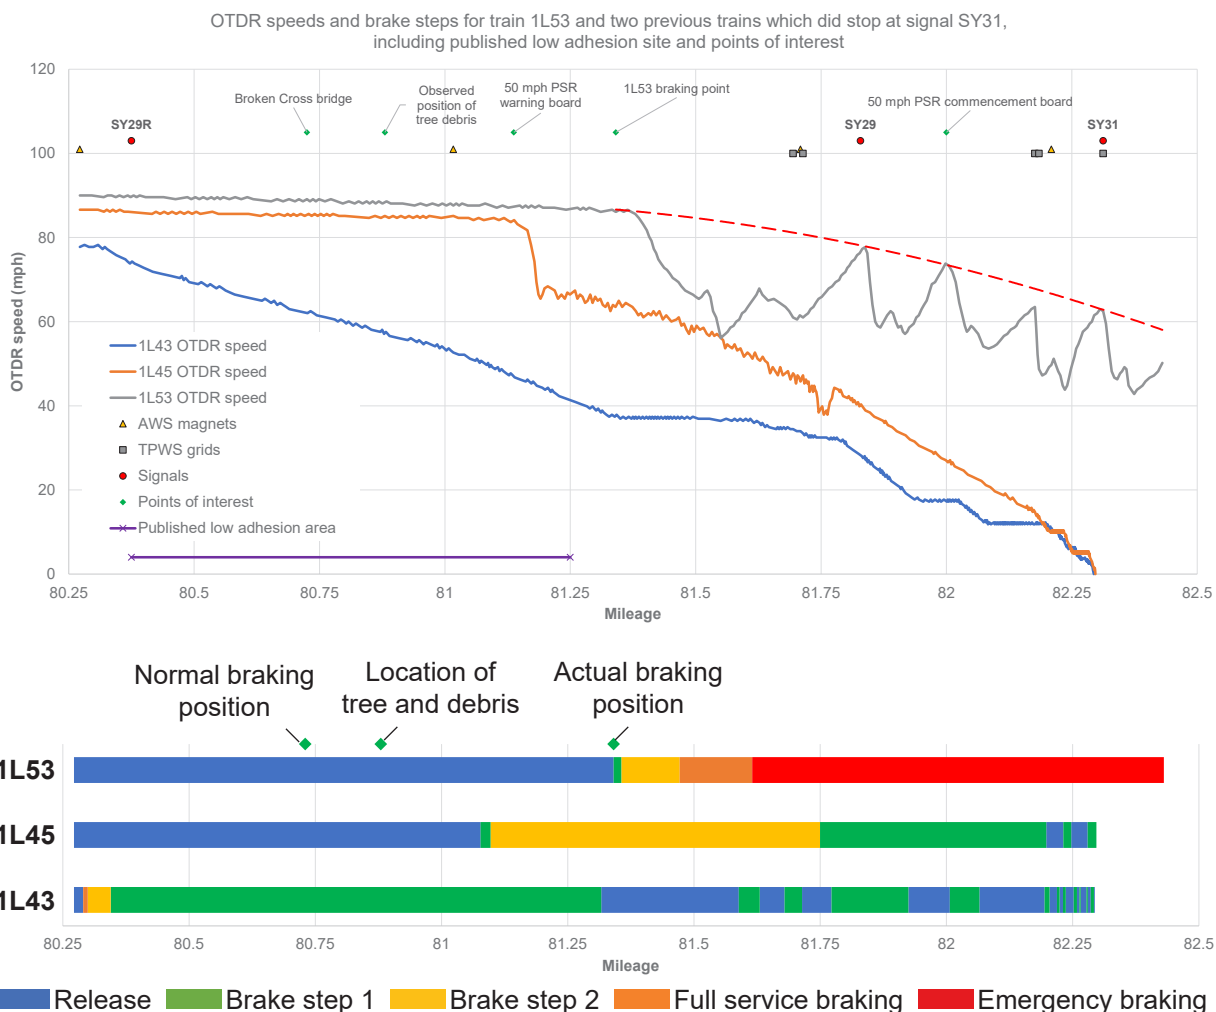
- 64 Equipment fitted to the train recorded that the WSP system was active from the start of braking and throughout the various brake applications, and this would have demanded the sanding system to discharge sand onto the railhead. However, this had a limited effect on reducing the speed of the train (figures 34 to 36).

- 179 The last train to encounter signal SY31 showing a red aspect before train 1L53 was train 1L45 (formed of a three-carriage class 159 unit). At 16:45 hrs, when the weather was still dry, the driver of train 1L45 braked shortly before the PSR warning board, beyond the location of the fallen tree, but around 420 metres before the actual braking point of train 1L53, while travelling at 84 mph (135 km/h). Train 1L45 took approximately 1,980 metres to stop. This consisted of approximately 790 metres in brake step 1 and 1,080 metres in brake step 2. For the remainder of the distance, train 1L45 was coasting. Train 1L45 stopped approximately 25 metres on approach to signal SY31. Although the driver of train 1L45 braked later than the driver of the earlier train 1L43, and encountered a greater level of WSP activity, this train was also able to stop before passing signal SY31 (figure 34).

Figure 34: Speeds for trains 1L43 (blue), 1L45 (orange) and 1L53 (grey) as recorded by their respective OTDRs, and important locations. The red dashed line indicates an approximation of train 1L53's 'ground speed'. The OTDR has recorded the measured wheel as travelling more slowly because it is sliding. A similar but less pronounced effect can be seen during part of train 1L45's data. Braking techniques employed by train drivers of trains 1L43, 1L45 and 1L53 are shown in the graph below.

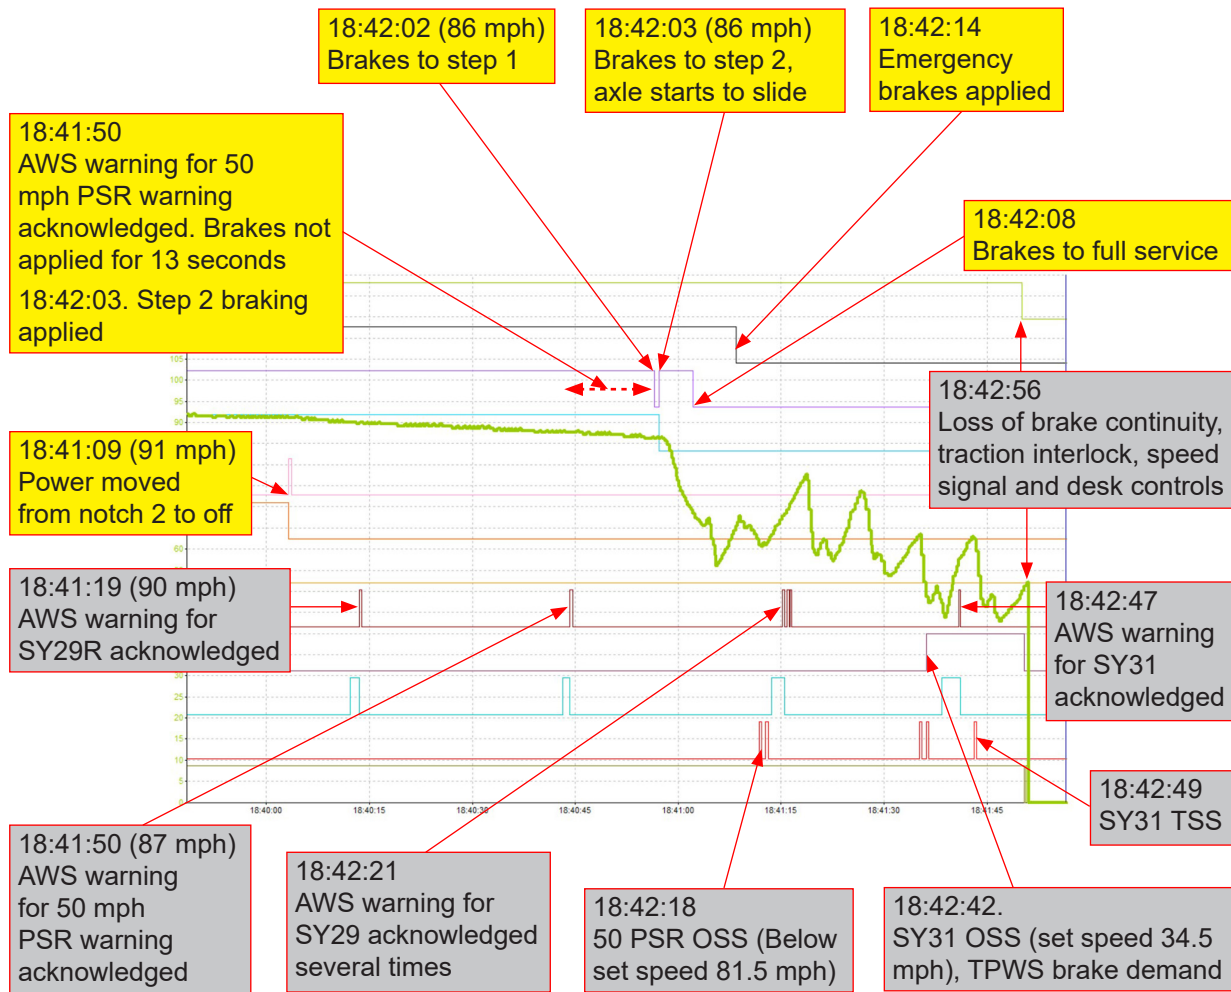
- 175 The driver stated that on the evening of the accident he intended to use the fallen tree and associated debris that he had seen on his earlier journey to London as his marker after which to start braking (paragraph 47 and see paragraph 181). The tree was 250 metres beyond Broken Cross bridge and braking here was also consistent with the range of braking points used by other drivers. However, OTDR data shows that the driver actually applied the brakes approximately 750 metres beyond the location of the fallen tree and associated debris and 1,000 metres beyond Broken Cross bridge, with the train travelling at 86 mph (138 km/h) (figure 35 and see paragraph 189).

Figure 35: Annotated OTDR trace from train 1L53 showing braking and AWS/TPWS activations and acknowledgements.

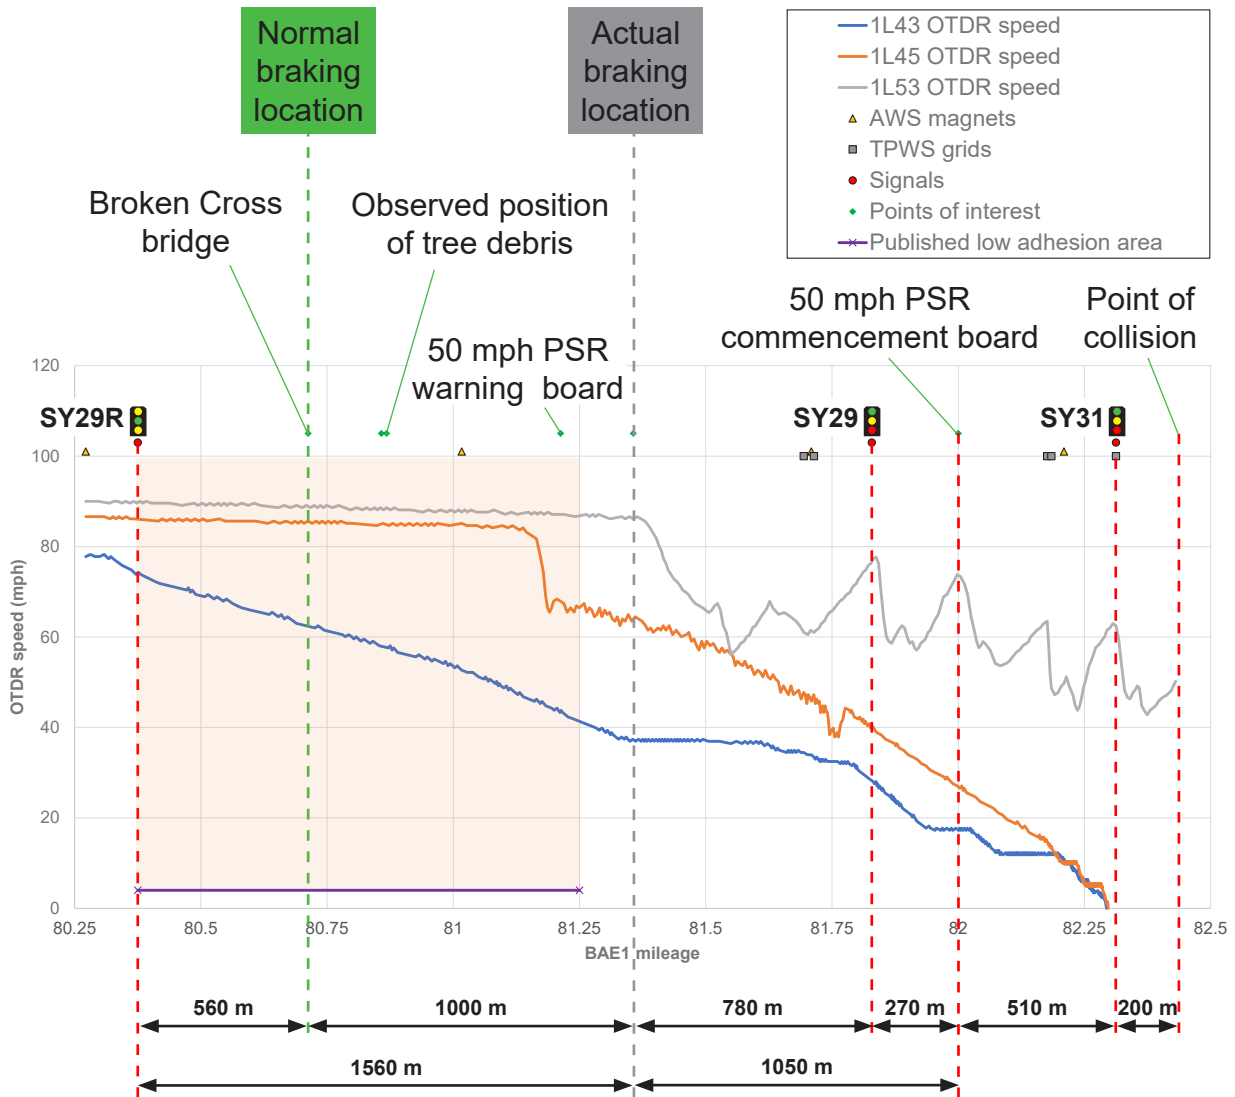
- 186 The signalling on the approach to Salisbury Tunnel Junction provides an excessive braking distance for passenger trains between signals SY29R and SY31 (figure 36). Excessive braking distances mean that drivers must delay full braking beyond the double yellow aspect signal, otherwise they could stop short of the red signal and/or incur time delays on their journey.

Figure 36: Annotated OTDR traces from trains 1L43, 1L45 and 1L53 showing important locations and distances.

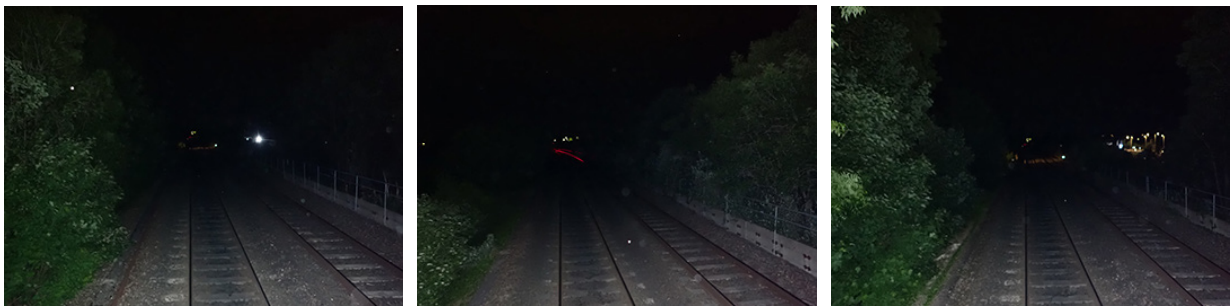
- 194 Signal SY29 is approached around a left-hand curve after a straight section of railway. Along this straight section, there is an increase in artificial lighting from streetlights as the train approaches the outskirts of Salisbury, as well as a local garage forecourt and a supermarket car park (figure 38). The light cast from the signal aspect at signal SY29 can also be visible, reflecting on the rails, although on the evening of the accident the reflection from the railhead may have been limited due to the railhead contamination.

Figure 38: RAIB reconstruction showing the environment on approach to signal SY29: (left) 798 metres from signal SY29; (centre-enhanced) reflection from lighting from signal SY29 at danger on the railhead; and (right) 773 metres from signal SY29 with street lighting and car forecourt lighting visible.

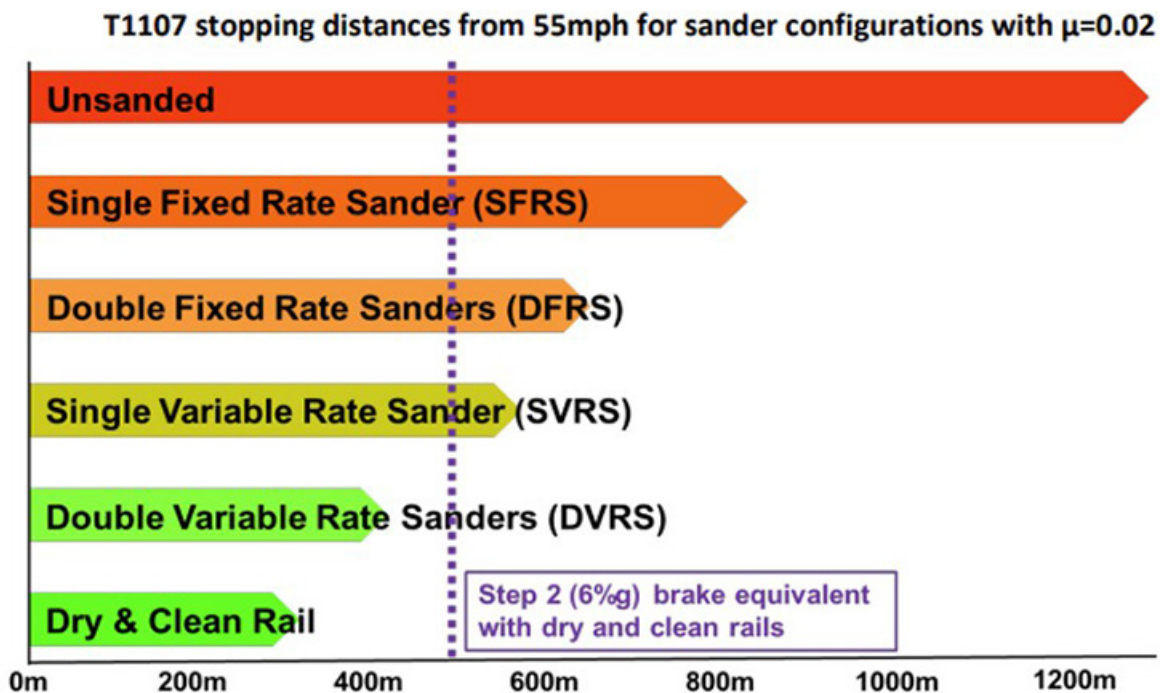
221 RSSB research illustrates the potential benefits of enhanced sanding systems, as shown in figure 39. RAIB has undertaken a simple analysis, using the underlying data from the RSSB research, to estimate the effect if train 1L53 had been fitted with a DVRS system. The higher sand delivery rates of a DVRS system would certainly have provided better low adhesion braking performance, which would have led to a reduced collision speed. Although it is not possible to be certain of the actual benefits of DVRS in the specific circumstances of this accident, the analysis undertaken by RAIB suggests that it is probable that the collision would have been avoided altogether. The analysis also suggests that it is possible that a DVRS equipped train would not have passed signal SY31.

Figure 39: Diagram from RSSB research project T1107 showing the potential benefits of variable rate sanding systems.

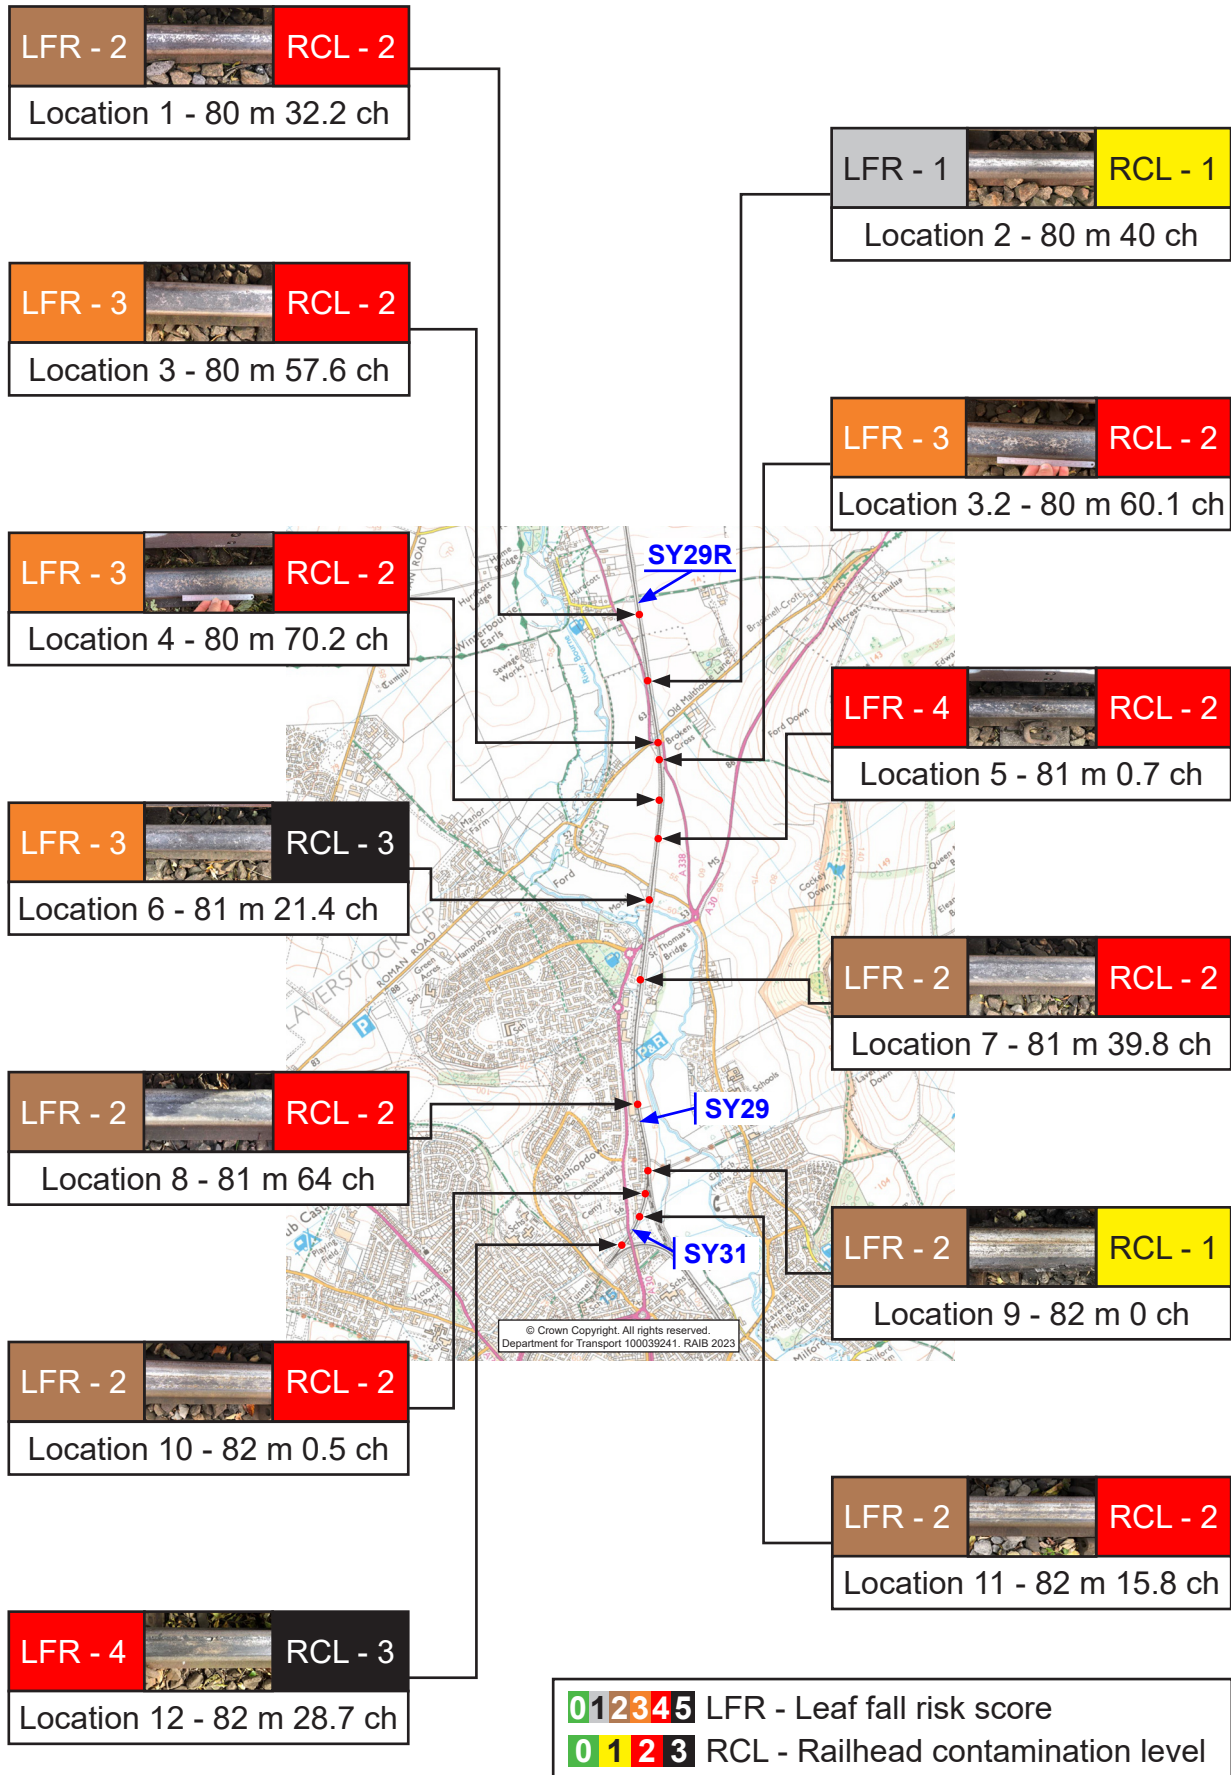
223 Documentary and witness evidence shows that before the accident Network Rail's Wessex route had not correctly identified sections of track as HRLA sites. This was probably because the information (figure 40) that the SDS was provided with and which they were using to identify such locations was inaccurate. These inaccuracies arose because the process employed to inspect and risk assess locations, and the subsequent dissemination of the information gathered, was ineffective (paragraph 136).

Figure 40: Braking locations for train 1L53 with predicted leaf fall risk scores (0 to 5) from the leaf fall assessment completed in June 2021 and corresponding physical railhead contamination level found on site (0 to 3) on 31 October 2021.

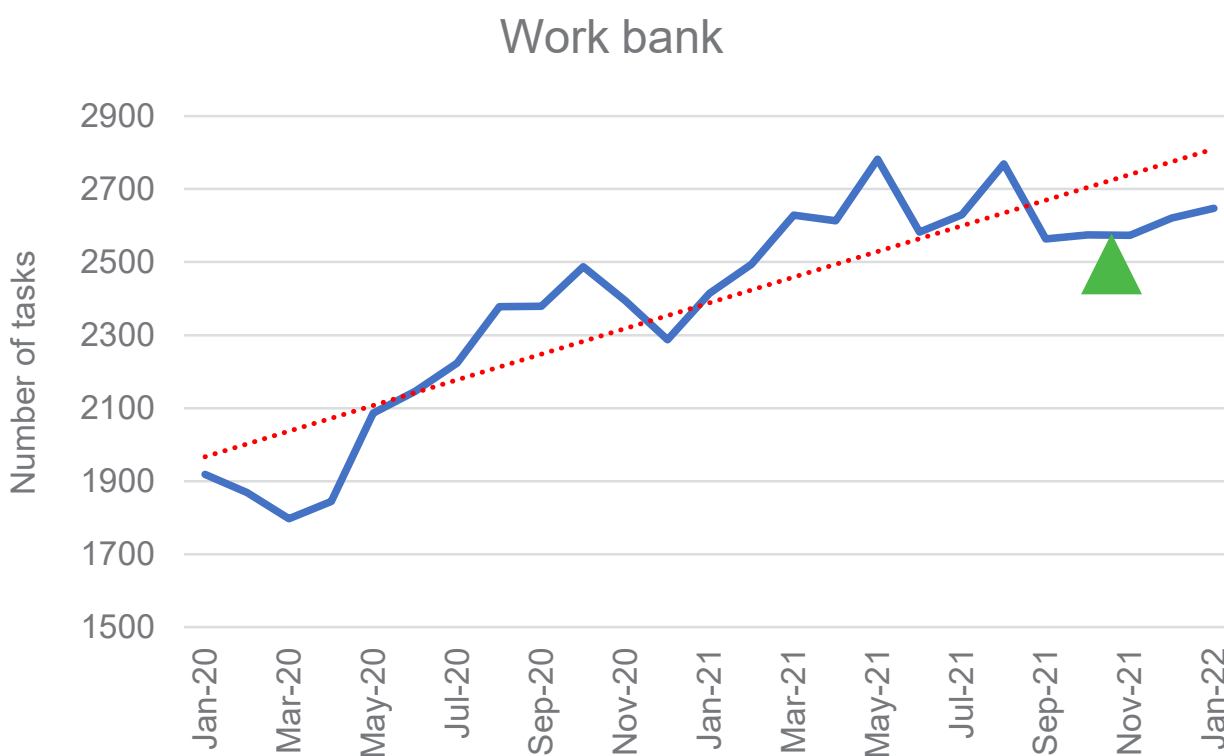
Figure 41: Ellipse work bank (number of tasks) levels (blue solid line) and mean average level (red dotted line) between January 2020 and January 2022 (green triangle shows accident date).

229 During 2020 and 2021, the SDS realised they were struggling with workload and that management of the autumn process could not be undertaken by one person alone. This problem had also been identified by one of their predecessors in 2017. This predecessor prepared a proposal to increase the number of seasons delivery staff to mitigate the risks of relying on a single, relatively junior member of staff. Neither Network Rail's Wessex route nor South Western Railway operations departments formally responded to the proposal, although a lack of budget for the new roles was stated in a subsequent conversation as a reason for not pursuing the new roles.

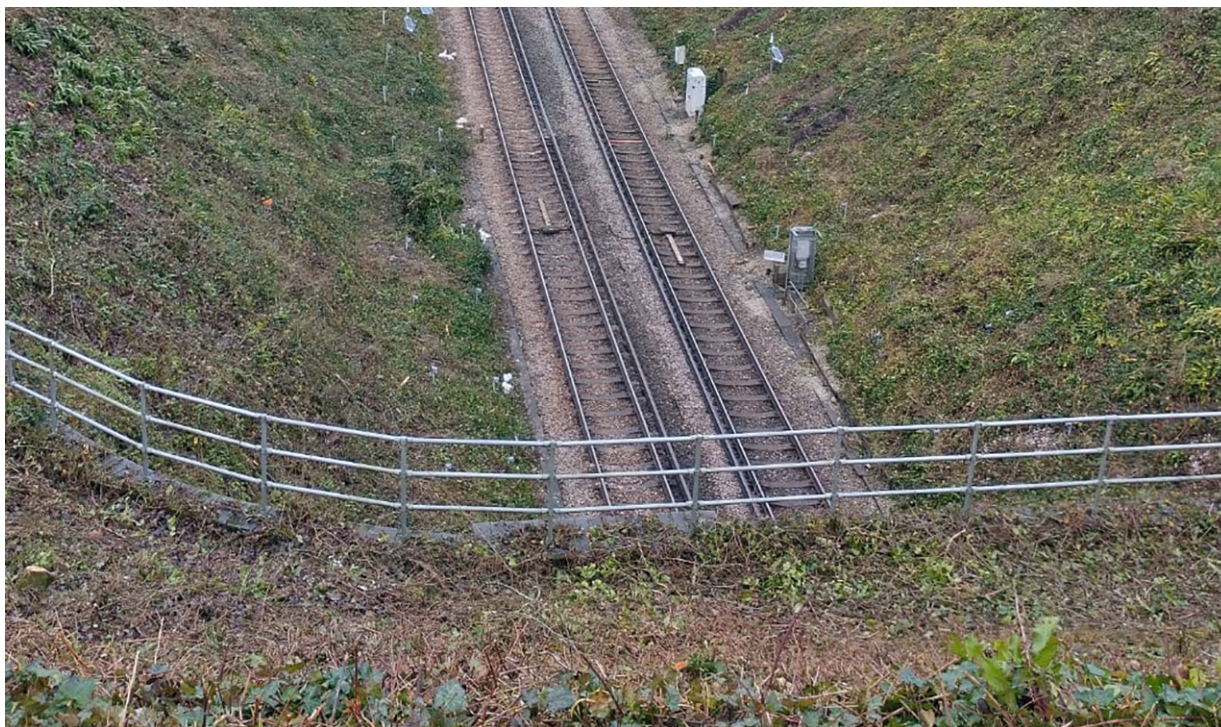
238 When the SAE asked the off track section manager to address the excessive vegetation growth on the Up and Down Main lines at Salisbury in February 2021 (paragraph 226), the off track section manager reported that the complexity of the lines made track access difficult, so it was not possible to schedule such a maintenance task to inspect or cut back the vegetation.

Figure 43: Image taken from a vantage point by a Network Rail MOM inspecting an HRLA site (post-vegetation clearance).
