Rail Accident Investigation Branch

Rail Accident Report

Collision between passenger trains at Salisbury Tunnel Junction, Wiltshire 31 October 2021

Report 12/2023
October 2023

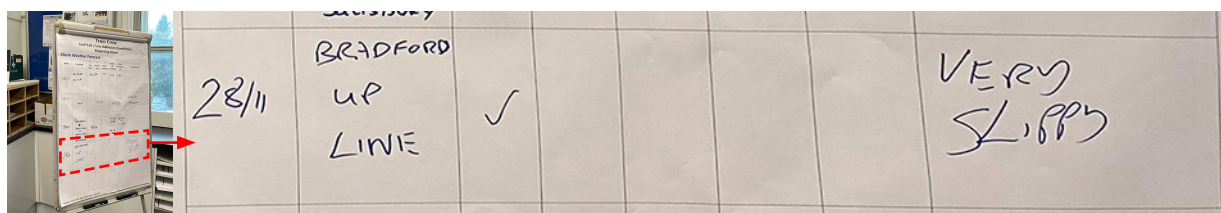
- 274 During autumn 2021, SWR's driver managers installed flip charts at booking-on points as an informal means for drivers to communicate to each other any adhesion issues during their journeys (figure 44). Witness evidence shows that some drivers did not consult the flip charts, either because they did not book on for duty at the booking-on point or because they believed they were out of date by the time they read them. Some drivers were under the impression that reporting low adhesion on the flip chart meant that they were not required to formally report it to the signaller.

Figure 44: Flip chart (dated 28 November 2021) used by drivers at Salisbury depot to report low adherence conditions and other safety issues.
