# Rail Accident Report

## **Serious injury to a passenger alighting from a train at Loughborough Central station 14 January 2023**

Report 13/2023  
October 2023

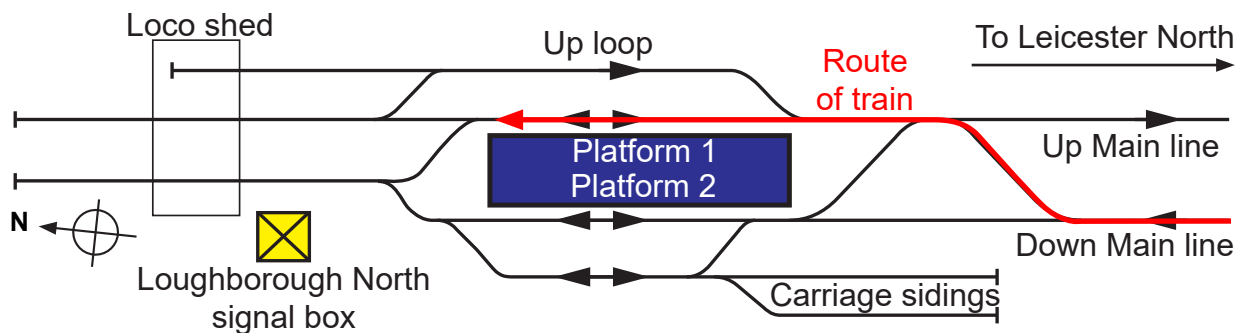
Figure 3: Layout of the track around Loughborough Central station.

- 55 Loughborough Central station has two platforms, numbers 1 and 2, located between the Up and Down Main lines (a configuration referred to as an 'island platform' (figure 3)). Platform 1 runs along the east side of the station. The horizontal length of each platform, between the ramps at each end, is 122 metres.
- 56 At the north end of the island, a ramp is provided which slopes from platform height to ground level. This ramp runs across the whole width of the platform island. Visitors can use a path down the middle of the ramp to access a walkway that leads to the Locomotive Shed and a picnic area. The level part of the platform is marked out by white lines painted on the platform edge. At each end, where the platform end ramp starts, there is a short white line perpendicular to the platform edge (figures 6 and 11).

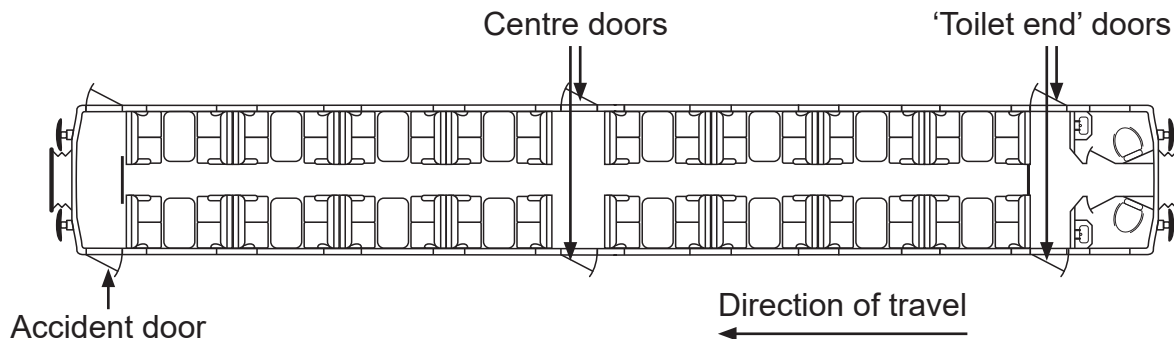
Figure 5: Layout of a Mk1 Tourist Second Open (TSO) coach.

58 Coach 4857 had a pair of toilets at one end with the vestibule inboard of them (paragraph 14, figure 5). Consequently, the passenger doors at that end are around 1.36 metres further inboard than the leading end doors. When the train travelled north from Leicester North station, the toilets were at the trailing end of coach 4857. If the coach had been orientated with the ‘toilet end’ leading, the external door at that end would have been adjacent to the start of the platform end ramp.
