Rail Accident Investigation Branch

Derailment Mechanism

Rail Accident Investigator's Seminar

Carmont derailment site

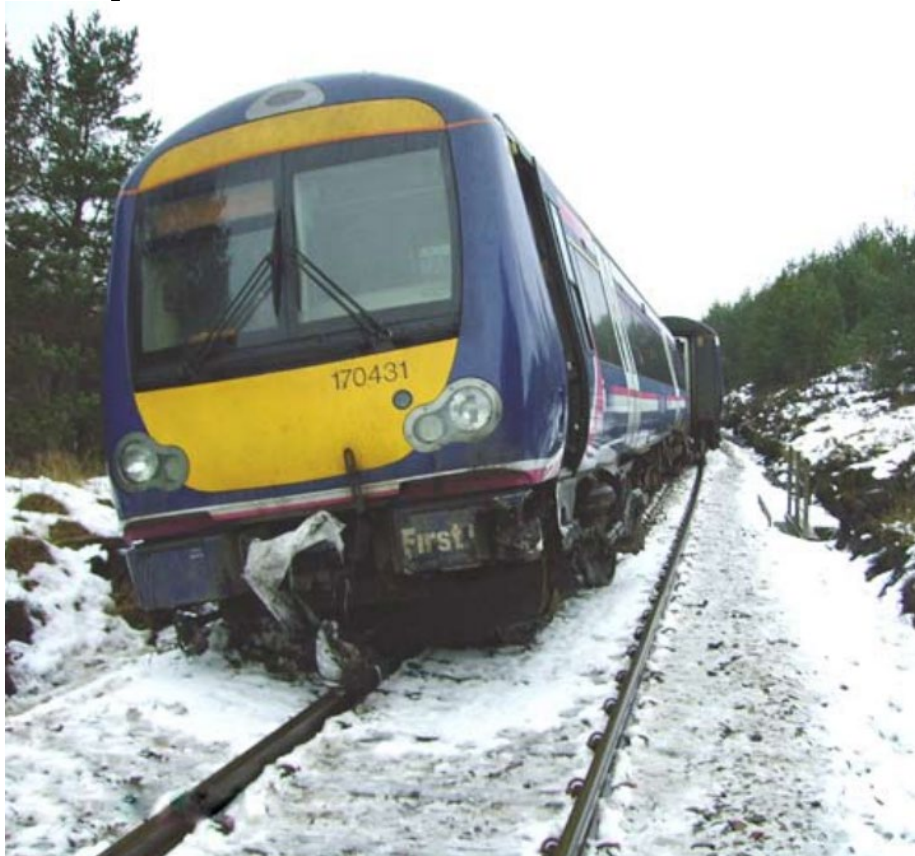
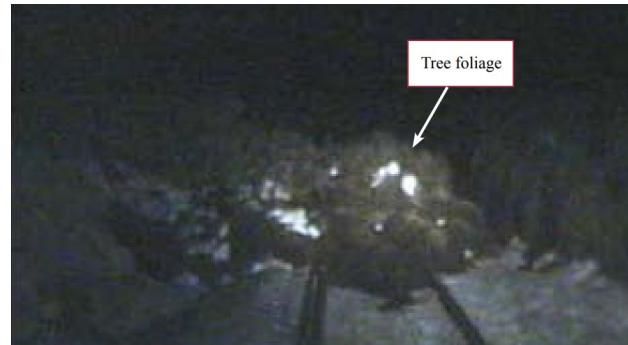
Moy 26 November 2005

Landslide debris accumulated under cab lifting the wheels, resulting in leading vehicle immediately deviating from the track

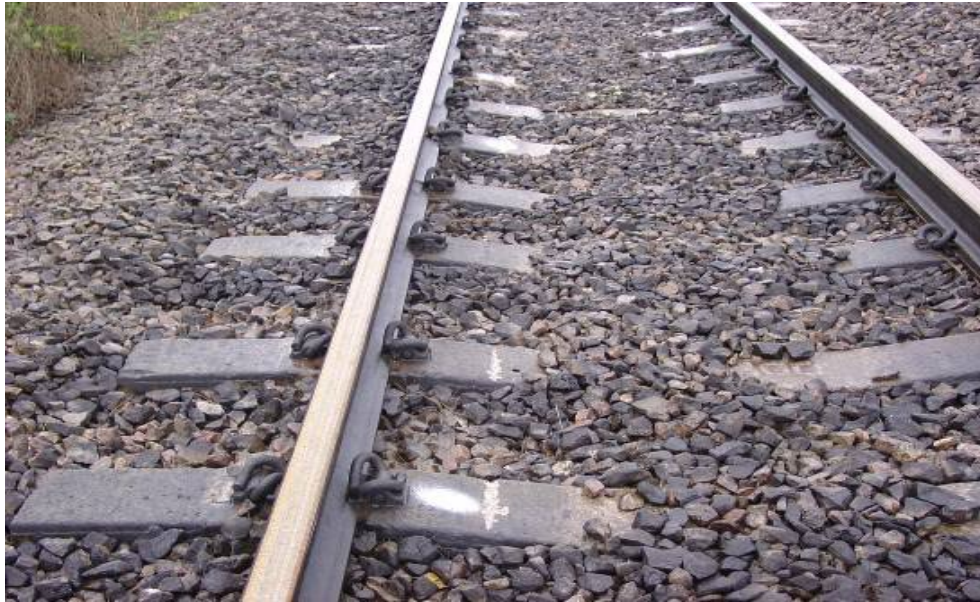
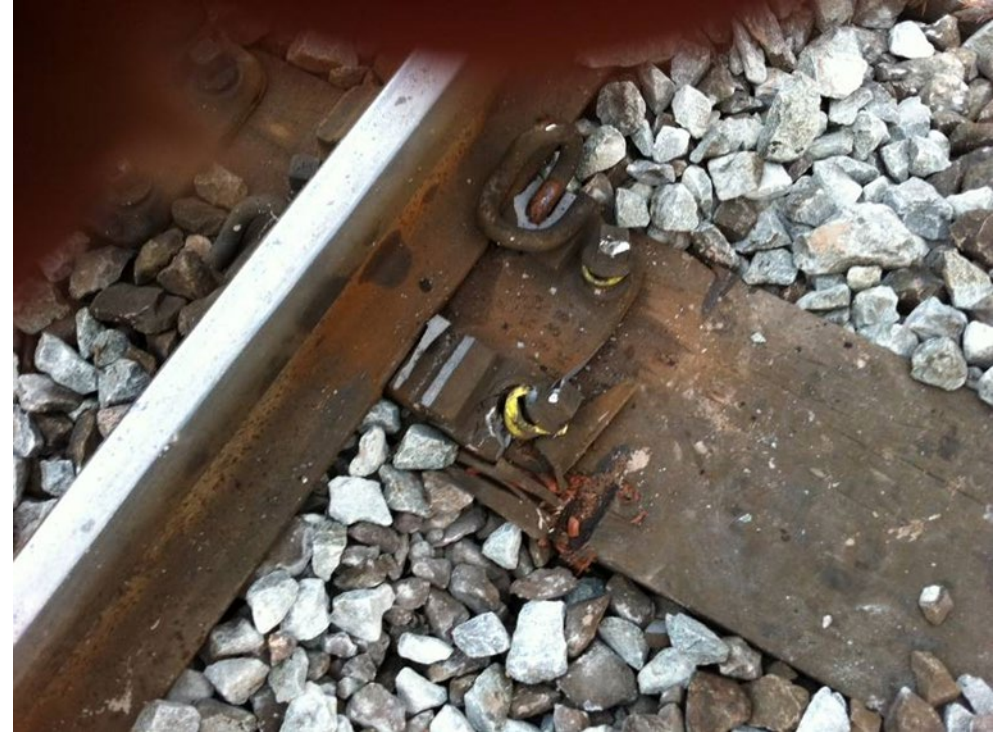
Wheel path

- Derailed wheels leave damage on the track.
- Use to identify point of derailment (PoD).

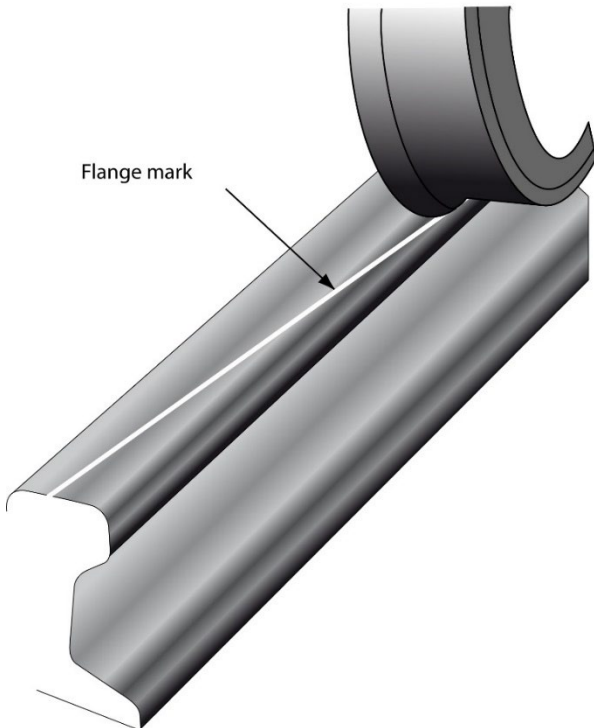
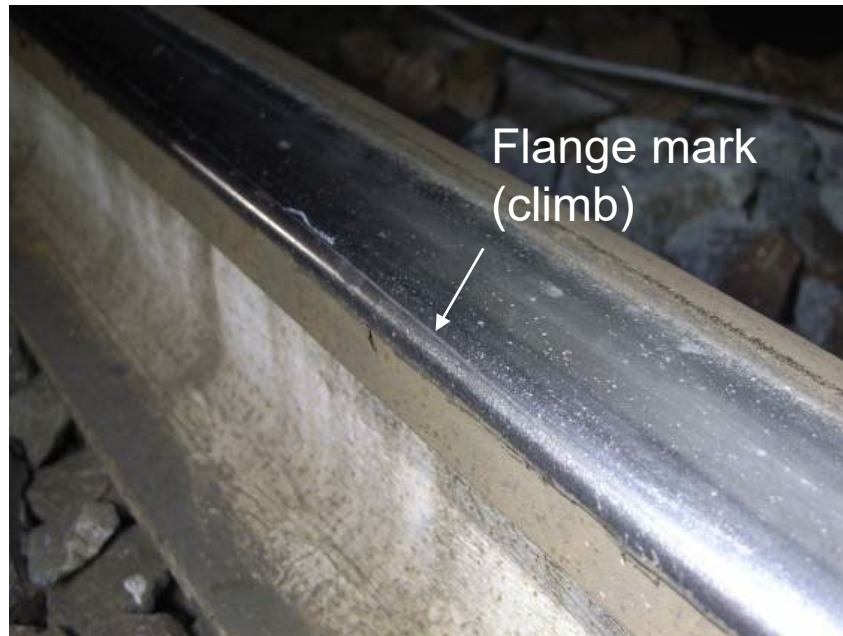
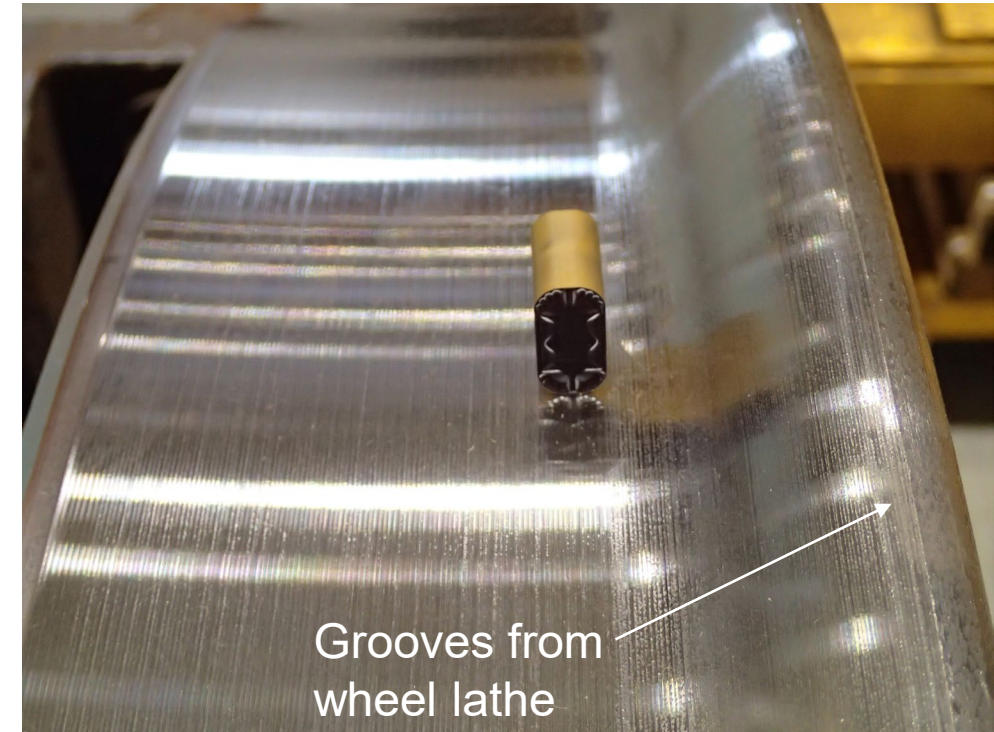
Flange marks

- Marks from wheel flange as it:
 - climbs the gauge face
 - runs over the rail head
 - drops down the field face

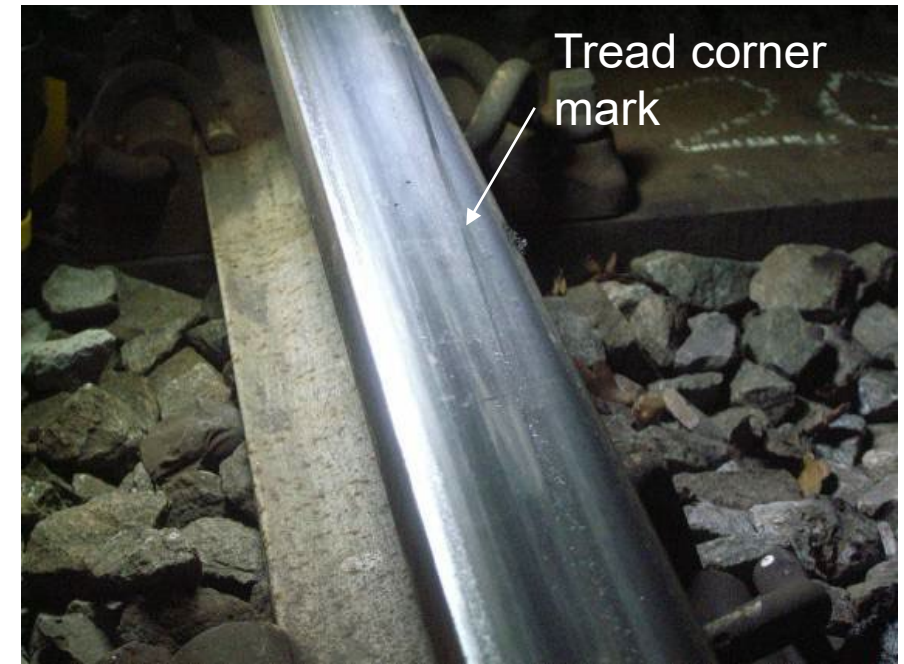
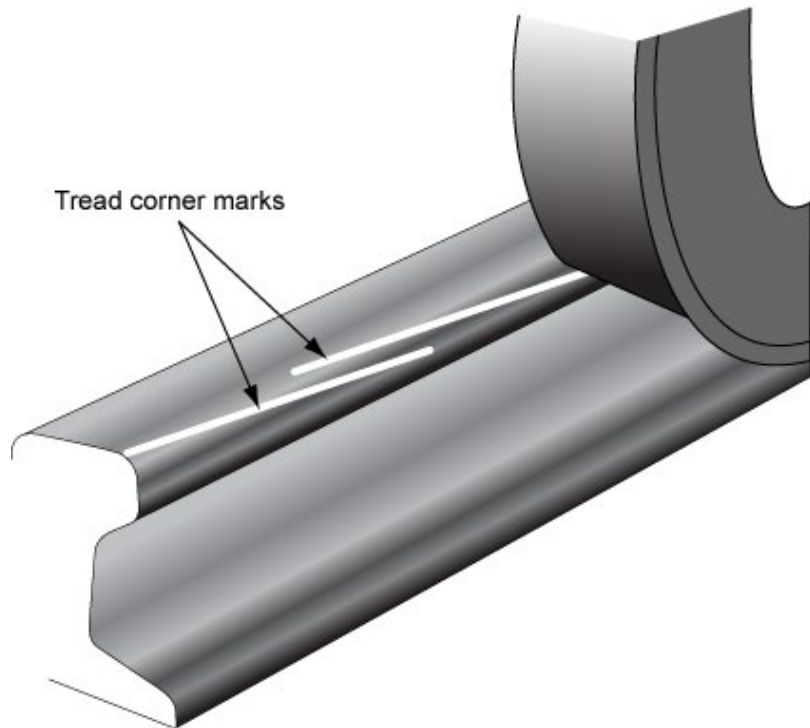
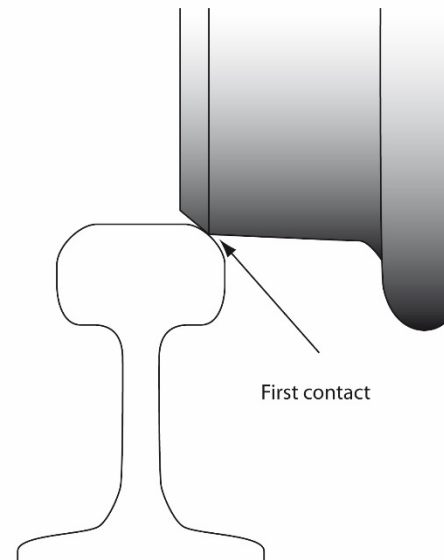
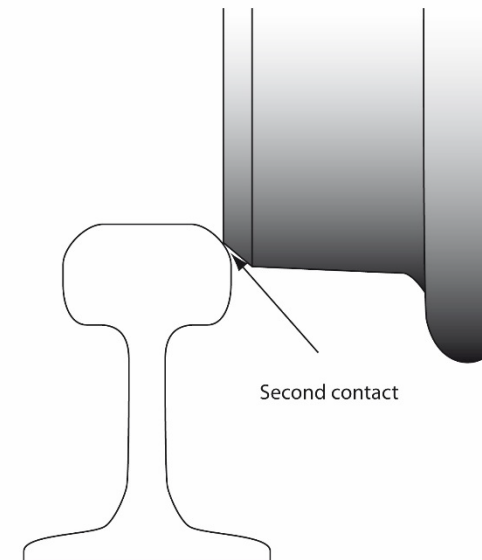
Tread corner marks

- As wheel flange drops down the field face, the wheel opposite drops into the four-foot forming a tread corner mark.

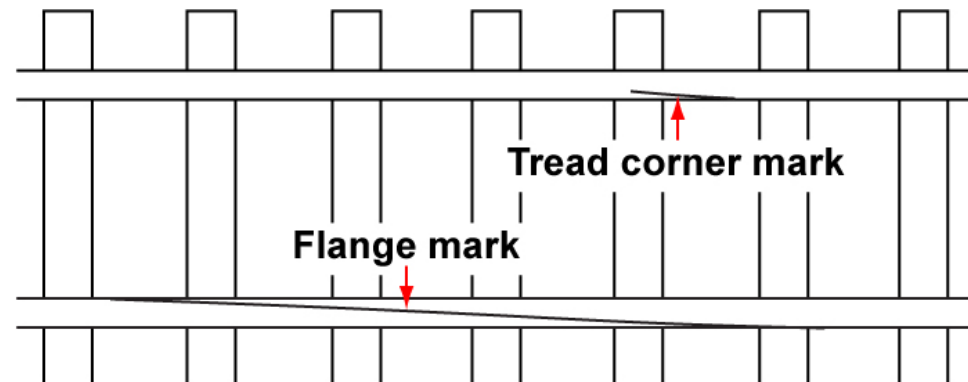
- RH flange climbs gauge face
