Rail Accident Investigation Branch

# Rail Accident Report

## **Freight train derailment at Petteril Bridge Junction, Carlisle 19 October 2022**

Report 10/2023  
October 2023

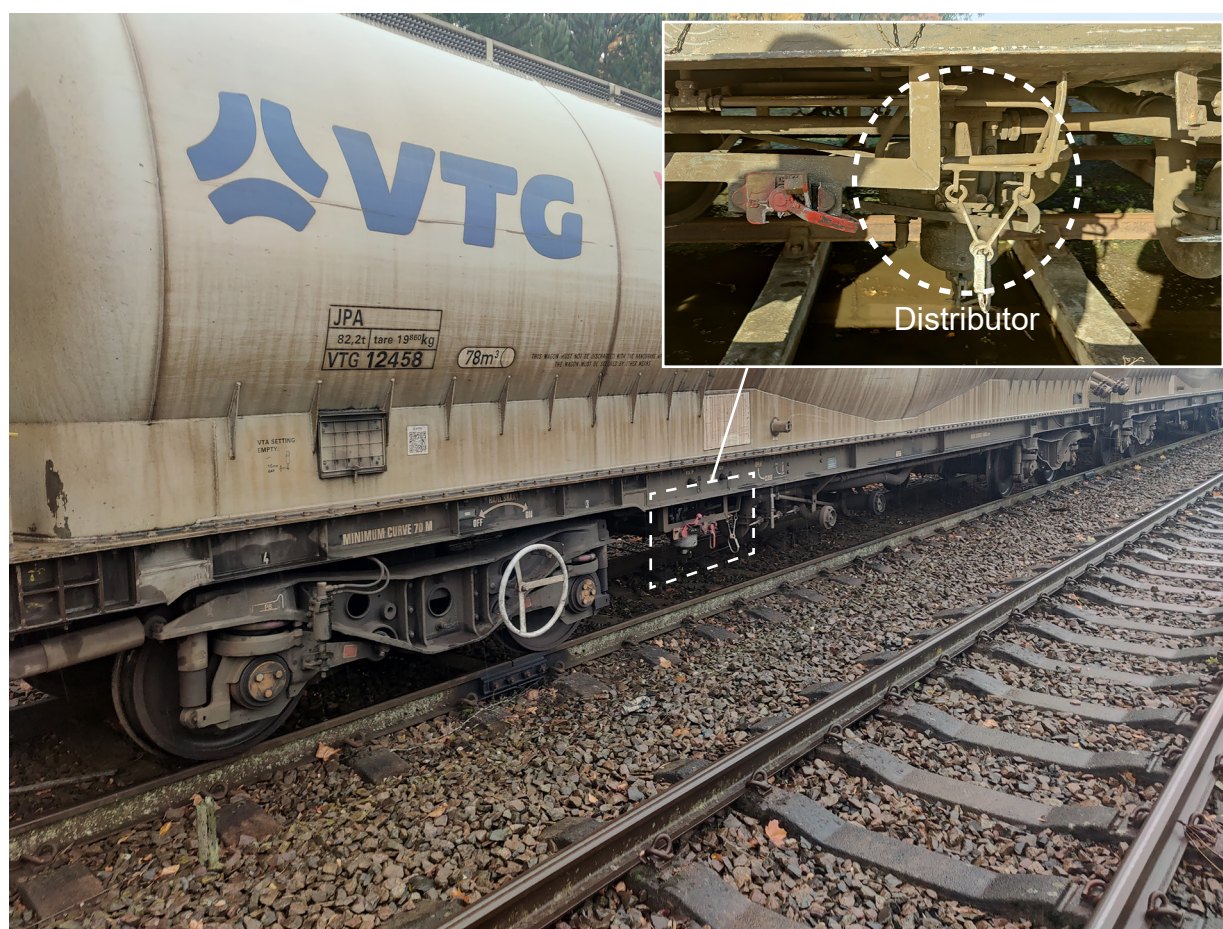
Figure 5: A JPA wagon and the location of its distributor (auxiliary reservoir hidden under wagon).

- 18 Each wagon is fitted with a single brake distributor (figure 5) and a separate auxiliary air reservoir located under the centre of the wagon body. A reduction in the pressure in the train's brake pipe causes the distributor to operate and admit air from the auxiliary reservoir to the two brake cylinders on each bogie of the wagon. Air pressure in the brake cylinder then moves a piston which, in turn, acts through a system of rods and beams to apply the brake blocks to the wheel treads. As with most freight wagons, JPA wagons are not fitted with a wheel slide protection system. Such systems, common on passenger trains, detect wheelsets starting to slide when braking and automatically reduce the brake force being applied to the sliding wheelset until the system determines that they are no longer sliding.

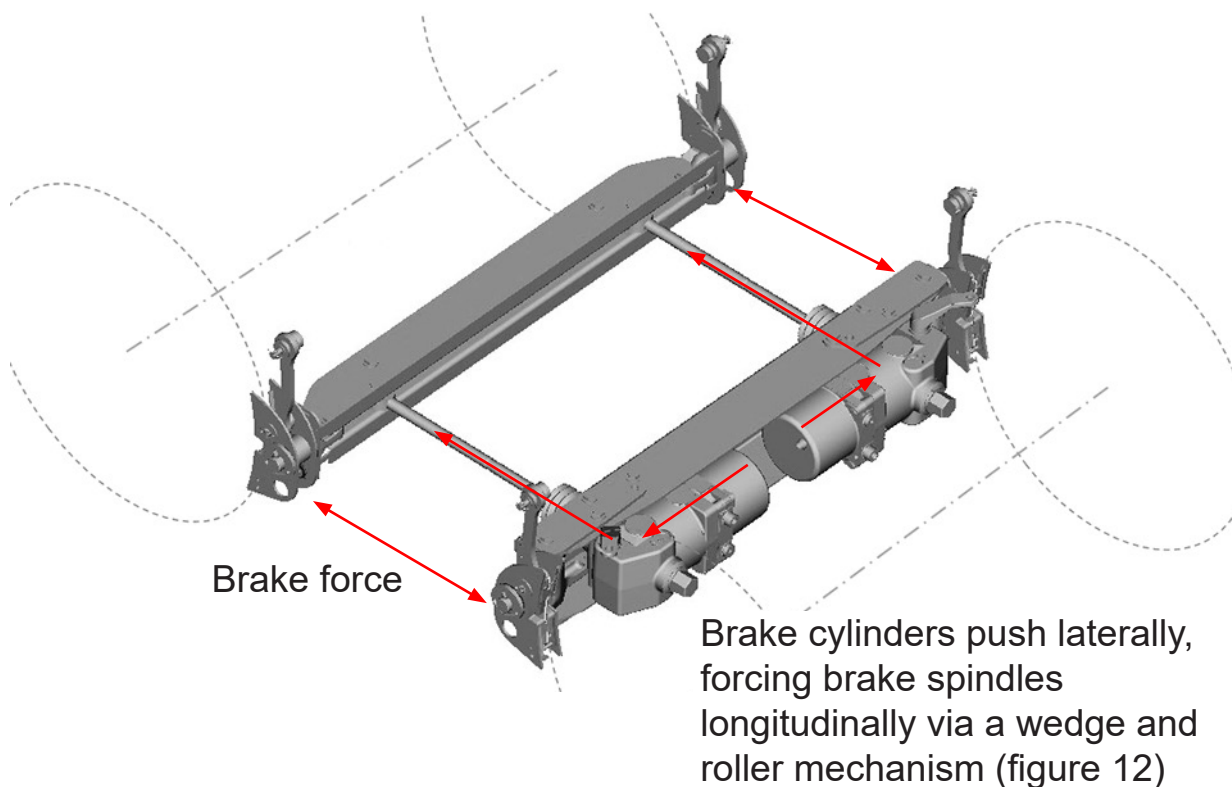
Figure 6: BFCB braking system for one bogie (brake blocks not shown).

20 The BFCB system consists of two transverse beams fitted between the axles (figure 6). The ends of both beams are attached to brake block holders, suspended from brackets on the bogie by hangers. The inner primary beam (the one nearest the centre of the wagon) carries a pair of brake cylinders that operate by extending longitudinal rods, which pass through the bogie frame. These spindles push the primary and secondary beams apart, pressing the brake blocks against the wheels with equal force (figure 7). The system is self-adjusting, automatically taking up excessive slack (for example, caused by brake block wear) by means of slack adjusters within the brake cylinders.

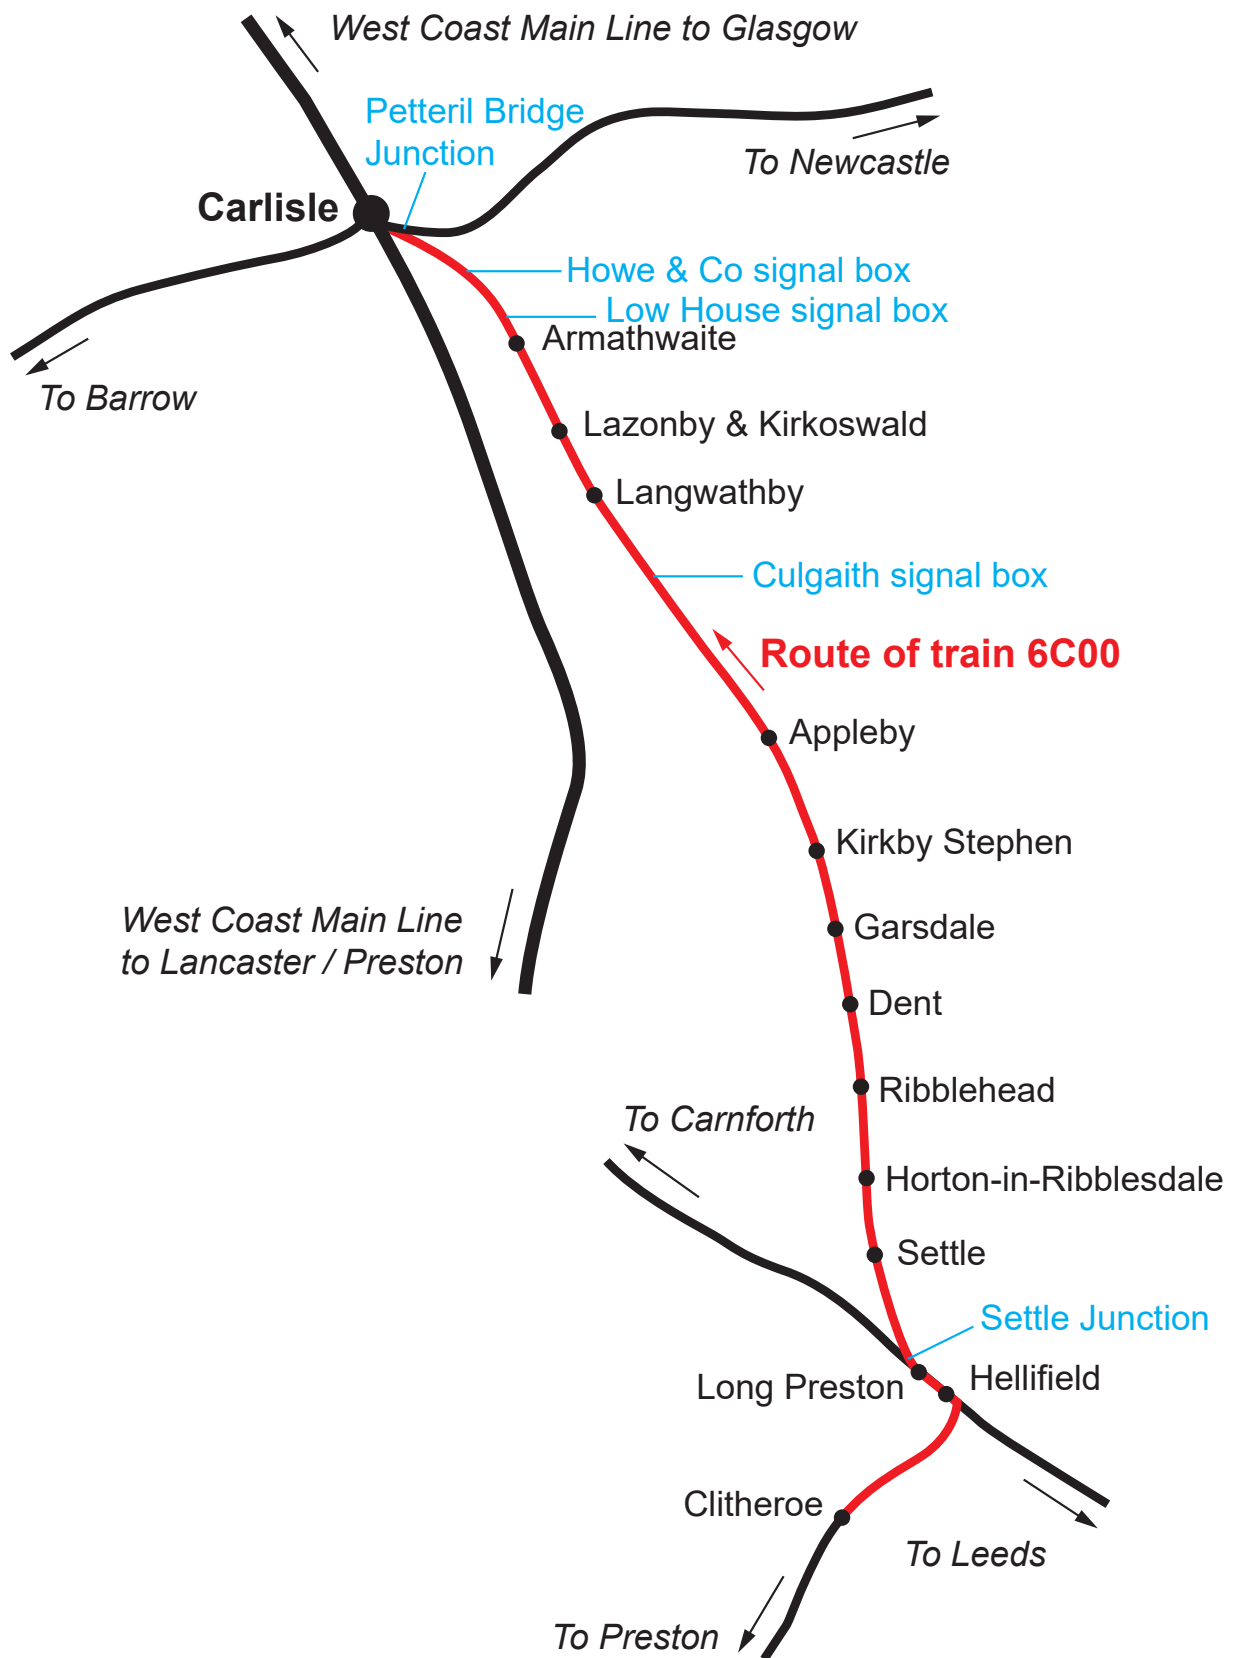
Figure 8: Route of train 6C00.

- 23 The signaller at Culgaith signal box (figure 8) had been a signaller for 20 years and had operated Culgaith signal box for most of that period. This signaller held the relevant competencies required to operate Culgaith signal box at the time of the accident. Network Rail stated that there was no record of this signaller having been involved in any relevant safety-related incidents.

- 24 The signaller at Low House signal box (figure 8) had worked as a relief signaller for 23 years, covering several signal boxes on the Settle to Carlisle line, including both Low House and Culgaith. This signaller held the relevant competencies required to operate these signal boxes. Network Rail stated that there was no record of this signaller having been involved in any relevant safety-related incidents.

- 80 Figure 31 shows that a wheel flat with a depth of at least six millimetres would be required before a false flange sufficient to leave marks on converging rails at points could exist. That would require the wheel to have slid for some distance, probably several miles, before it would leave evidence of false flange marks. This suggests that the slide was initiated somewhere between Blea Moor and Ais Gill (figure 8).

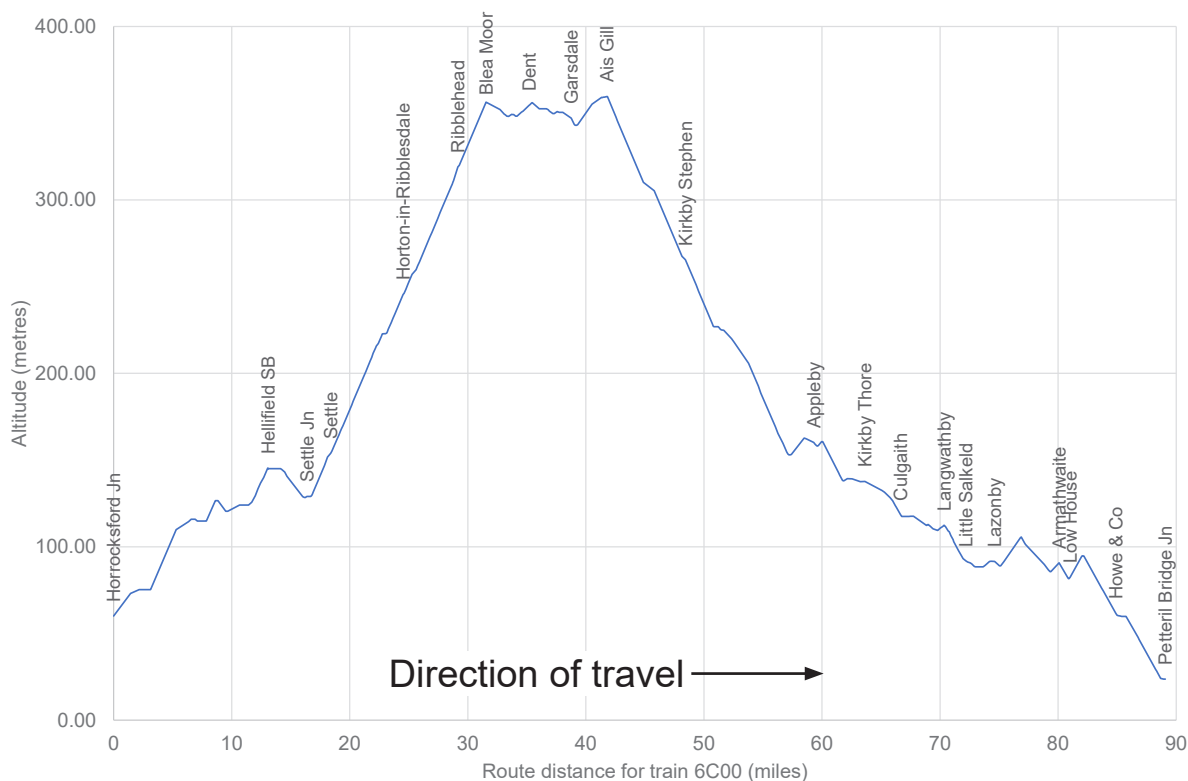
Figure 9: Gradient profile for the route of train 6C00.

- 30 At Hellifield, the train joined the route via Settle Junction to Carlisle (the Settle to Carlisle line). After a gentle climb, the route includes a long, steep ascent into the north Pennine hills, with a 15 mile (24 km) stretch at an average gradient of 1 in 107. There is then a flatter 10 mile (16 km) long stretch along the top of the hills before a 15 mile (24 km) long descent at an average gradient of about 1 in 120, followed by a gentler descent towards Petheril Bridge Junction. Figures 8 and 9 show the route and gradient profile for the journey of train 6C00 from Clitheroe to Carlisle.

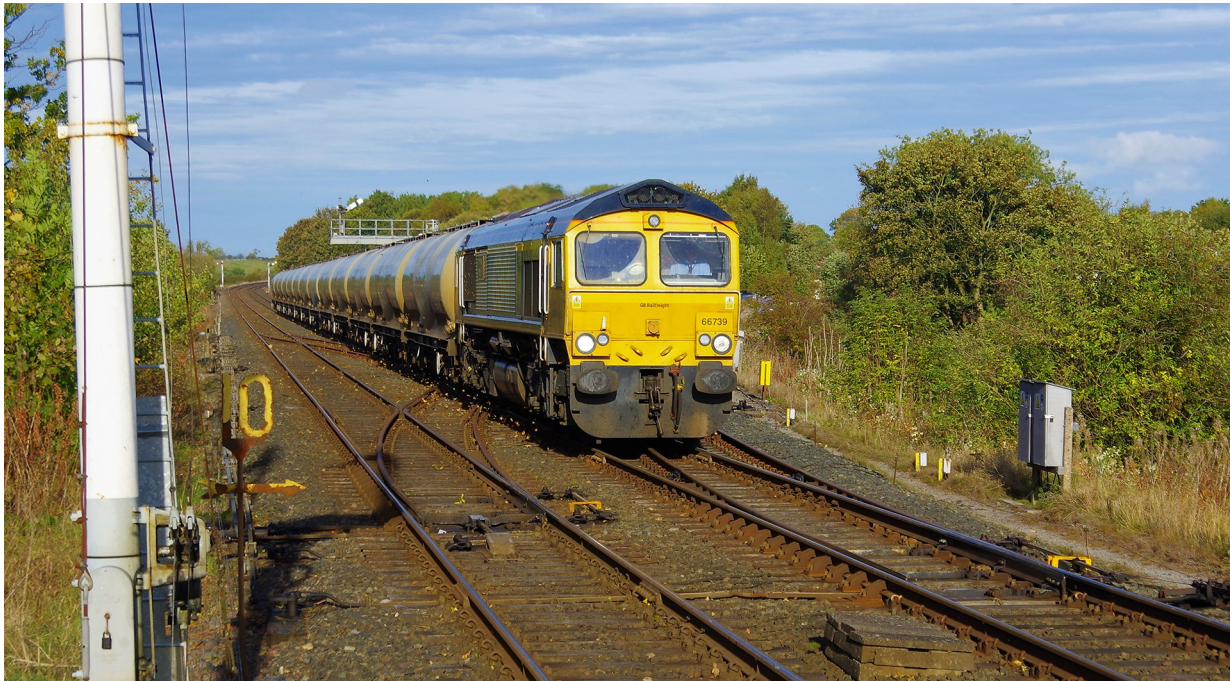
47 At 12:27 hrs on 19 October 2022, train 4N00 (figure 13) arrived in the loading sidings at Clitheroe cement terminal from Carlisle, after reversing into the terminal from Horrocksford Junction (figure 14). Train 4N00 conveyed twelve of the empty wagons that would later form train 6C00, as well as an additional thirteenth empty wagon that was to be detached at Clitheroe for maintenance.

Figure 13: Train 4N00 on its southbound journey at Appleby (courtesy of Paul Berry).

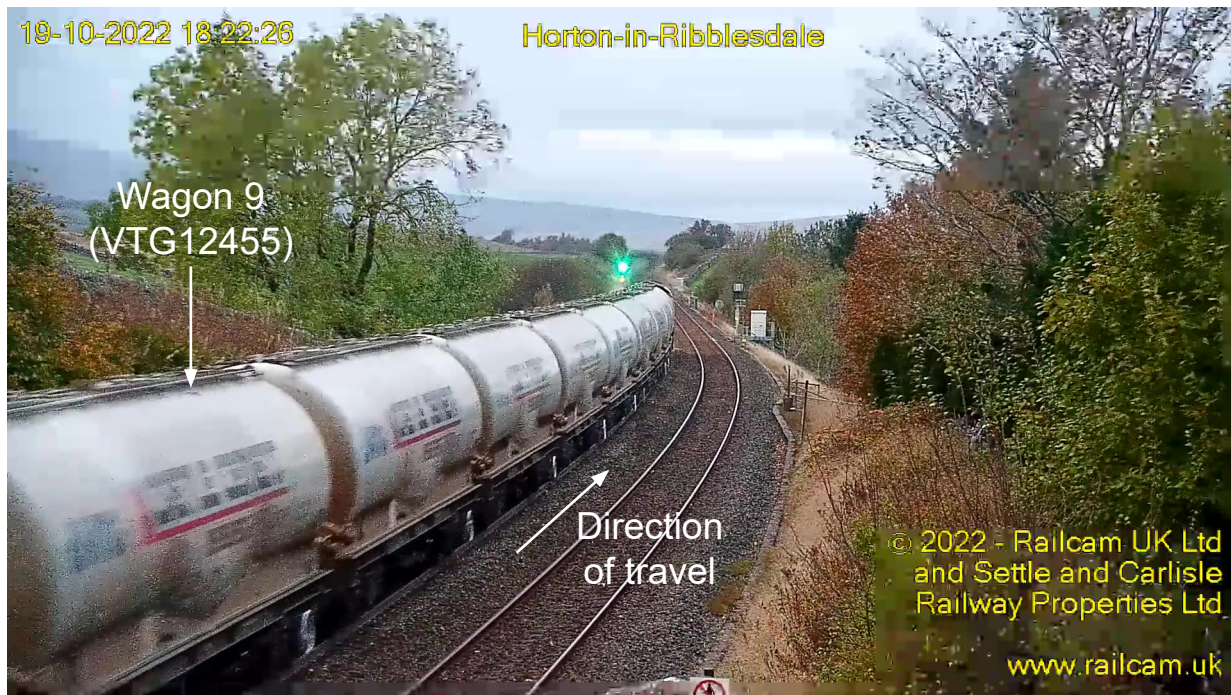
Figure 15: Train 6C00 passing Horton-in-Ribblesdale (courtesy of Railcam UK and the Friends of the Settle-Carlisle Line).

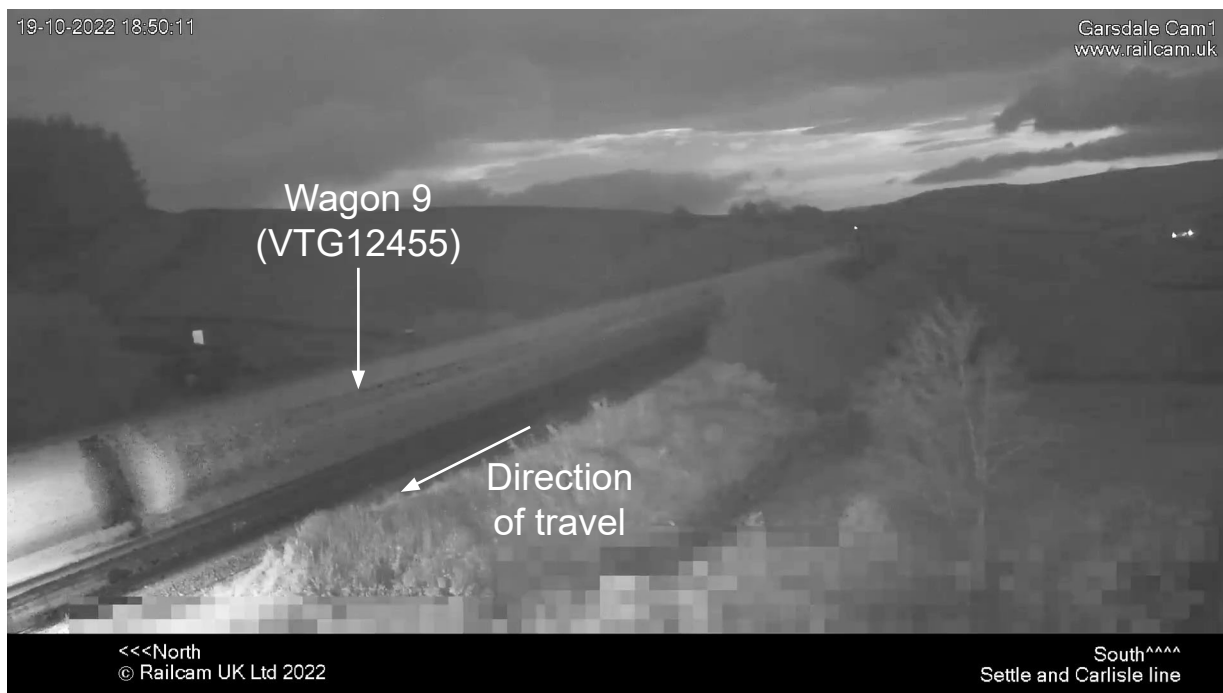
- 54 At 18:50 hrs, the train passed another public webcam at Garsdale (figure 16), by which time it was getting dark. A review of this footage by RAIB did not identify any visual or audible signs of a problem with the train.

Figure 16: Train 6C00 passing Garsdale (courtesy of Railcam UK and the Friends of the Settle-Carlisle Line).

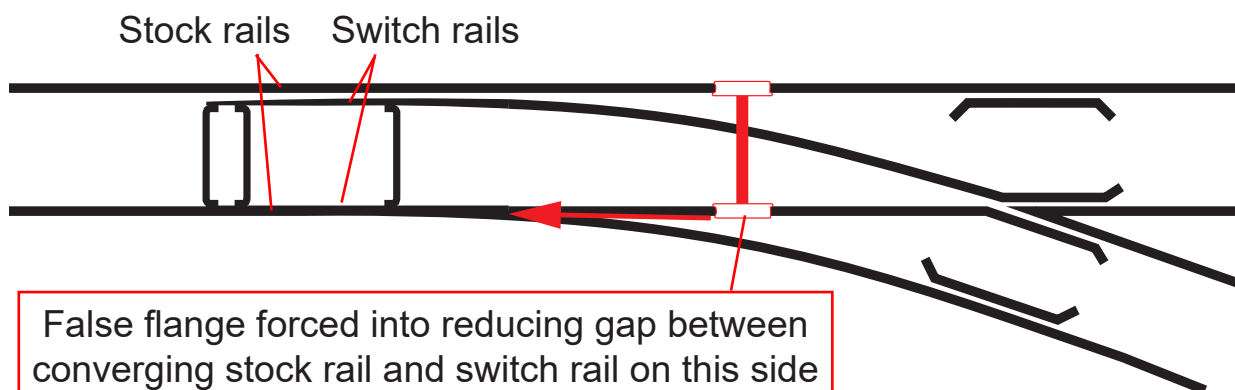
69 Marks at the site showed that, during the initial stage of the derailment, the outer edge of the false flange on the leading left wheel of the ninth wagon had become trapped between the converging stock rail and switch rail at 679A points (figure 23). In the absence of a false flange, the outer edge of the wheel would have passed over the top of the converging rails, with the contact surface of the wheel transitioning from the switch rail to the stock rail. Figure 24 shows the marks on the inside of the stock rail as the outer edge of the trapped false flange on the leading left wheel ran along the inside of it at the tip of the switch rail as the wheel dropped into the four-foot (the gap between the running rails).

Figure 23: Route of the false flange at trailing points.

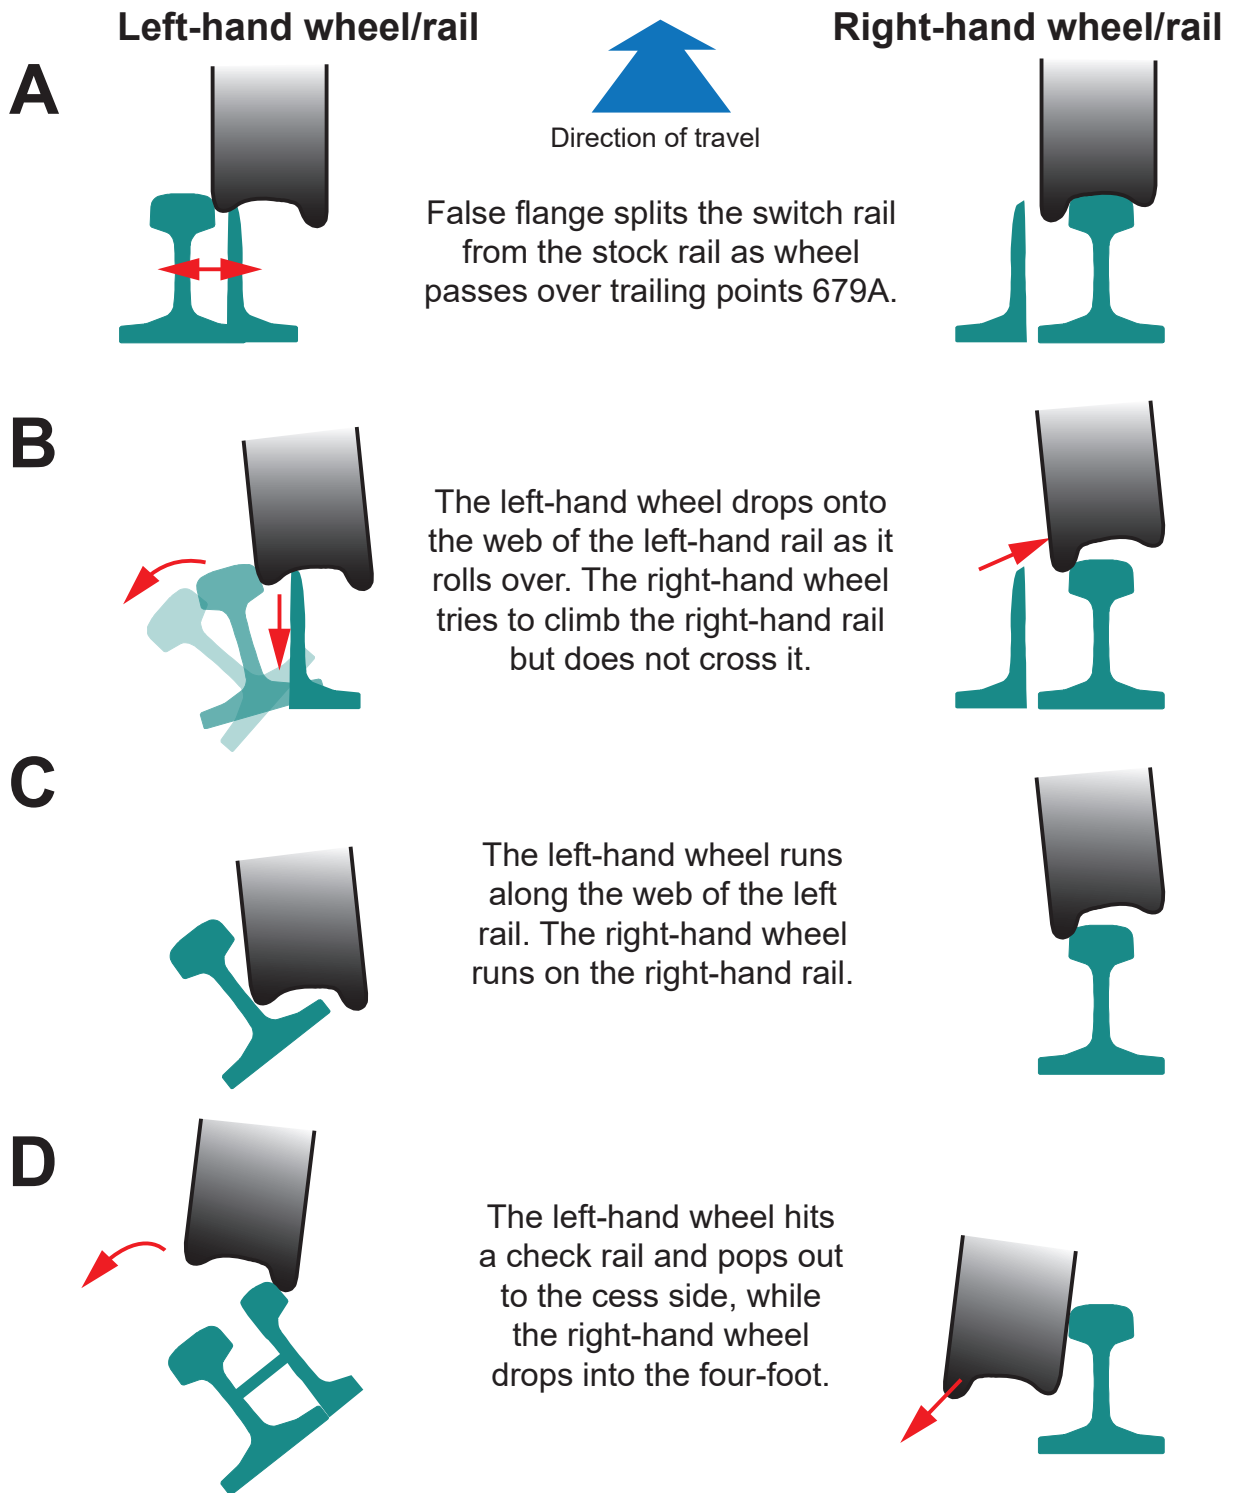
Figure 25: Derailment mechanism.

- 70 This event, and the subsequent stage of the derailment mechanism is illustrated in figure 25. The left wheel dropped inside the left rail after it passed the end of the switch rail, with its outer face then pushing the left rail outwards, while the flange of the right wheel was pushing against the right rail and trying to climb up onto it. The track fixings holding the left rail in position then gave way and the rail shifted laterally and started to roll over. A few metres further on, the left wheel collided with a check rail that was mounted inside the left rail as part of the next set of points. This caused the left wheel to climb over the left rail, and the right wheel to drop into the four-foot.

- 71 This derailment mechanism, where a wheel with a false flange on the outside edge derails at a set of trailing points has been seen at a number of previous derailments. Examples include Hatherley ([RAIB report 08/2006](#)), Dunkeld & Birnam ([RAIB safety digest 01/2019](#)), and Llangennech ([RAIB report 01/2022](#)).

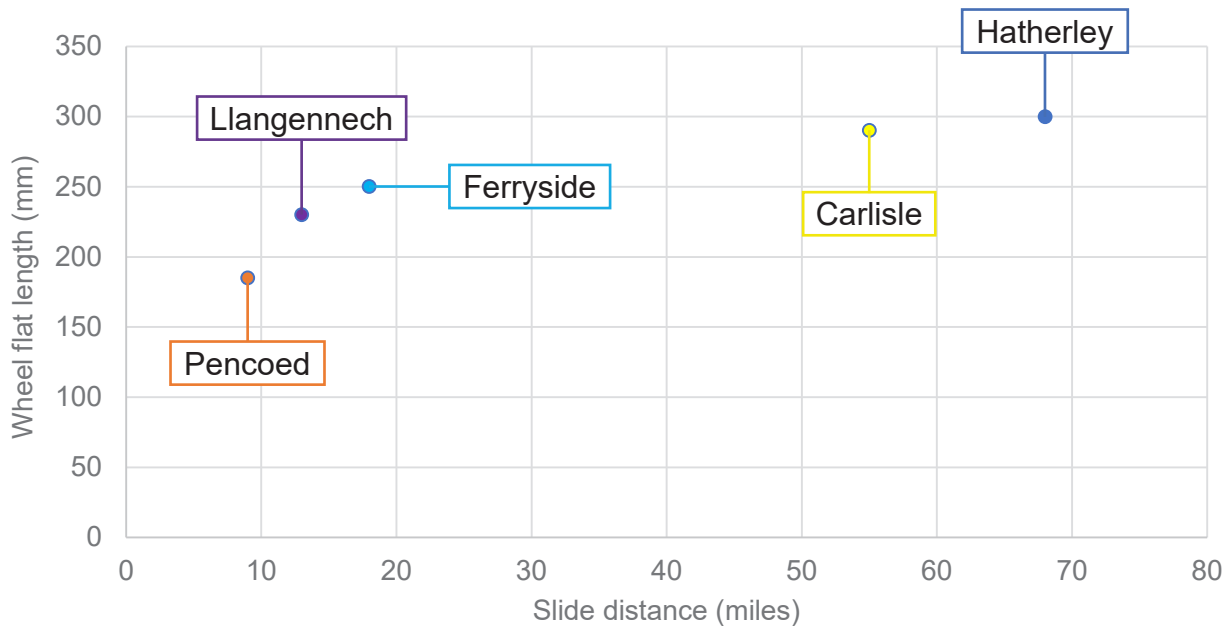
- 77 The size of the wheel flats generated over this length of slide is consistent with the wheel flats and slide distances observed in the investigations described in paragraph 75, and with that recorded during an additional derailment at Hatherley ([RAIB report 08/2006](#)). The graph in figure 26 shows the observed relationship between wheel flat length and likely slide distance.

Figure 26: Wheel flat lengths and slide distances during previous incidents.

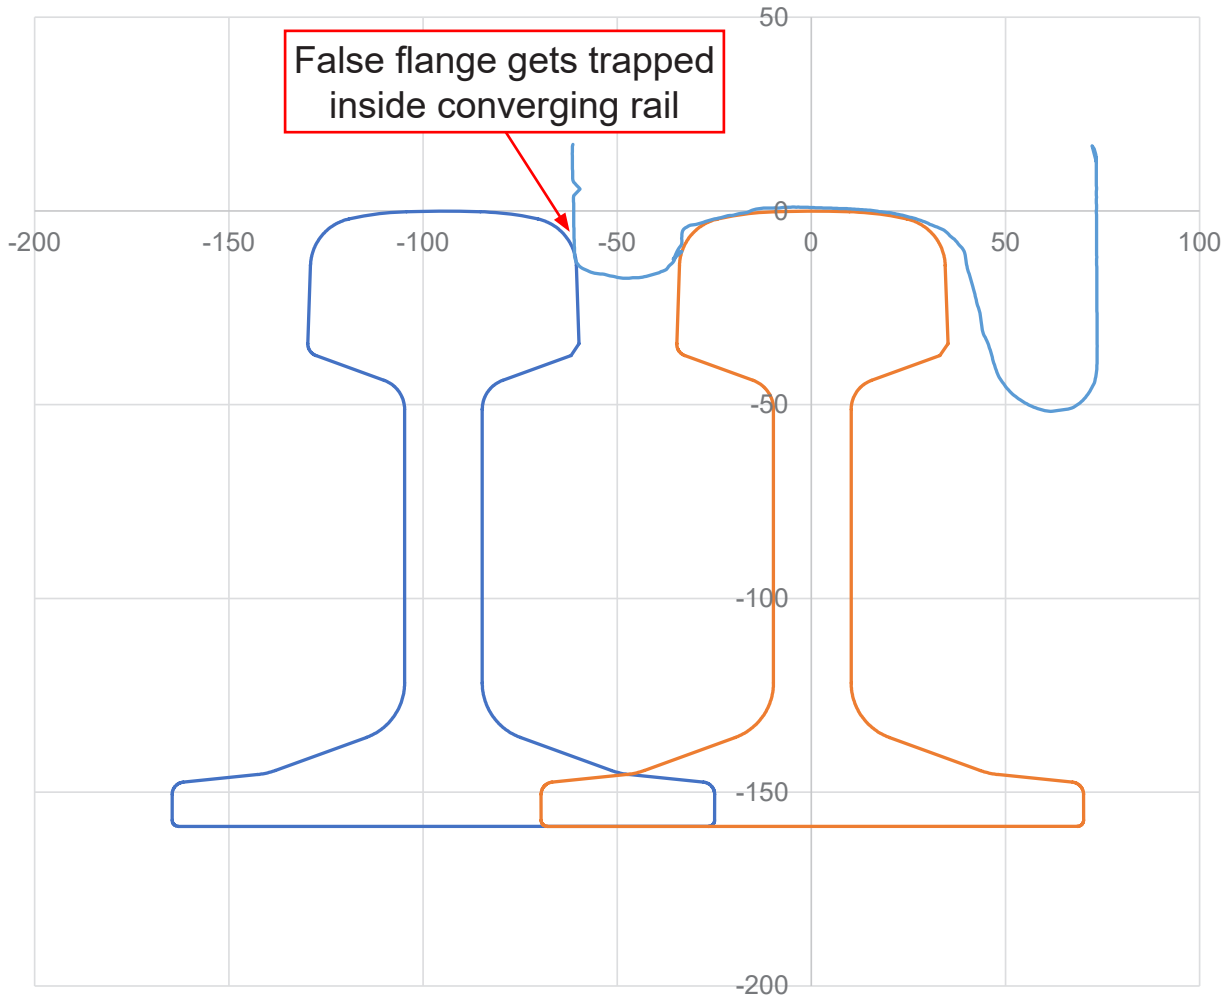
- 78 The wheel flats that resulted in the initial derailment of the ninth wagon were sufficiently deep that a false flange had been created on the outside of the wheel, that protruded below the level of the railhead (figure 27). When a sliding wheel with a false flange passes over a set of points, the false flange on the outside of the rail comes into contact with the converging and diverging rails and leaves marks as it is dragged over the top of them without derailing (figure 28). If the false flange is sufficiently big, the speed is sufficiently low, and the angle of the converging rail is shallow enough, then the false flange can become trapped between the converging rails at trailing points and result in a derailment, as described in paragraph 70.

Figure 27: False flange protruding below railhead level.

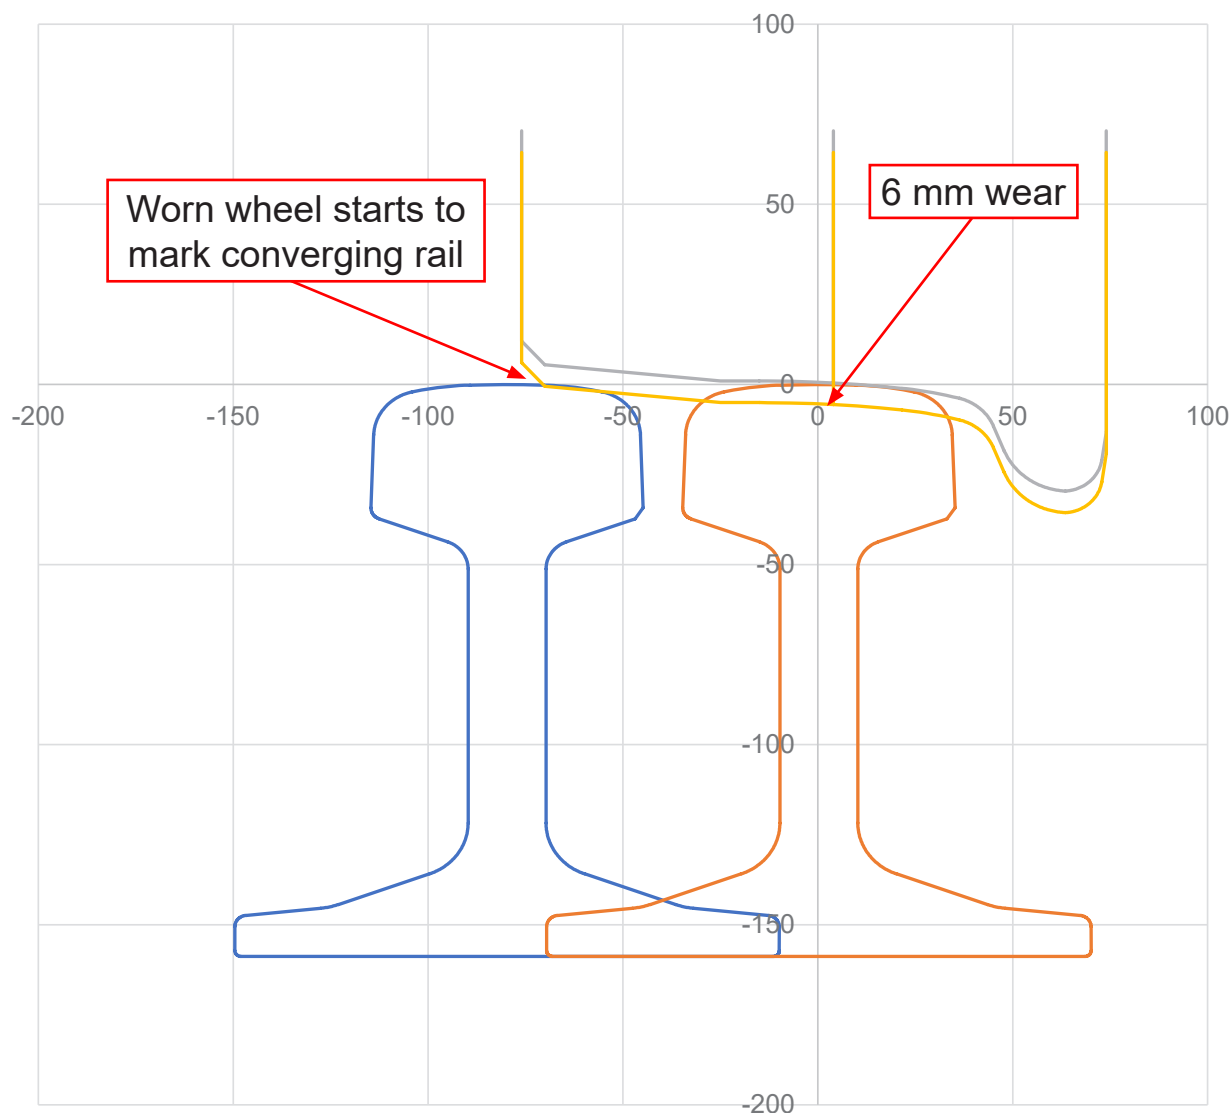
Figure 31: Illustration of wheel flat depth required to show false flange marks.

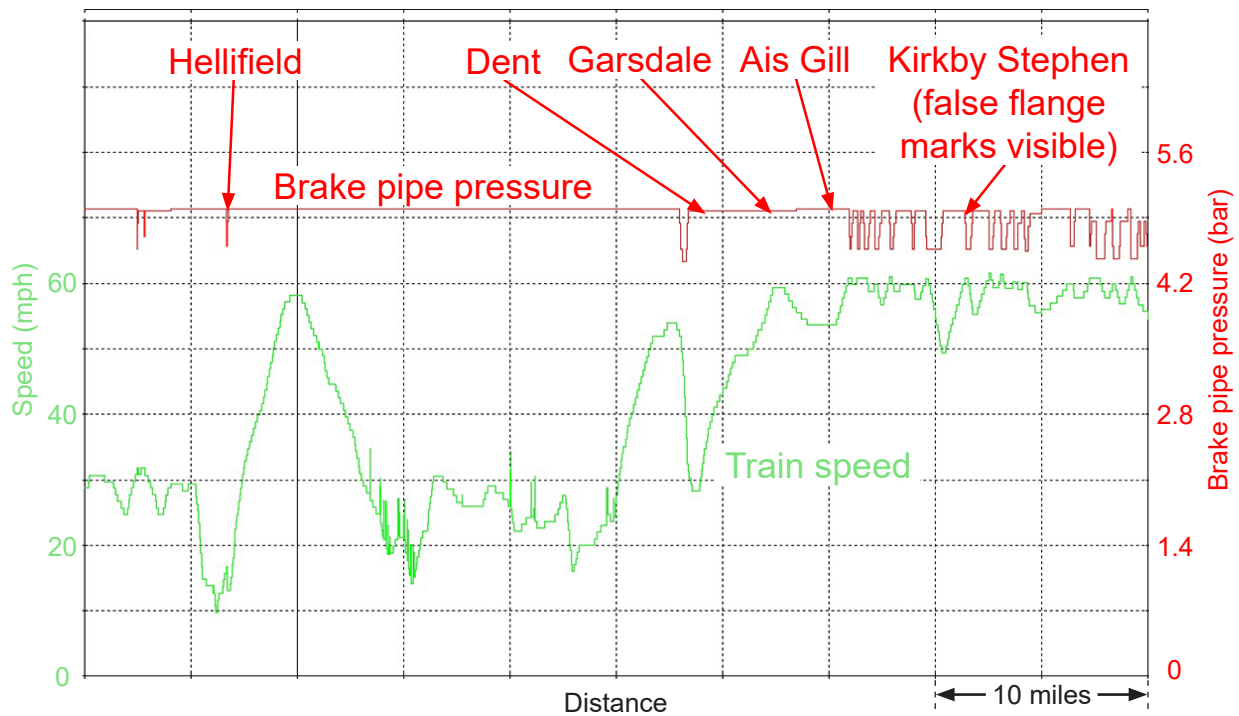
81 Given the absence of significant defects on the wagon braking system (paragraphs 34 to 46) and the unlikelihood of the other possible causes (see paragraphs 89 to 97), it is most likely that the wheel slide started during a brake application. Examination of data taken from the locomotive's on-train data recorder (OTDR) showed that there was a number of fairly short, light (4.6 bar brake pipe, or <25% full service) brake applications after the train had passed Ais Gill. These started about 6.2 miles (10 km) before Kirkby Stephen (figure 32), where the first false flange marks were seen. Before that there was a single, longer and harder (4.4 bar brake pipe, or 35% full service) brake application on the approach to Dent station. This brake application was 3.9 miles (6.2 km) before Garsdale and 13.7 miles (22 km) before Kirkby Stephen.

Figure 32: OTDR data showing speed and brake applications.

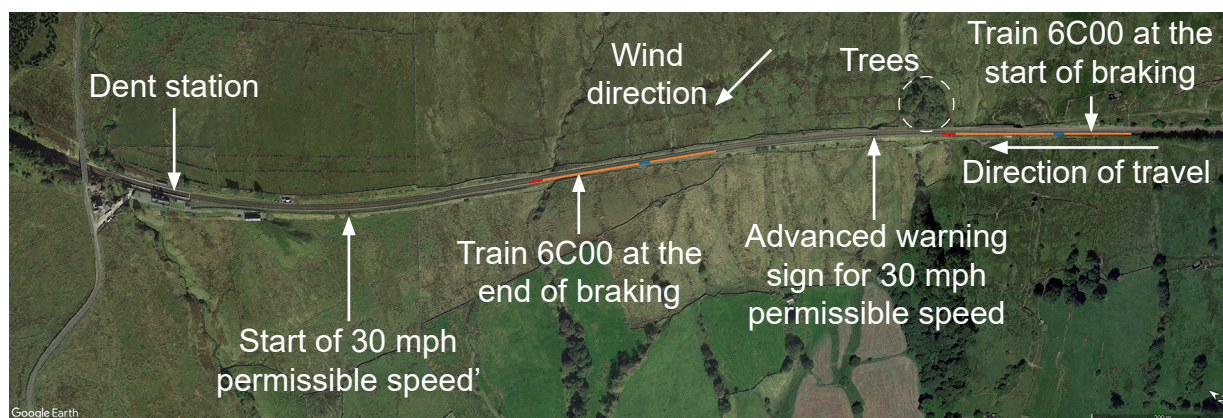
99 At Dent, the driver made a normal brake application (35% of full service) that was about 30 seconds long, starting just before the advance warning board for the upcoming speed restriction (figure 33). During this brake application, the train passed a group of trees that was outside the railway boundary and surrounding a stream that passed under the railway in a culvert.

Figure 33: Satellite view of braking location at Dent (ninth wagon shown in blue).

100 As train 6C00 was traversing the Settle to Carlisle line, it was windy, with weather stations recording average wind speeds of around 15 to 20 mph (24 to 32 km/h), with gusting over 25 mph (40 km/h). This location is particularly exposed, being in the Pennine hills and near to the highest altitude mainline station in England at Dent. Given that it was mid-October, this made leaf fall from any trees in the vicinity likely.<sup>7</sup> Weather stations also recorded the air temperature at about 9°C, only about 1°C above the dew point (paragraph 27), making condensation on the railhead a possibility (as noted by signallers further north, paragraph 25). The combination of leaf fall conditions and possible condensation means that it is credible that there were low wheel/rail adhesion conditions at this location.

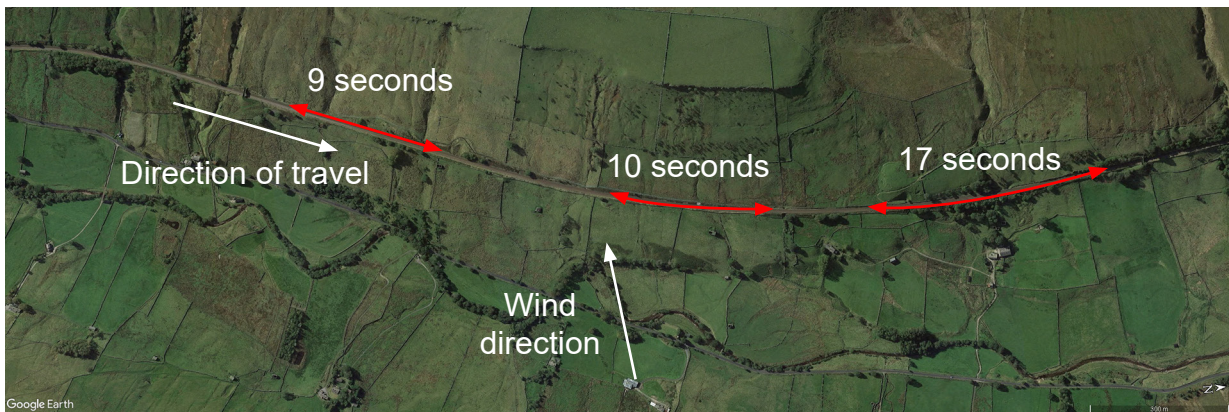
Figure 34: Satellite view of braking location at Ais Gill.

101 After Ais Gill, the driver made several shorter, lighter brake applications to manage the speed of the train (figure 34). There were more individual scattered trees here than at Dent, but there was no concentrated source of leaf fall until a cutting where the third brake application was made. The same environmental conditions would probably have been present here as at Dent, although the leaf fall source was more spread out. However, low wheel/rail adhesion at this location would also have still been a possibility.

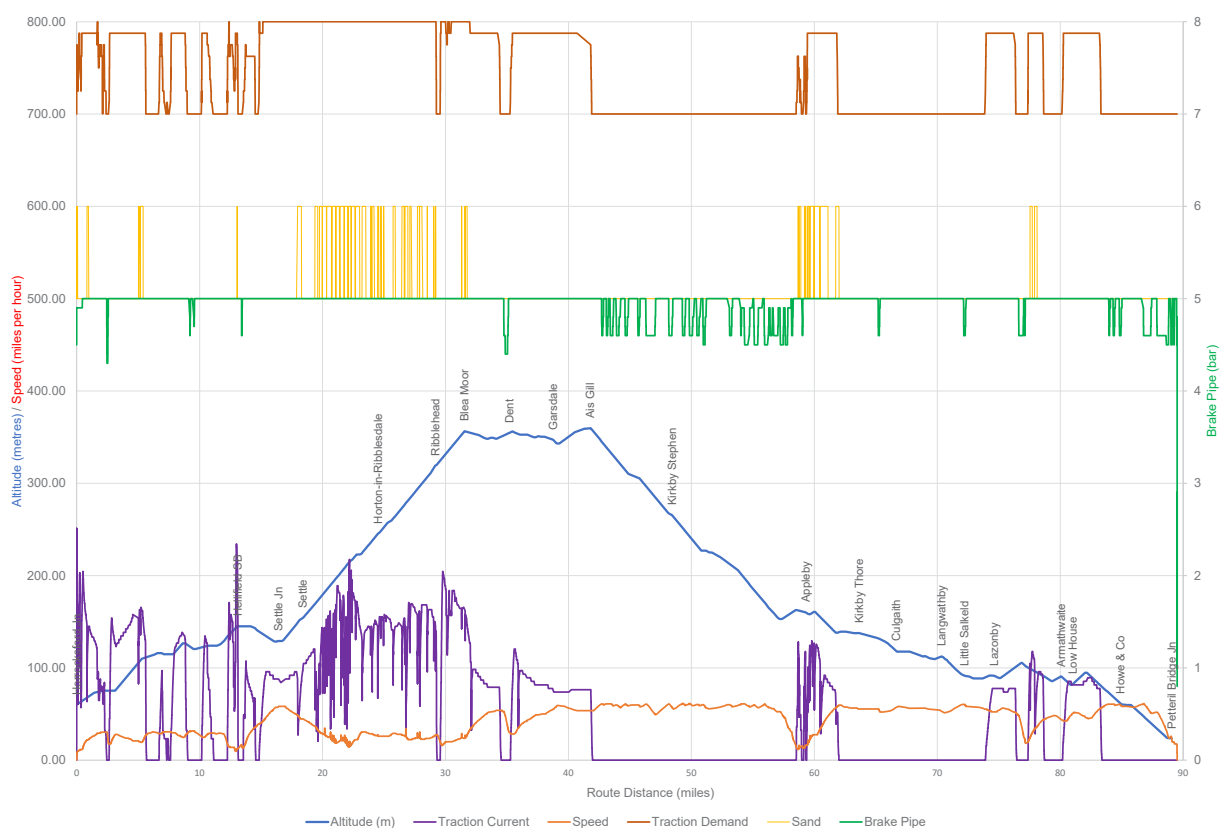
- 105 Examination of the OTDR data from the locomotive showed that its wheels were experiencing wheel slip when traction was being applied by the driver, particularly when the locomotive was at full power on the long climb from Settle to Blea Moor, and when accelerating at Appleby and after Lazonby & Kirkoswald (figure 35). This demonstrates that adhesion levels were low at many places along the route, and the locomotive was managing this by limiting the amount of power that was being applied to the wheels and by depositing sand onto the railhead just ahead of the wheels to improve adhesion conditions.

Figure 35: Locomotive data showing low adhesion under traction.

106 Because the locomotive was experiencing wheel slip under traction, it was operating at the limit of the available adhesion in some locations. This meant that it was possible for RAIB to calculate the approximate average available adhesion (coefficient of friction between wheel and rail) using the weights of the locomotive and the train, the speed profile of the train and the gradients. RAIB made this calculation for three varying length sections of the line north of Settle, during which the locomotive was at full power and managing its traction output (table 1). This analysis can only be undertaken when the locomotive is providing traction and exhibiting wheel slip, so no similar analysis was possible in the vicinity of Dent and Ais Gill when the train was braking.

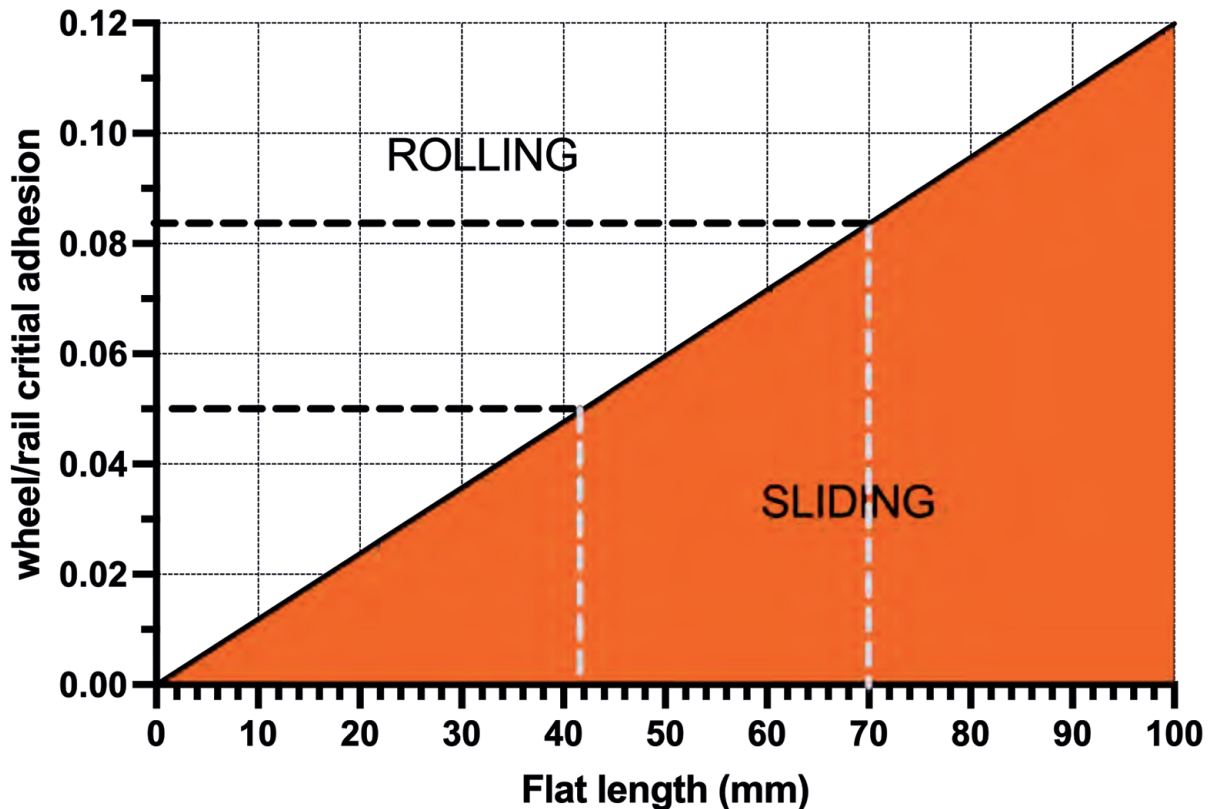
Figure 36: Plot showing the relation between wheel/rail critical adhesion and the flat length.

- 115 As the slide is maintained, the wheel flat will get larger, and the friction required for the wheel to be able to start rotating again also becomes larger. By the time the flat gets to 100 mm, the adhesion level then required needs to exceed 0.12, which is higher than the average seen (even with sand present) on the climb from Settle to Ribbleshead.

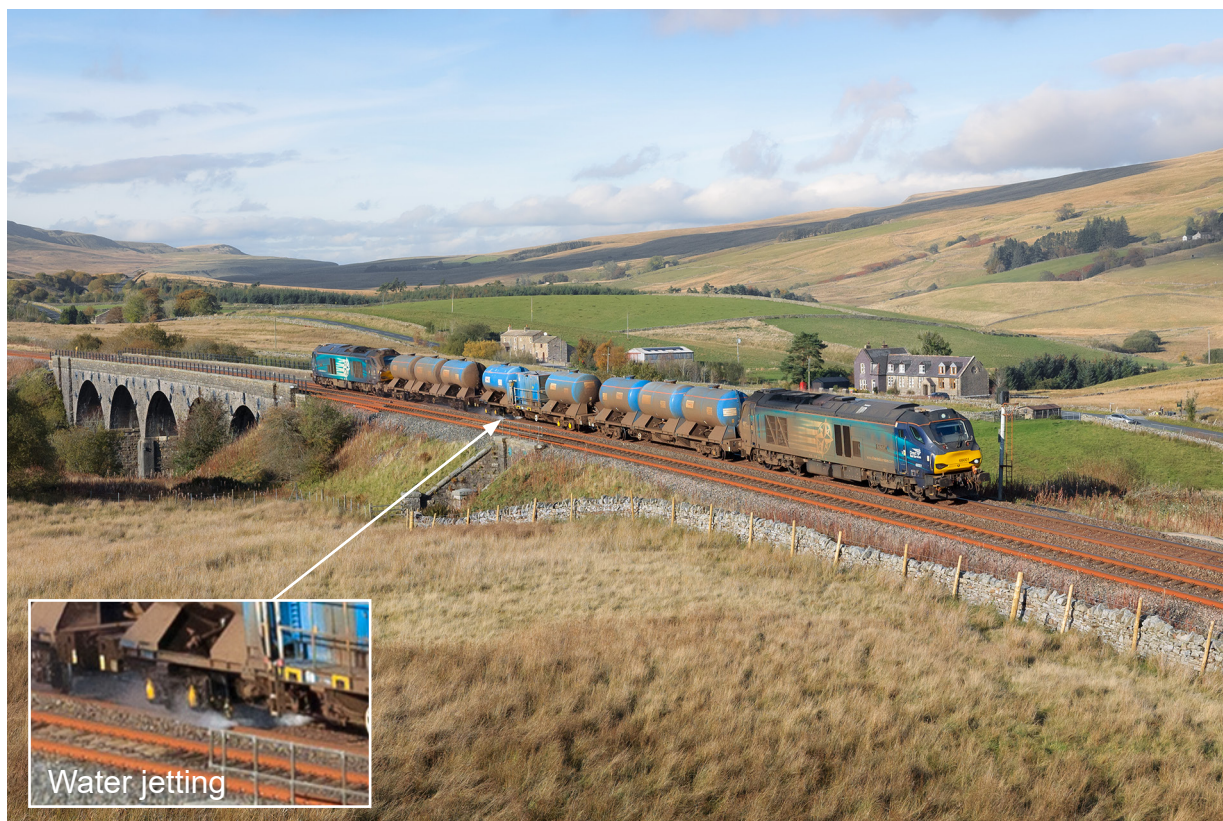
- 127 Network Rail managed low adhesion conditions on the entirety of the Settle to Carlisle line using an RHTT that jetted the surface of the rails with high pressure water (figure 37). This treatment was primarily undertaken at 60 mph (96 km/h), but defined sections of line, that required more intense treatment, were passed at speeds down to 30 mph (48 km/h).

- 128 The last RHTT to traverse the down line (towards Carlisle) was 22.5 hours before the passage of train 6C00. The next RHTT was due about 1.5 hours after train 6C00. Although the RHTT travelled over the line from Blackburn to Hellifield, via Horrocksford Junction, the primarily freight-only section from Horrocksford Junction to Hellifield was not treated.

Figure 37: The RHTT on the Settle to Carlisle line on the day before the derailment (courtesy of Aidan Fort).

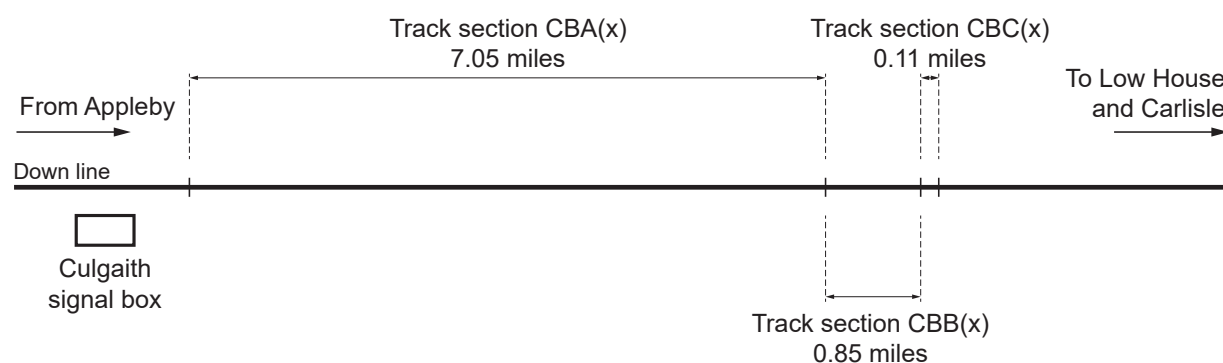
140 Once the train had reached Lazonby & Kirkoswald, it had left the last of the three axle counter sections controlled by Culgaith signal box (paragraph 59). At that point, the Culgaith signaller recognised that all three sections were still indicated as occupied. The track section occupation indicators had lit one-by-one as the train progressed but the signaller did not identify that the sections were not clearing sequentially as the train progressed until the train reached Lazonby & Kirkoswald. This was because the latter two sections were much shorter than the first and they lit up with little time delay between them (figure 38).

Figure 38: Configuration of the axle counters associated with Culgaith signal box.
