Rail Accident Investigation Branch

# Rail Accident Report

## **Freight train derailment at Petteril Bridge Junction, Carlisle 19 October 2022**

Report 10/2023  
October 2023

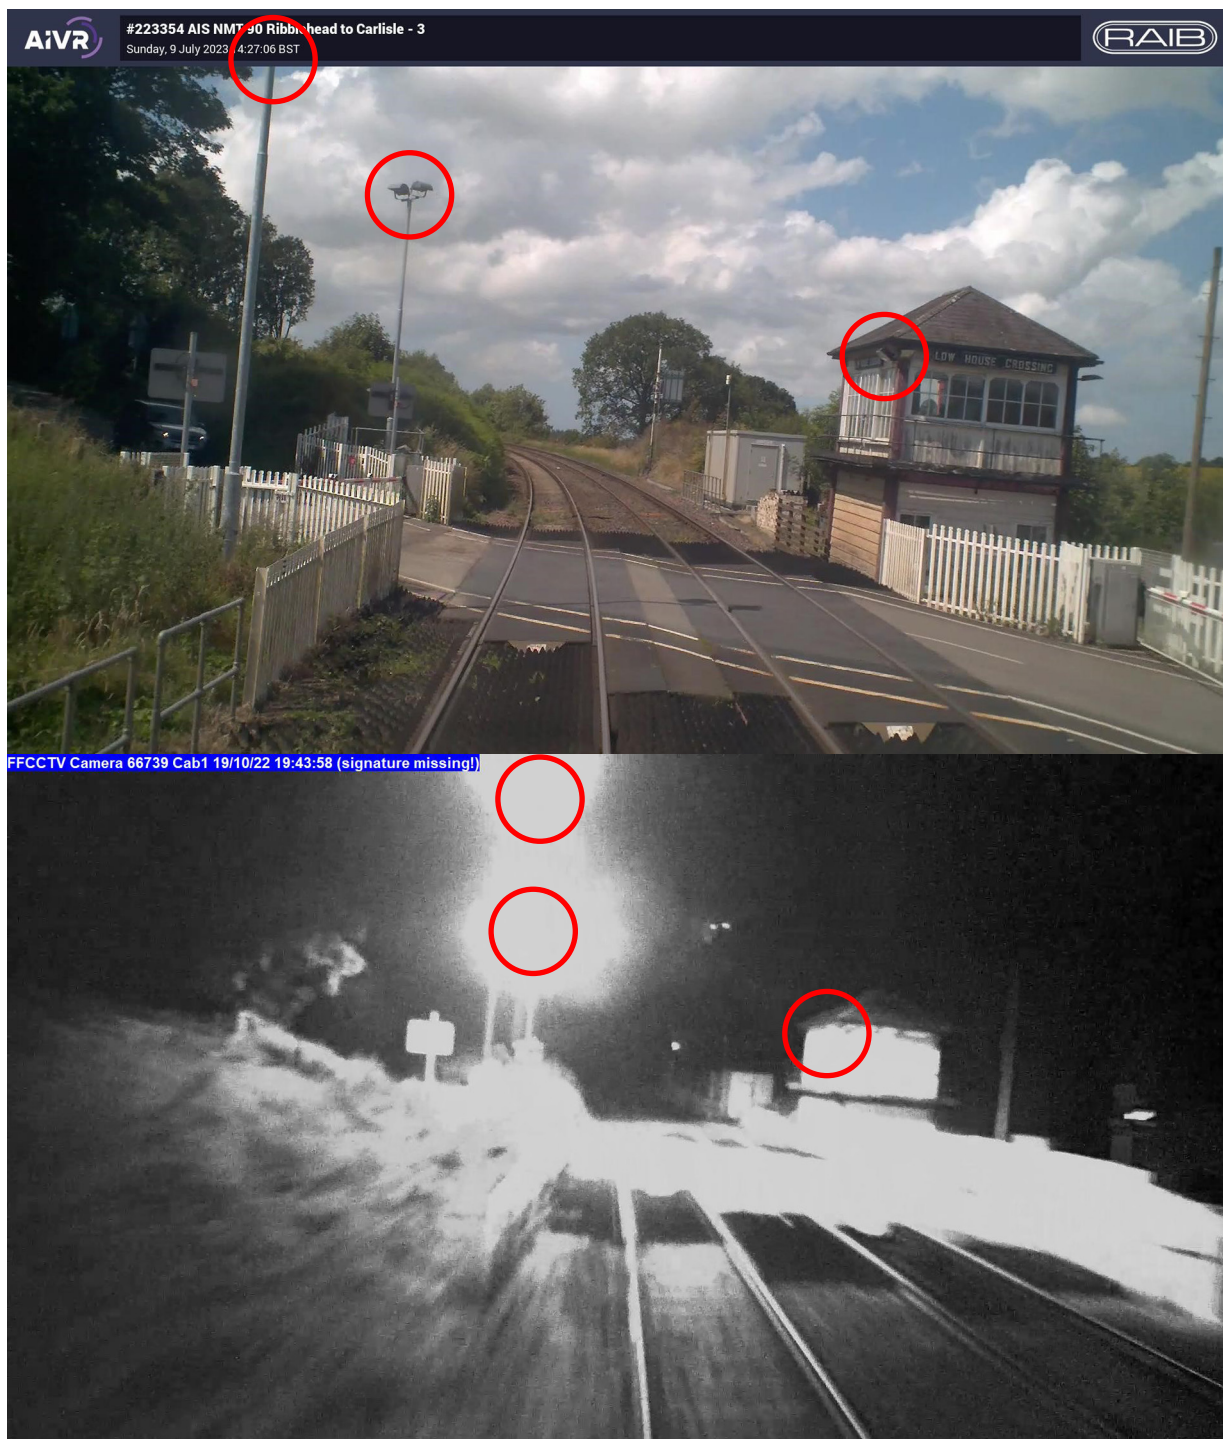
Figure 17: Rear-facing CCTV image from train 2H97 showing sparking at a wheelset on train 6C00 (courtesy of Northern Trains).

Figure 39: Low House signal box, with floodlights circled (top image courtesy of Network Rail, bottom image courtesy of GB Railfreight).
