ACCIDENT

Aircraft Type and Registration:	Schleicher AS-K 13, G-DCMK	
No & Type of Engines:	None	
Year of Manufacture:	1975 (Serial no: 13305)	
Date & Time (UTC):	12 August 2022 at 1054 hrs	
Location:	Troed yr Harn, Talgarth, Powys	
Type of Flight:	Training	
Persons on Board:	Crew - 2	Passengers - None
Injuries:	Crew - 2 (Serious)	Passengers - N/A
Nature of Damage:	Destroyed	
Commander's Licence:	BGA Instructor rating (Full)	
Commander's Age:	71 years	
Commander's Flying Experience:	7,099 hours (of which approximately 2,500 were on type) Last 90 days - 42 hours Last 28 days - 6 hours	
Information Source:	AAIB Field Investigation

Synopsis

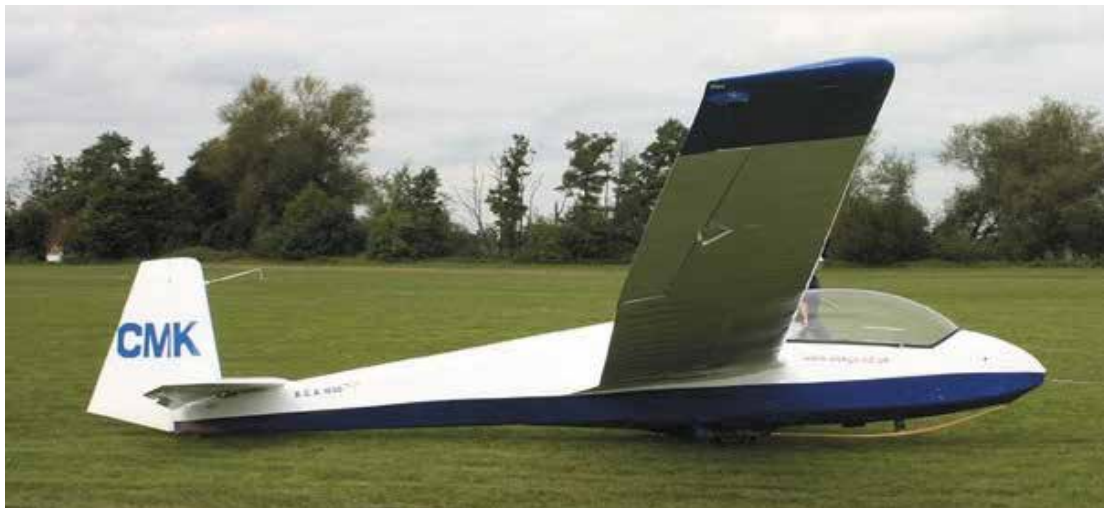
Figure 2
G-DCMK

The Schleicher AS-K 13 is a two-seat glider, commonly used for training. G-DCMK was purchased in June 2017 by the gliding club and was maintained by its members. The K 13 was designed to have two tow releases fitted, the first in the nose for aerotowing and a second “belly hook” under the fuselage, primarily for winch launching. At some point in the glider’s history the belly hook was removed and replaced with a light spring to maintain the cable tension through the guides. This would not have affected the operation of the nose release.

Nose tow release
