ACCIDENT

| Aircraft Type and Registration: | Pegasus Quik, G-CCPC | |
| Location: | East Fortune Airfield, East Lothian | |

Synopsis

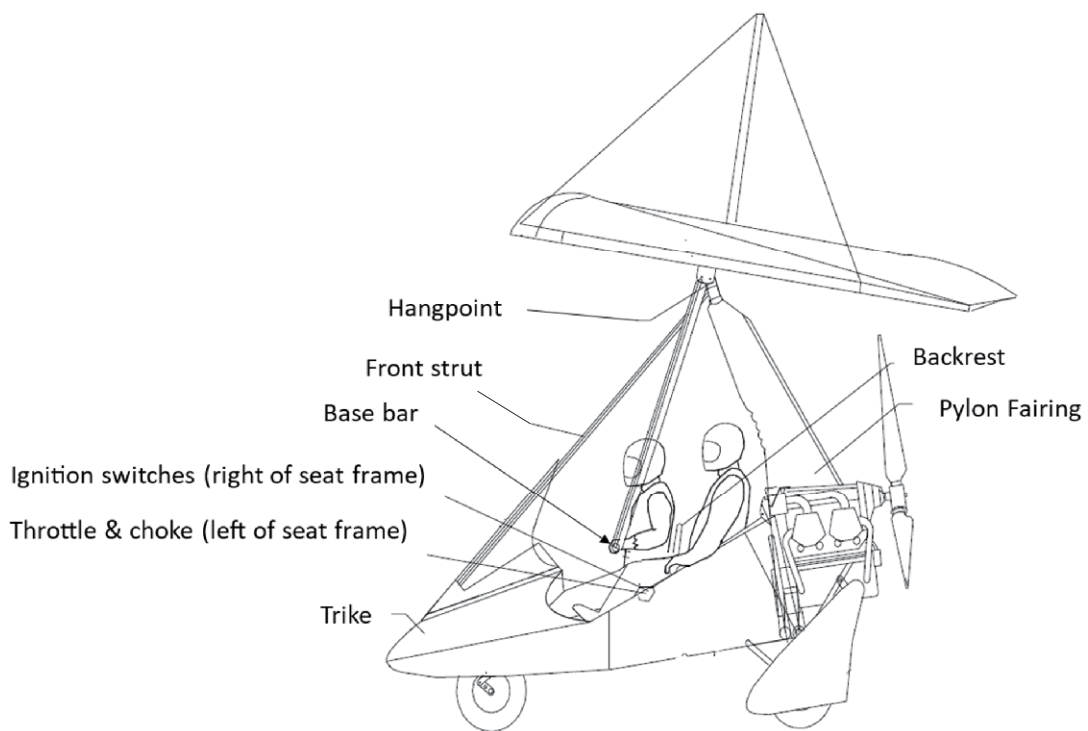
Figure 4

G-CCPC was a Pegasus¹ Quik flexwing microlight powered by a Rotax 912 ULS piston engine, which has a maximum rpm of 5,800. Significant features of the aircraft are shown in Figure 4.

Significant features of the Pegasus Quik aircraft

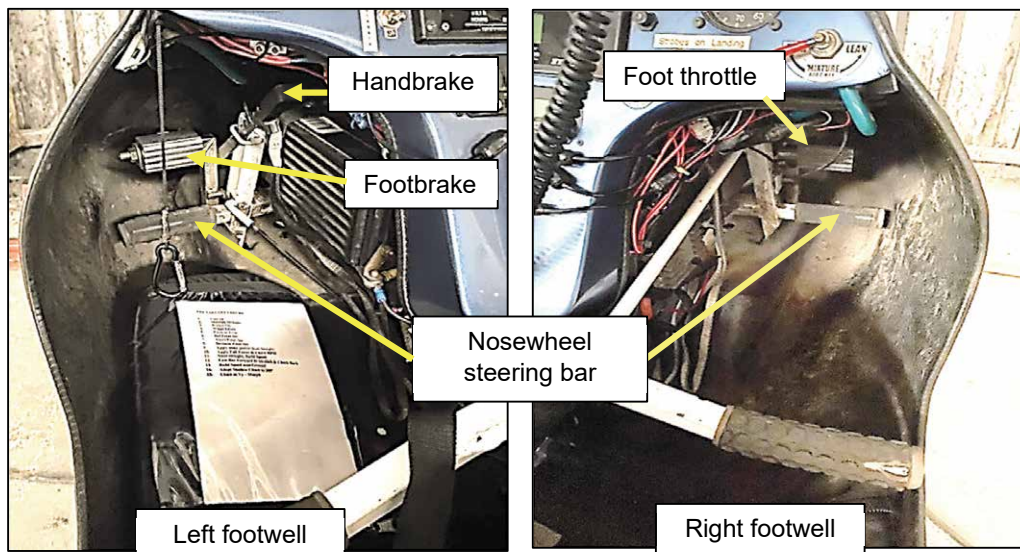
Figure 5

The aircraft is fitted with disc brakes on the two mainwheels, which can be operated by a hand lever located in the left footwell or a brake pedal located above the left footrest on the nosewheel steering bar (Figure 5). The aircraft does not have differential braking.

Location of footbrake, handbrake, foot throttle and nosewheel steering bar
